U.S.S. FRANKLIN HONSHU CV-13
19 MARCH 1945
BOMB DAMAGE
NAVY DEPT BUREAU OF SHIPS
8/13/45

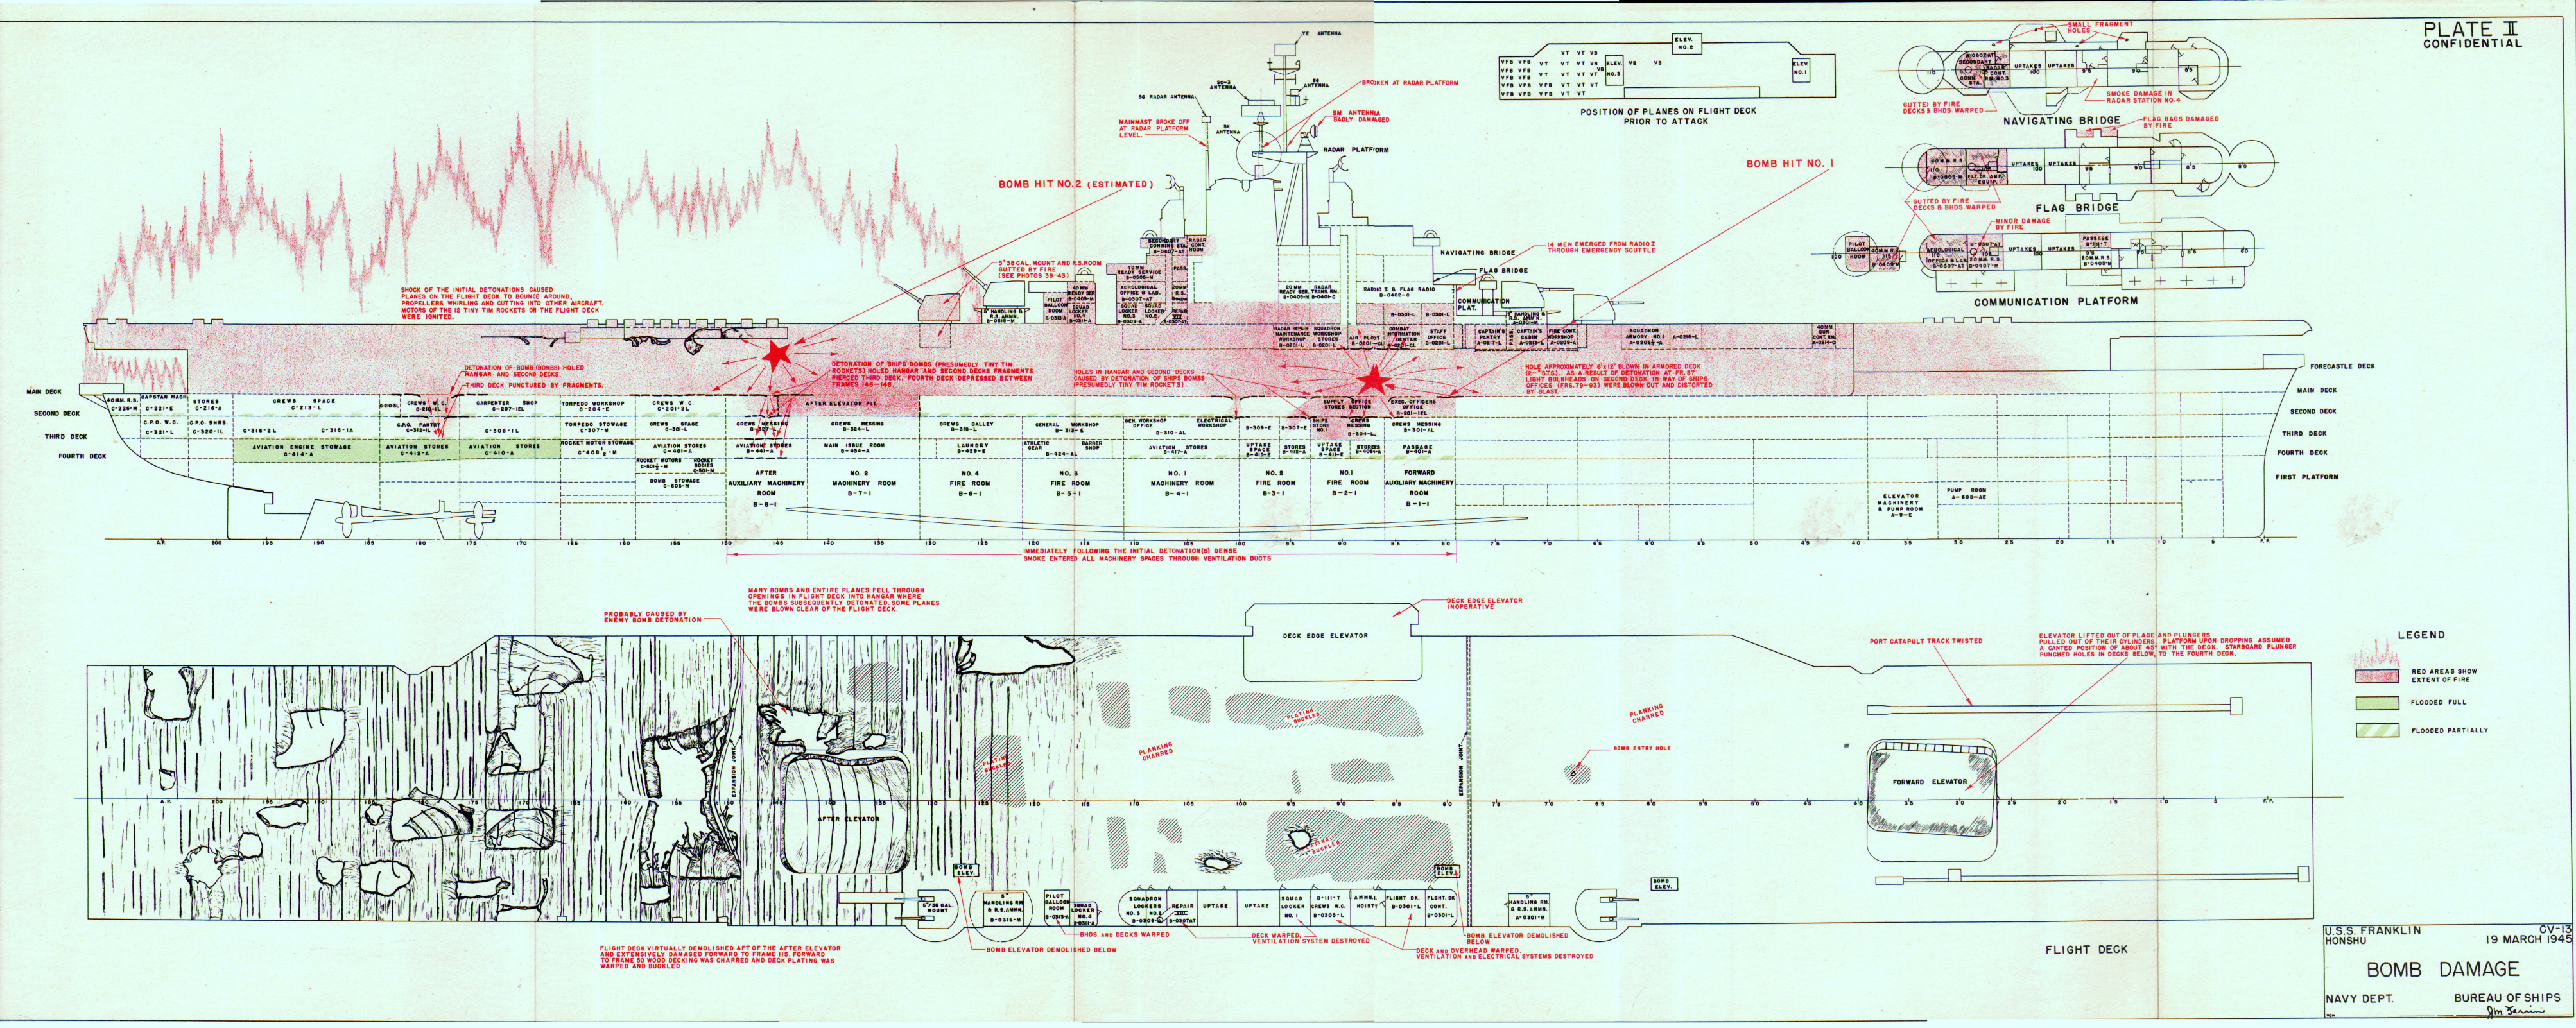
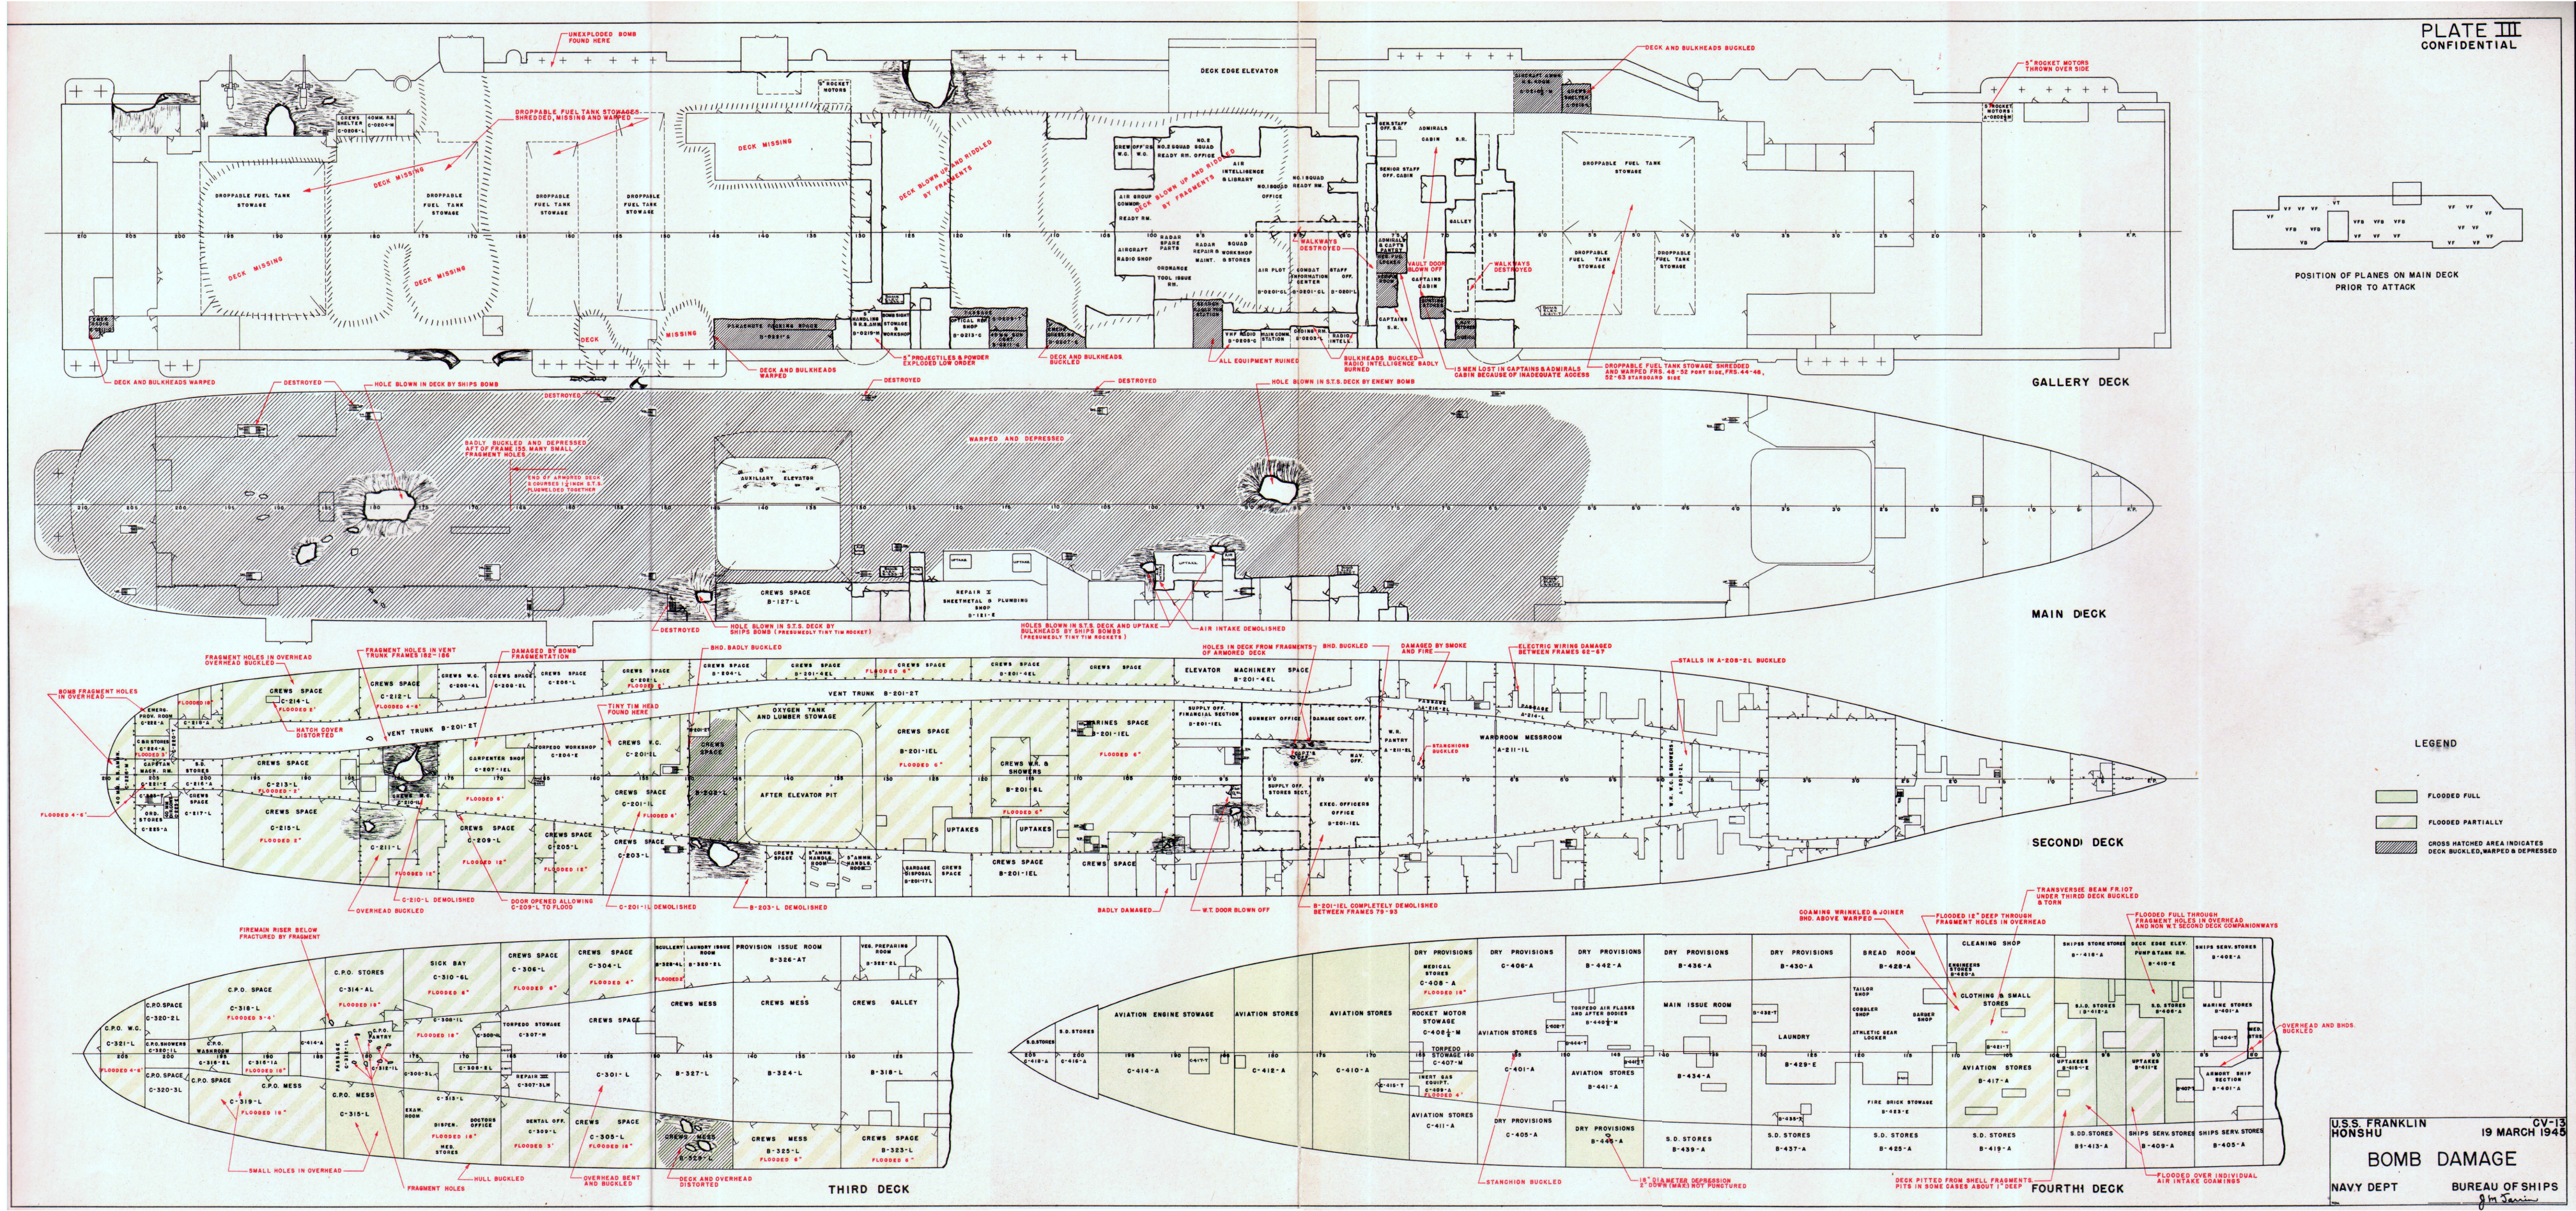
SHOCK OF THE INITIAL DETONATIONS CAUSED PLANES ON THE FLIGHT DECK TO BOUNCE AROUND, PROPELLERS WHIRLING AND CUTTING INTO OTHER AIRCRAFT. MOST OF THE 18 TINY TFM ROCKETS ON THE FLIGHT DECK WERE HIT.

DETONATION OF BOMB (BOMB) HOLED HANGAR AND SECOND DECK. THIRD DECK PUNCTURED BY FRAGMENTS.

DETONATION OF SHIP'S BOMBS (PRESUMEDLY TINY TFM ROCKETS) HOLED HANGAR AND SECOND DECK. FRAGMENTS PENETRATED THIRD DECK, FOURTH DECK DEBRIS BETWEEN FRAMES 145-148.

HOLES IN HANGAR AND SECOND DECK CAUSED BY DETONATION OF SHIP'S BOMBS (PRESUMEDLY TINY TFM ROCKETS).

HOLE APPROXIMATELY 6' IN DIAMETER BLOWN IN ARMORED DECK (L-324), AS A RESULT OF DETONATION AT 7:55. LIGHT BURSTING ON SECOND DECK IN WAY OF BOMB OFFICE, FRAMES 145-148 BLOWN OUT AND DISTORTED BY BOMB.

IMMEDIATELY FOLLOWING THE INITIAL DETONATION(S) DENSE SMOKE ENTERED ALL HIGHWAY SPACES THROUGH VENTILATION DUCTS.

MANY BOMBS AND ENTIRE PLANES FELL THROUGH OPENINGS IN FLIGHT DECK INTO HANGAR WHERE THE BOMBS SUBSEQUENTLY DETONATED. SOME PLANES WERE BLOWN CLEAR OF THE FLIGHT DECK.

PROBABLY CAUSED BY GREAT BOMB DETONATION.

DECK EDGE ELEVATOR INOPERATIVE.

PORT CATAPULT TRACK TWISTED. ELEVATOR LIFTED OUT OF PLACE AND PLUNGERS POLLED OUT OF THE 10 CLOUTERS. PLATFORM UPON DROPPING ASSUMED A SLOTTED POSITION OF ABOUT 45° TO THE DECK. STARBOARD PLUNGER PUNCTURED HOLES IN DECK BELOW TO THE FOURTH DECK.

FLIGHT DECK VIRTUALLY DEMOLISHED AFT OF THE AFTER ELEVATOR AND EXTENSIVELY DAMAGED FORWARD TO FRAME 175. FORWARD STAYAGE ON WOOD OPENING WAS CHAINED AND DECK PLATING WAS WARPED AND BUCKLED.

BOMBS AND DECKS WARPED.

DECK WARPED, VENTILATION SYSTEM DESTROYED.

BOMB ELEVATOR DEMOLISHED BELOW.

DECK AND OVERHEAD WARPED.

VENTILATION AND ELECTRICAL SYSTEMS DESTROYED.
