U.S.S. IDAHO entering ABSD-5

An inspection was made on the U.S.S. IDAHO by divers of the U.S.S. JASON on 29 June 1945 after that vessel suffered damage to her lower blisters and bottom while operating in the battle area. This inspection showed that the starboard lower blisters B-1, B-3, B-5 and B-7 were open to the sea. Each blister is five frames in length with four feet between frames. The damage began at frame 55 and extended to frame 90. Damage occurred to the lower set of blisters below the armor plate at the turn of the bilge, and the forward starboard bilge keel was damaged for about 30 feet of its length. It was also found that one blade of the No. 3 propeller was curled over a length of eight inches and cracked about four inches from the tip. On 18 July 1945 the U.S.S. IDAHO was dry-docked by the ABSD-5 for repairs by the JASON. All damaged

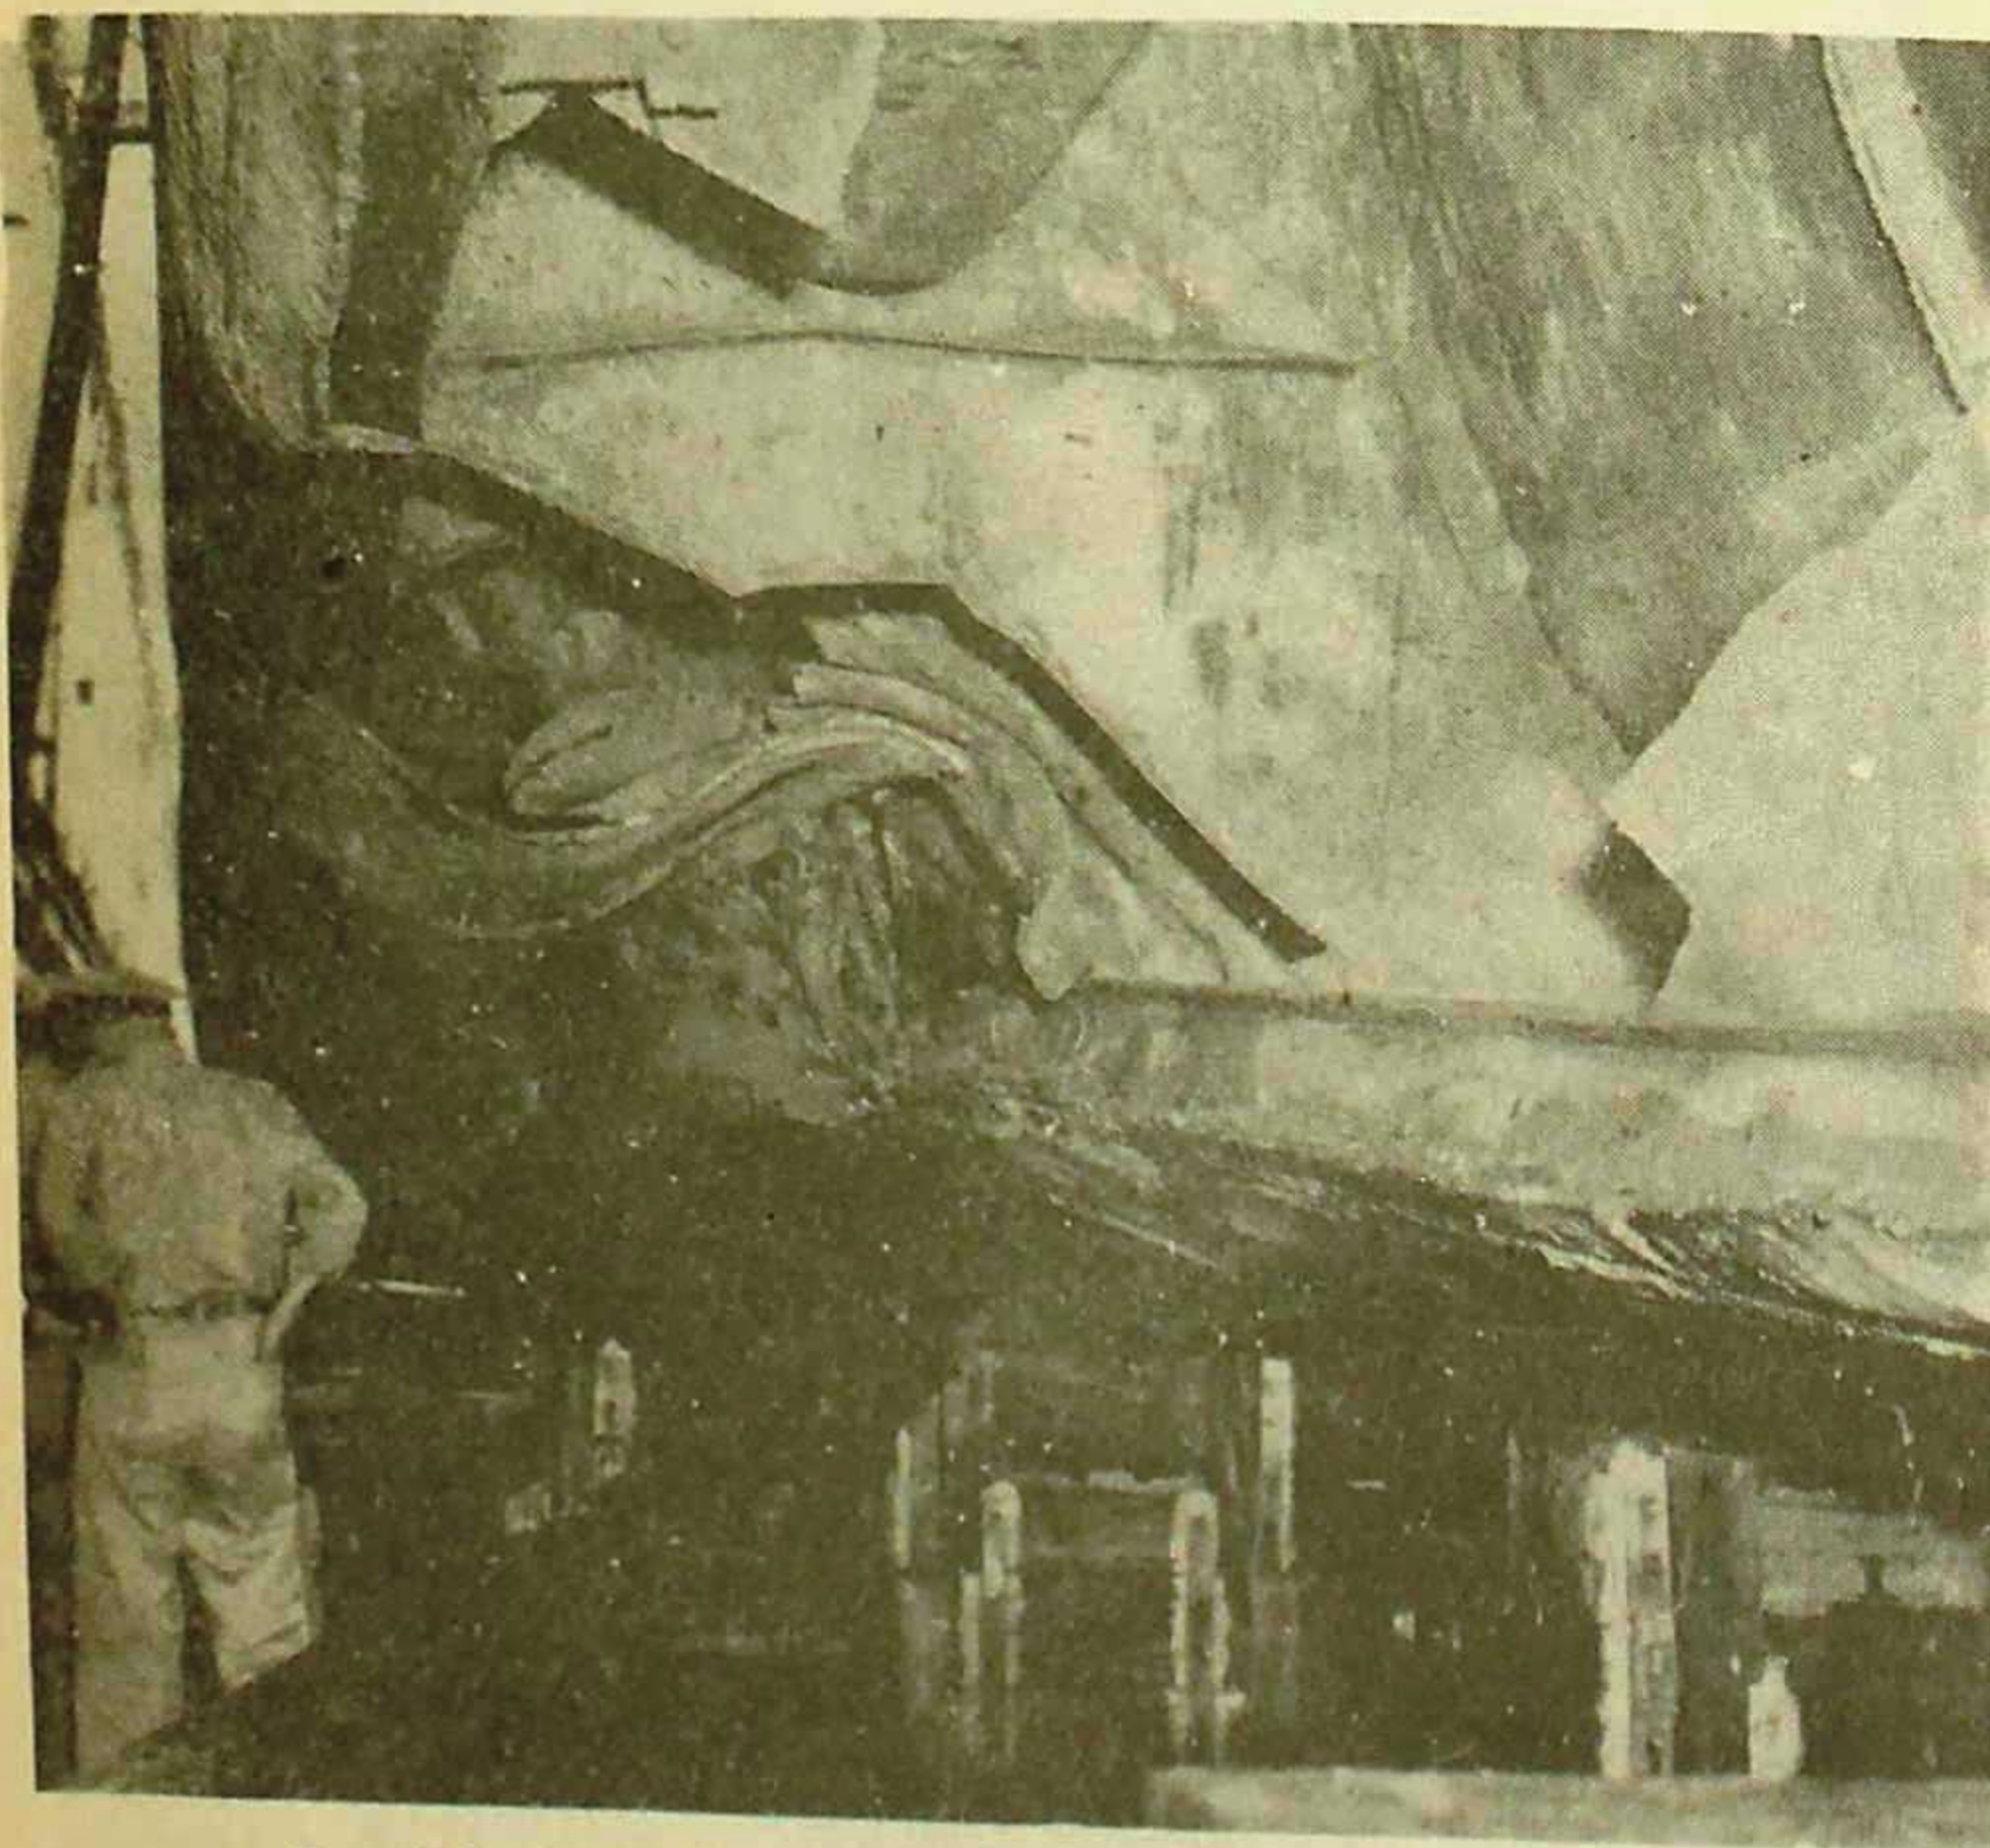
Looking aft, showing typical view of damage to bottom of IDAHO

frames, bulkheads, and the shell of the blisters were cut away between frames 55 and 80. The frames in these blisters were renewed with $\frac{1}{4}$ " steel plate, and the bulkheads were renewed with $\frac{3}{8}$ " steel plate to conform with the original structure. The shell plates were rolled and beveled on the two sides in the ship-fitter shop on board the JASON. The new plates were butt-welded on the edges and fillet-welded on the lapped ends. Intermittent tack-welding was employed on the back sides of the laps. All blisters were air-tested upon completion and found watertight. All internal structures in the blisters were restored to original condition, the manner of replacing the shell plating

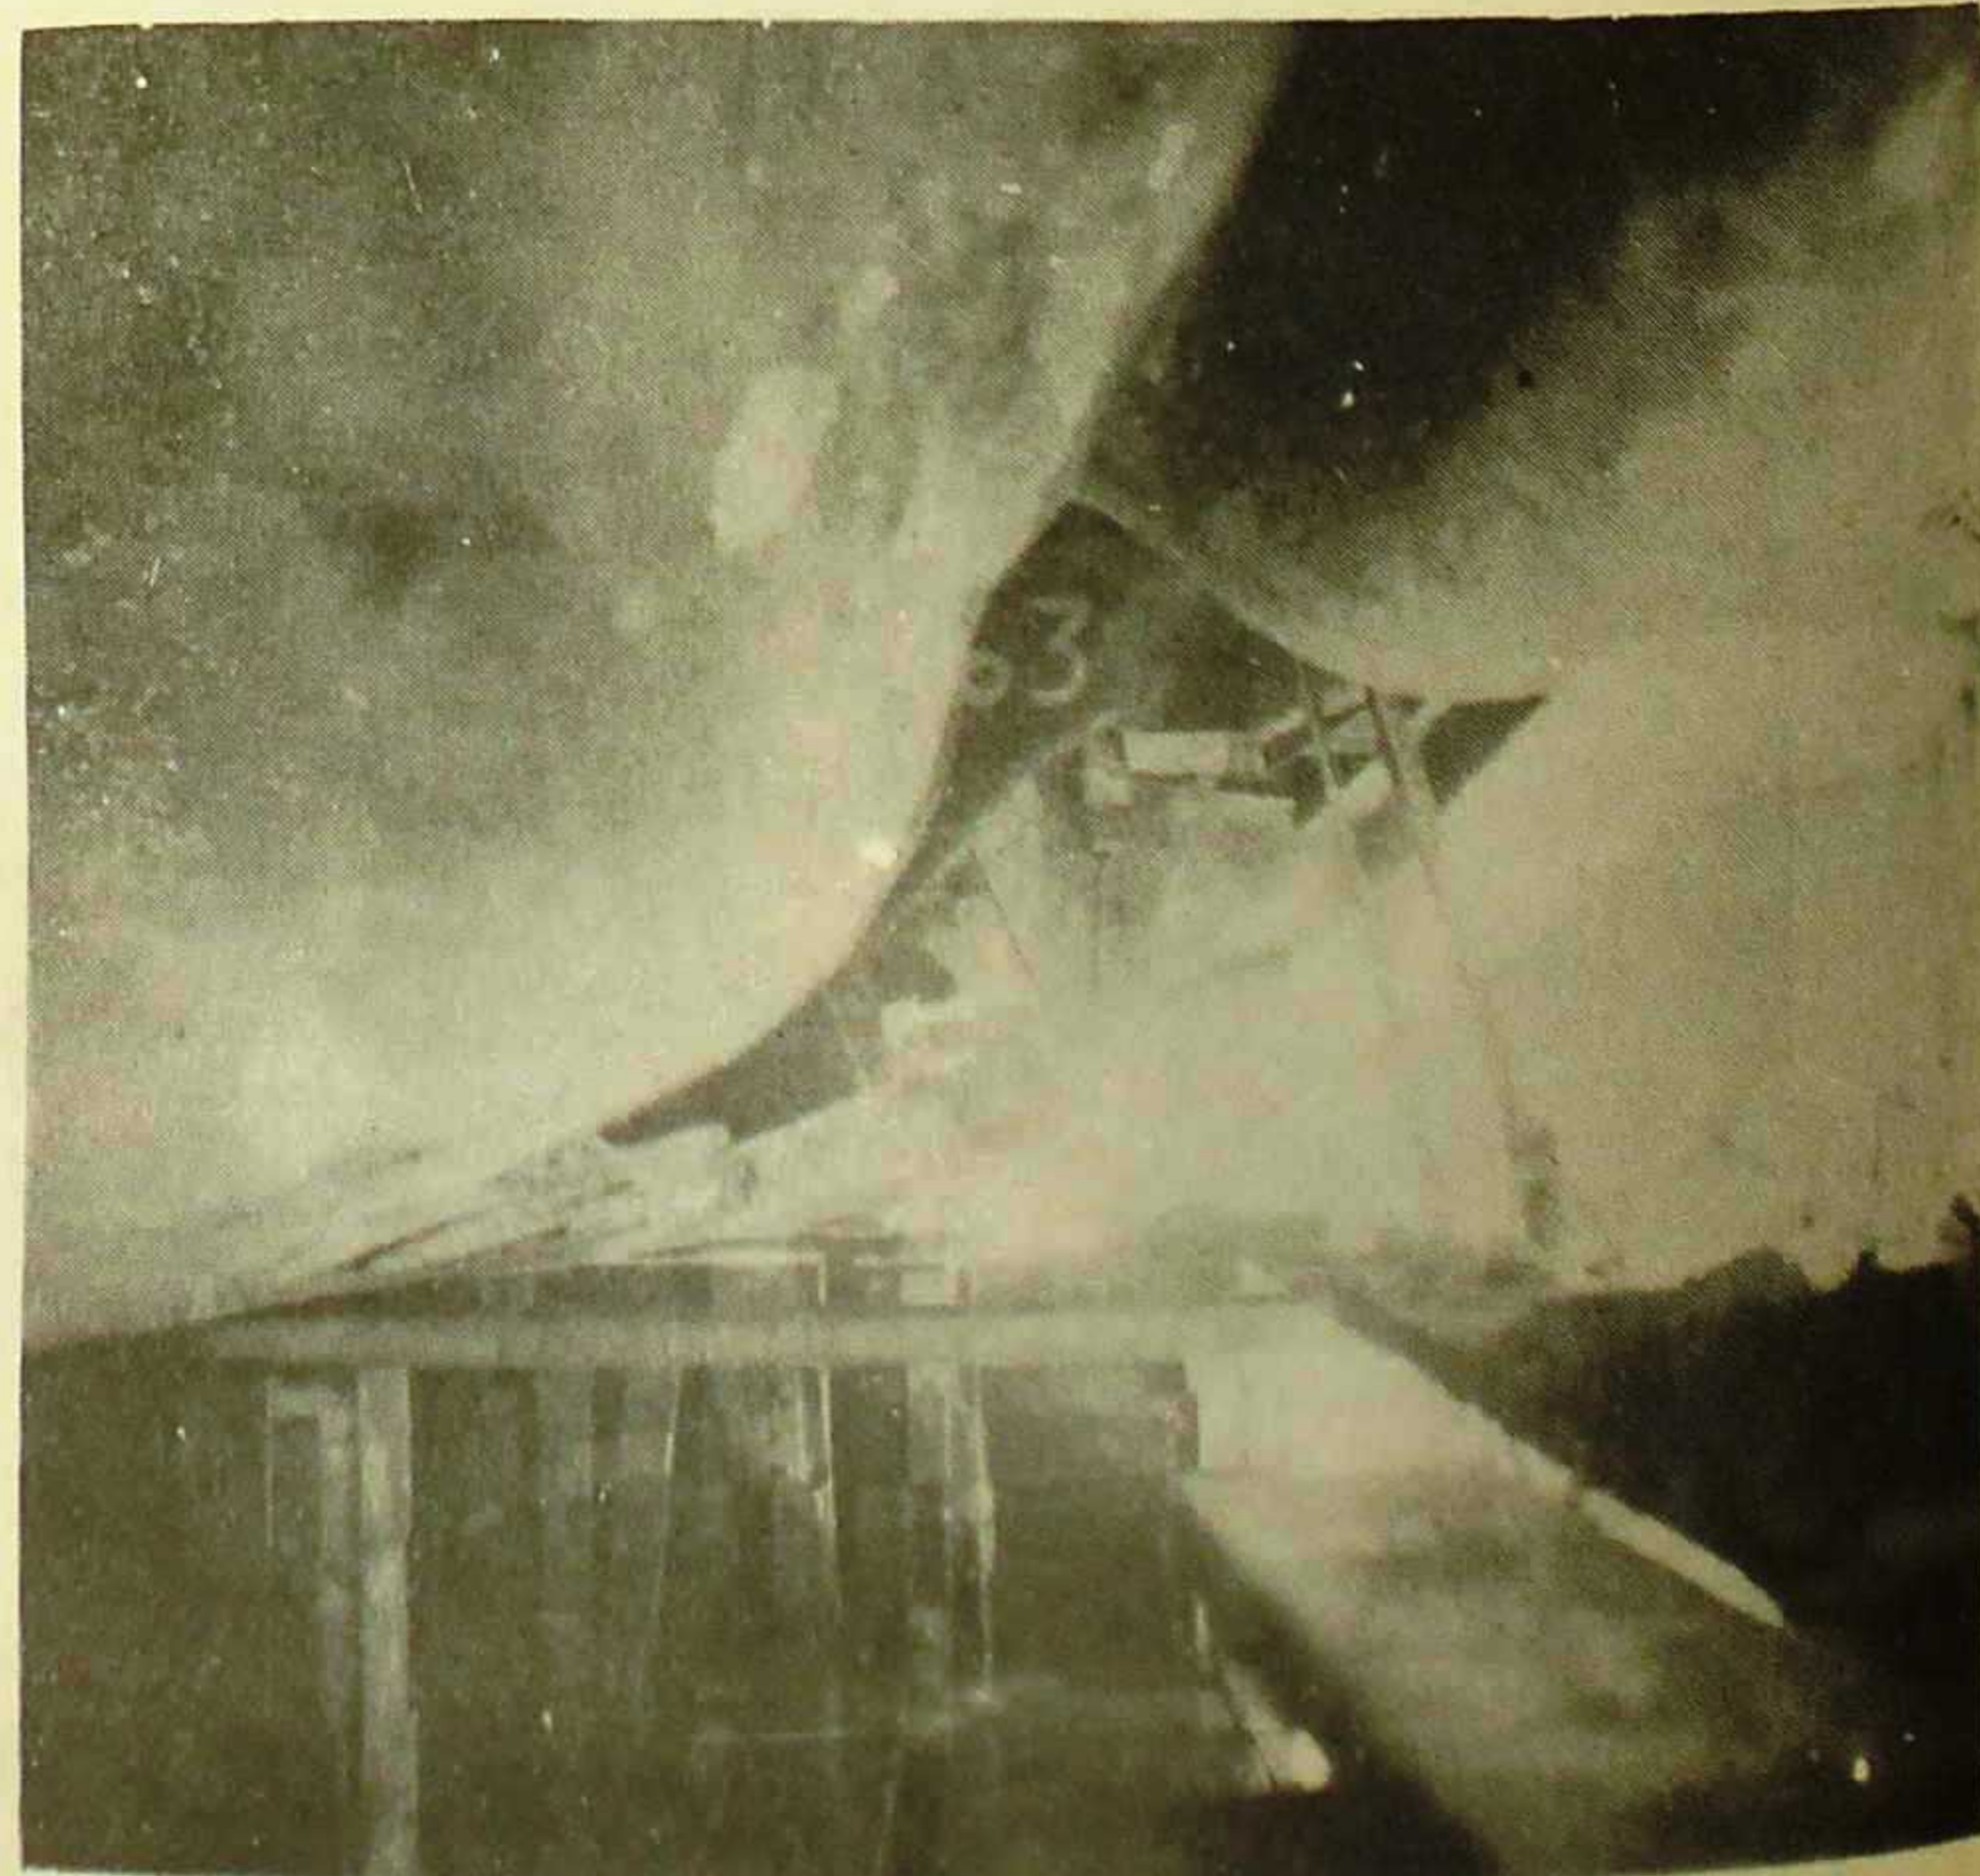
Looking forward, showing frame and shell plating partially removed

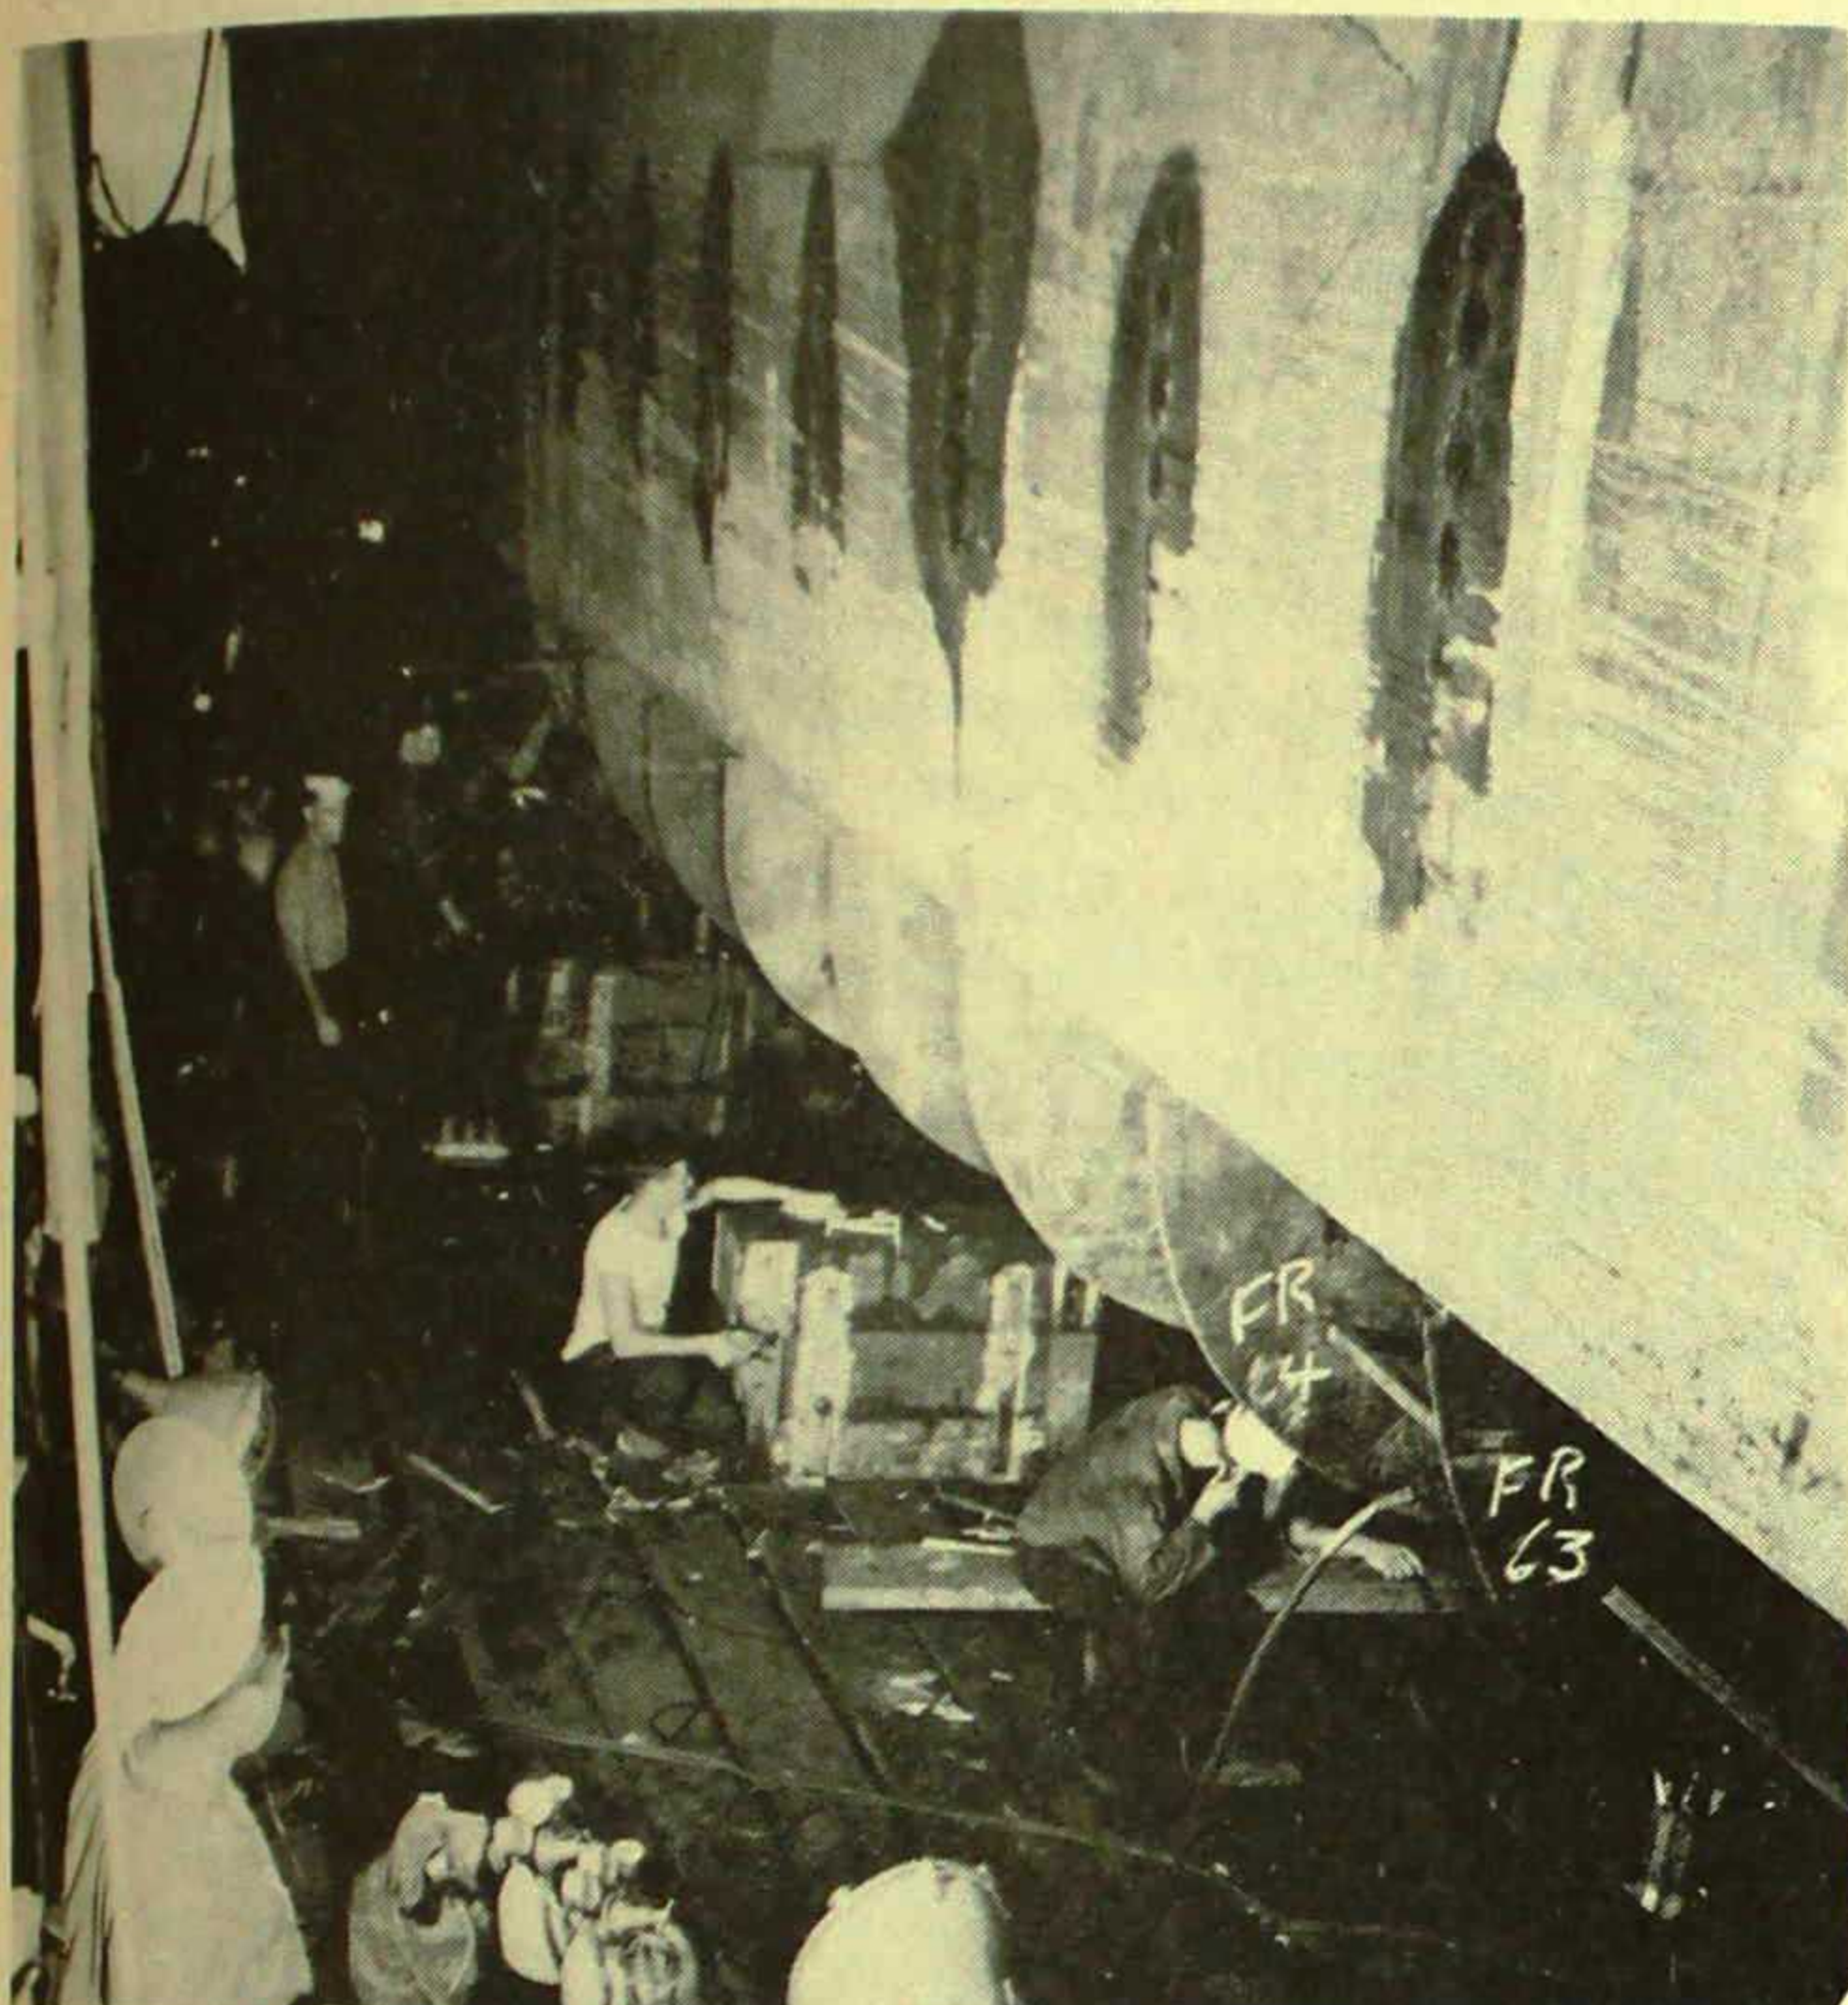
Looking aft, showing faired-in frames

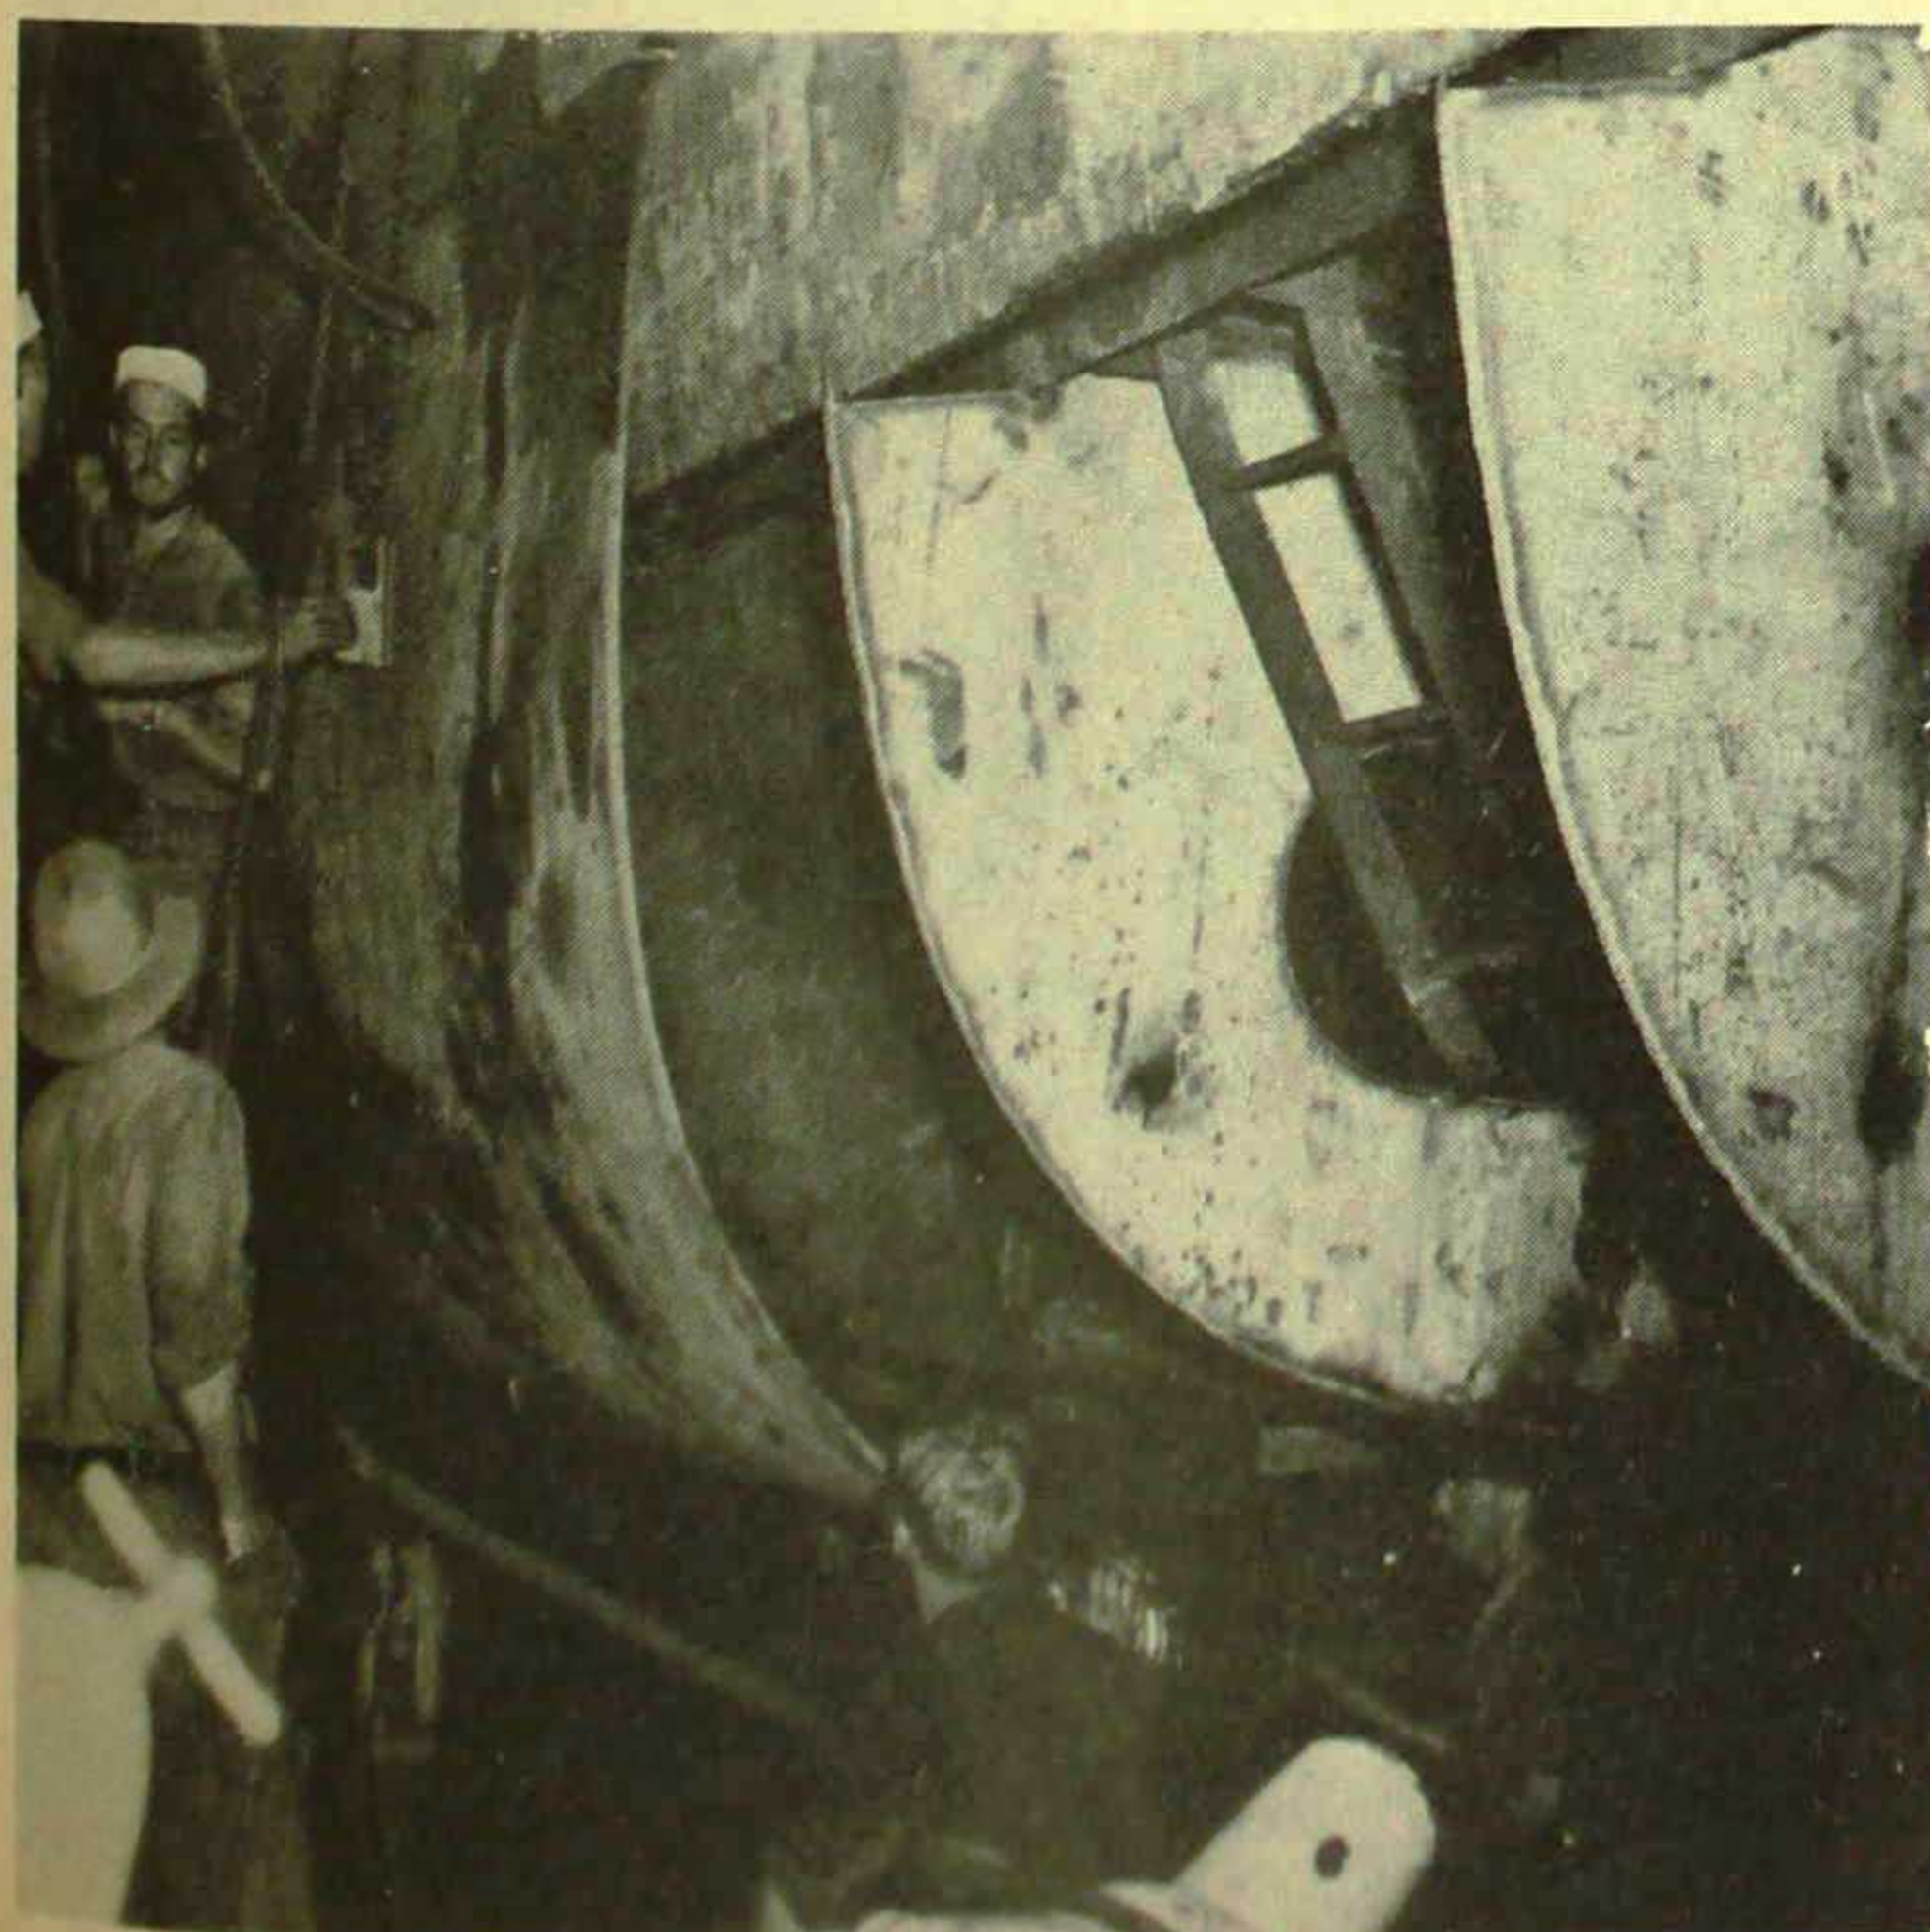
Shell plating being fitted in place

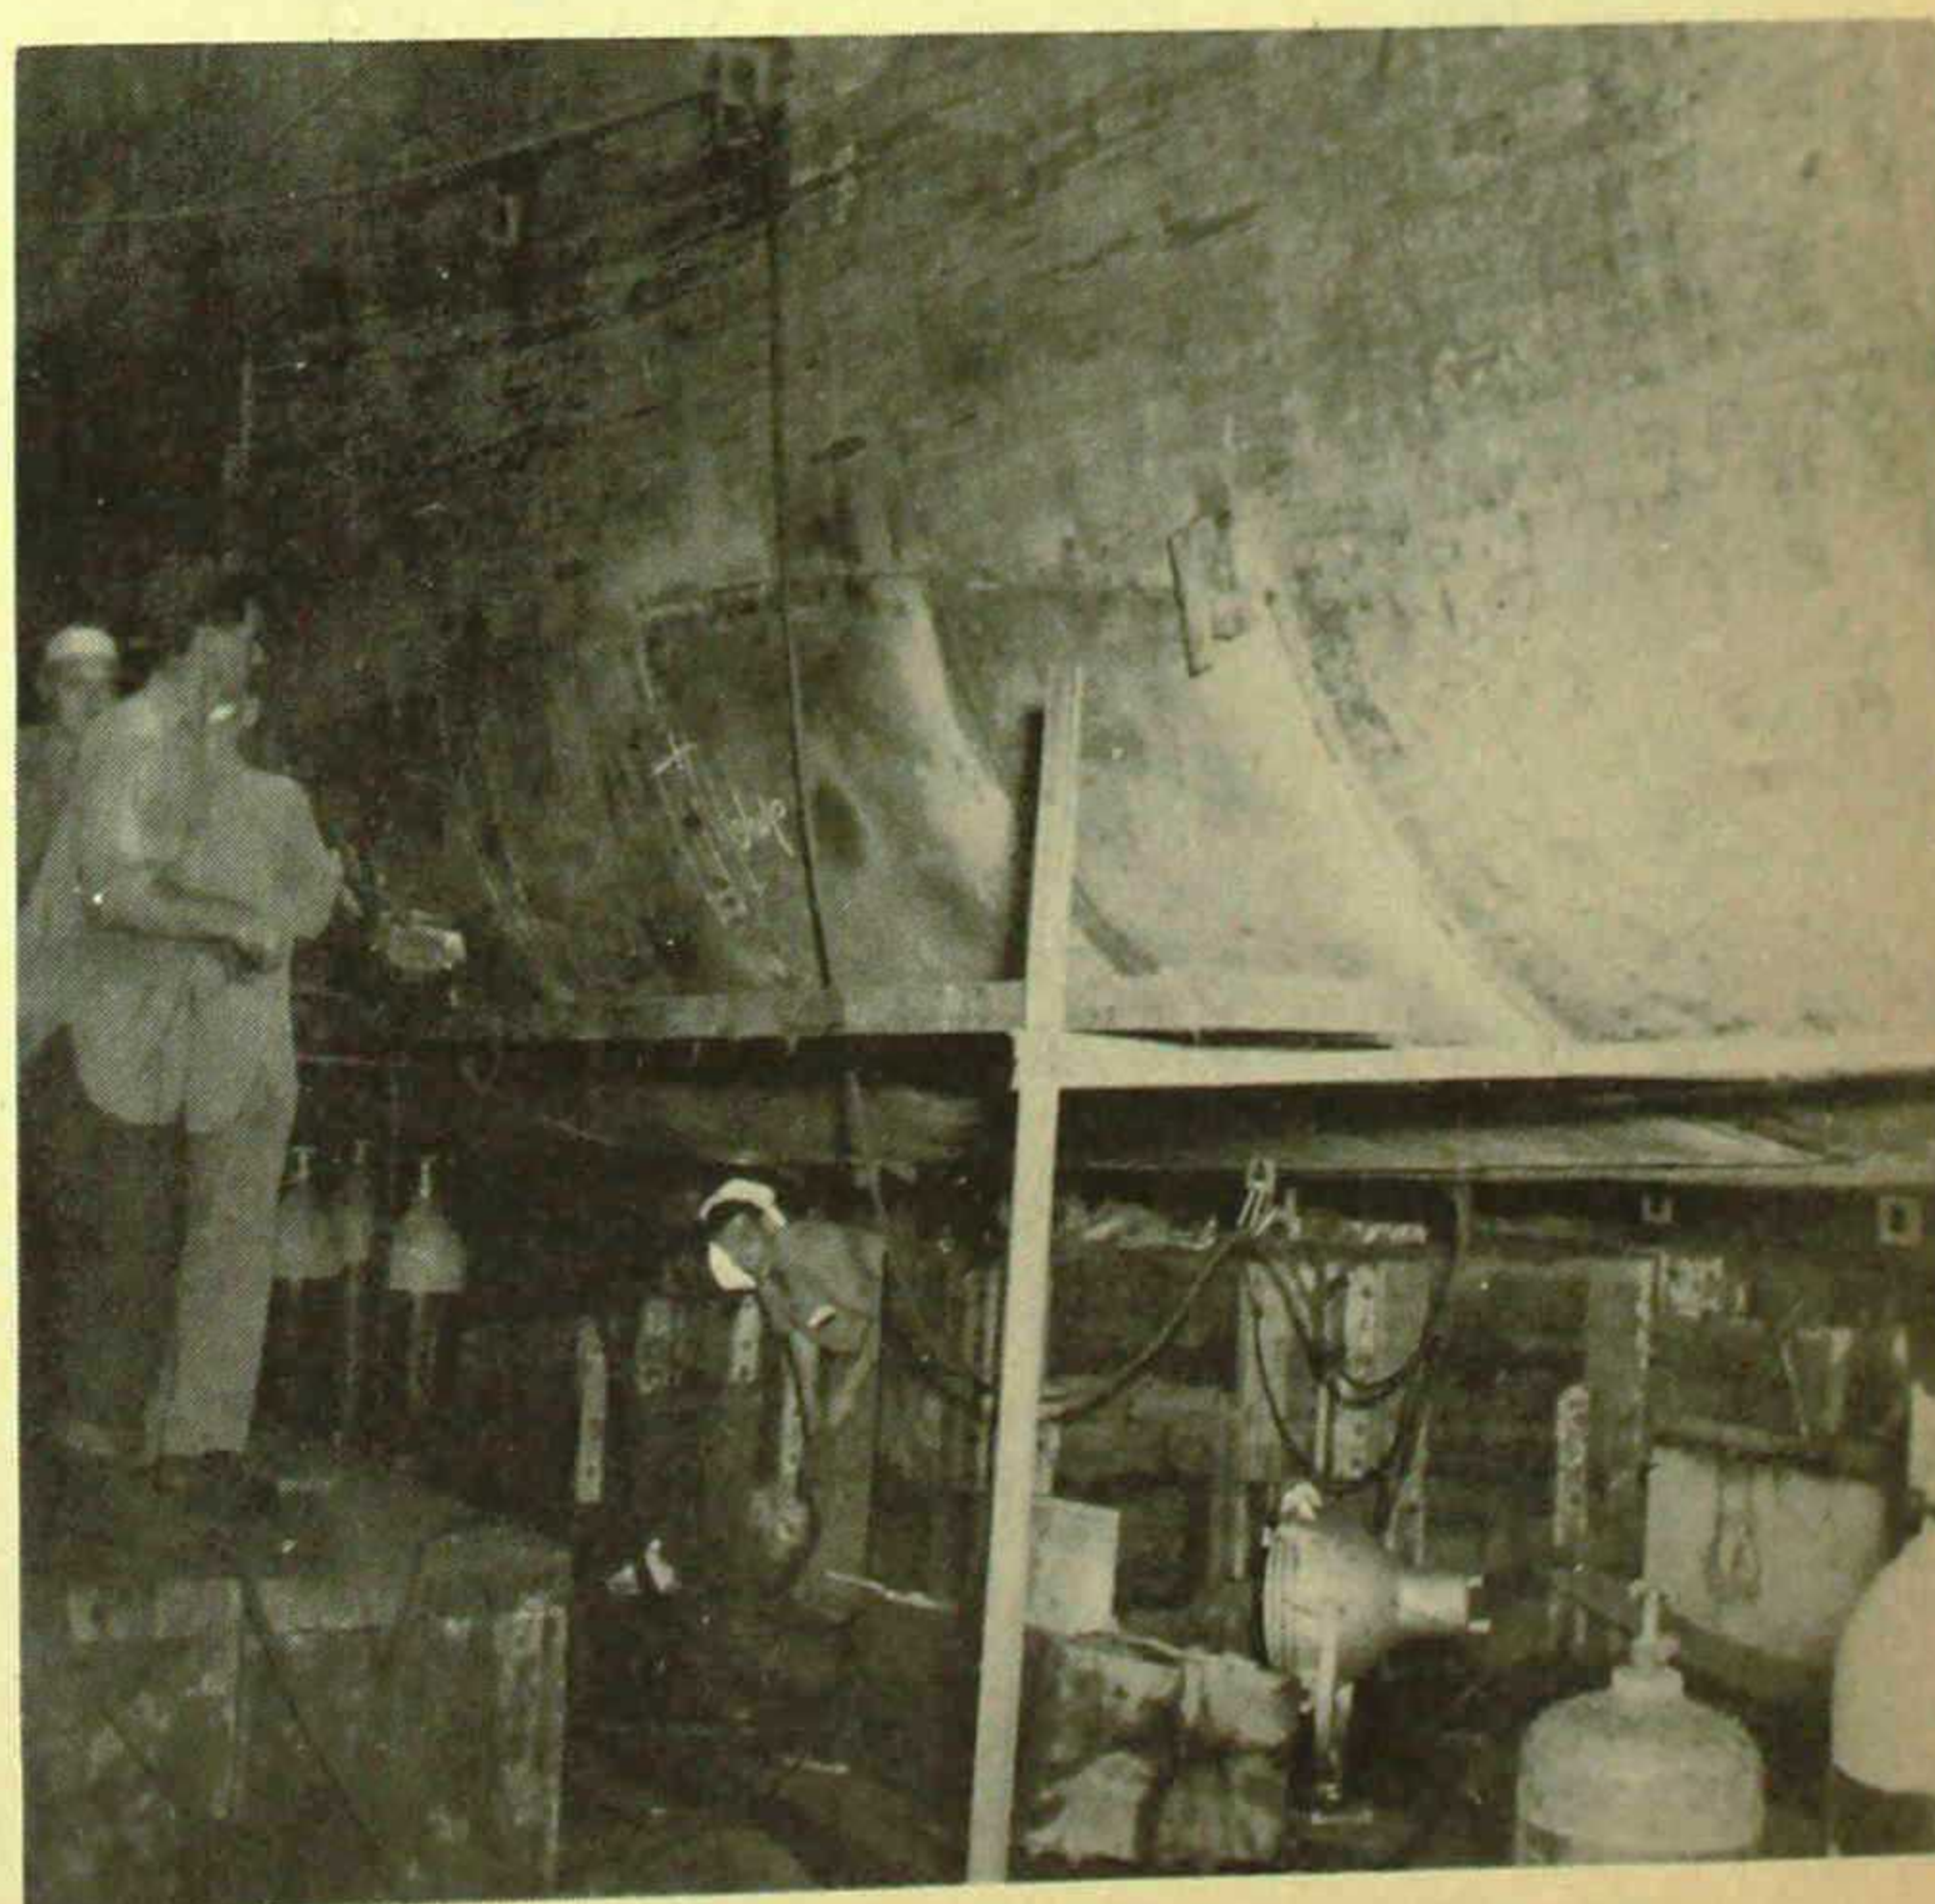
Shell plating completed
