# U. S. S. SOUTH DAKOTA (BB57)

## GUNFIRE DAMAGE

BATTLE OF GUADALCANAL  
14-15 NOVEMBER, 1942

WAR DAMAGE REPORT No. 57

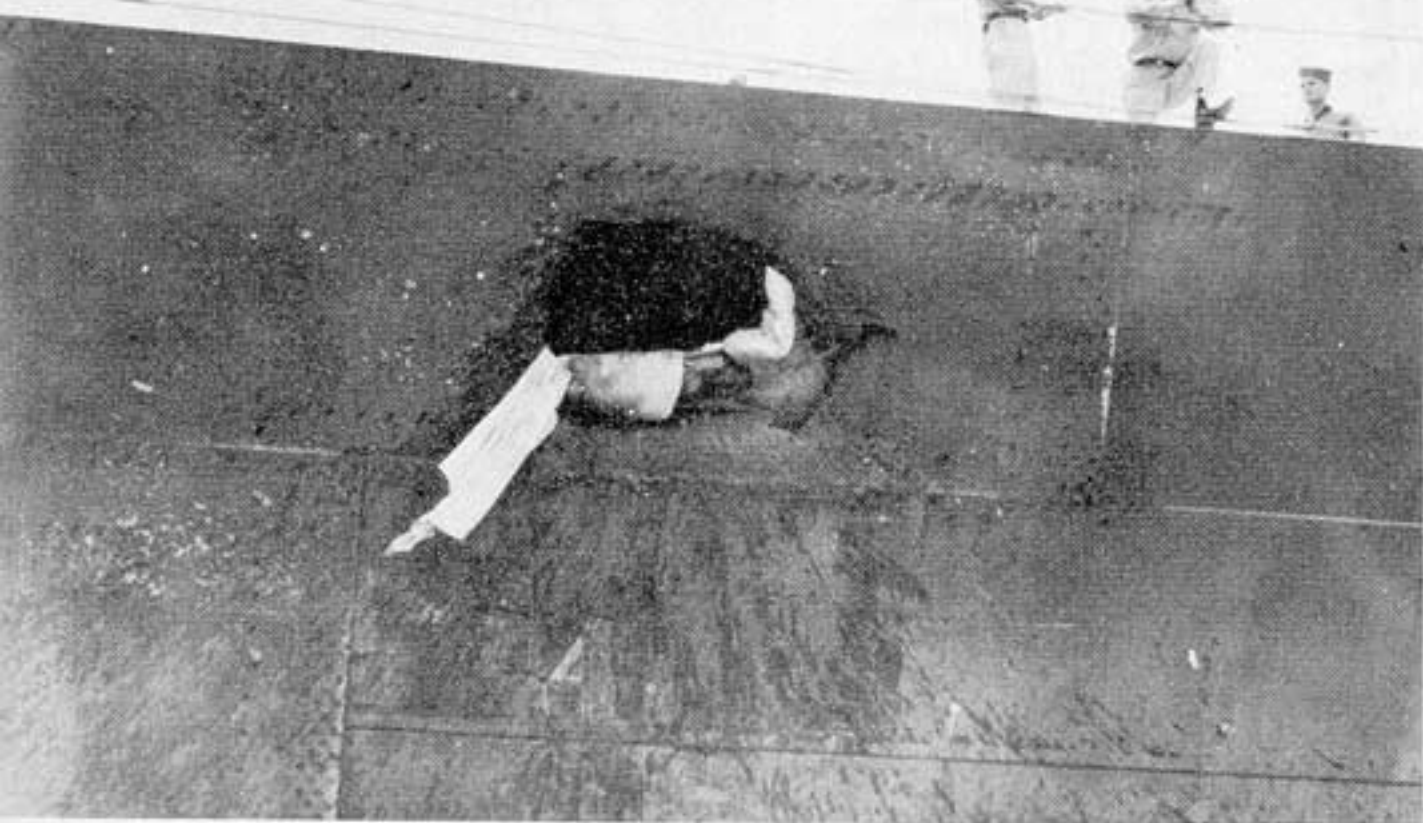
Photo 1: Hit No. 2. Hole blown in starboard sheer strake at frame 30. Note patch plates which were installed over smaller holes below sheer strake.

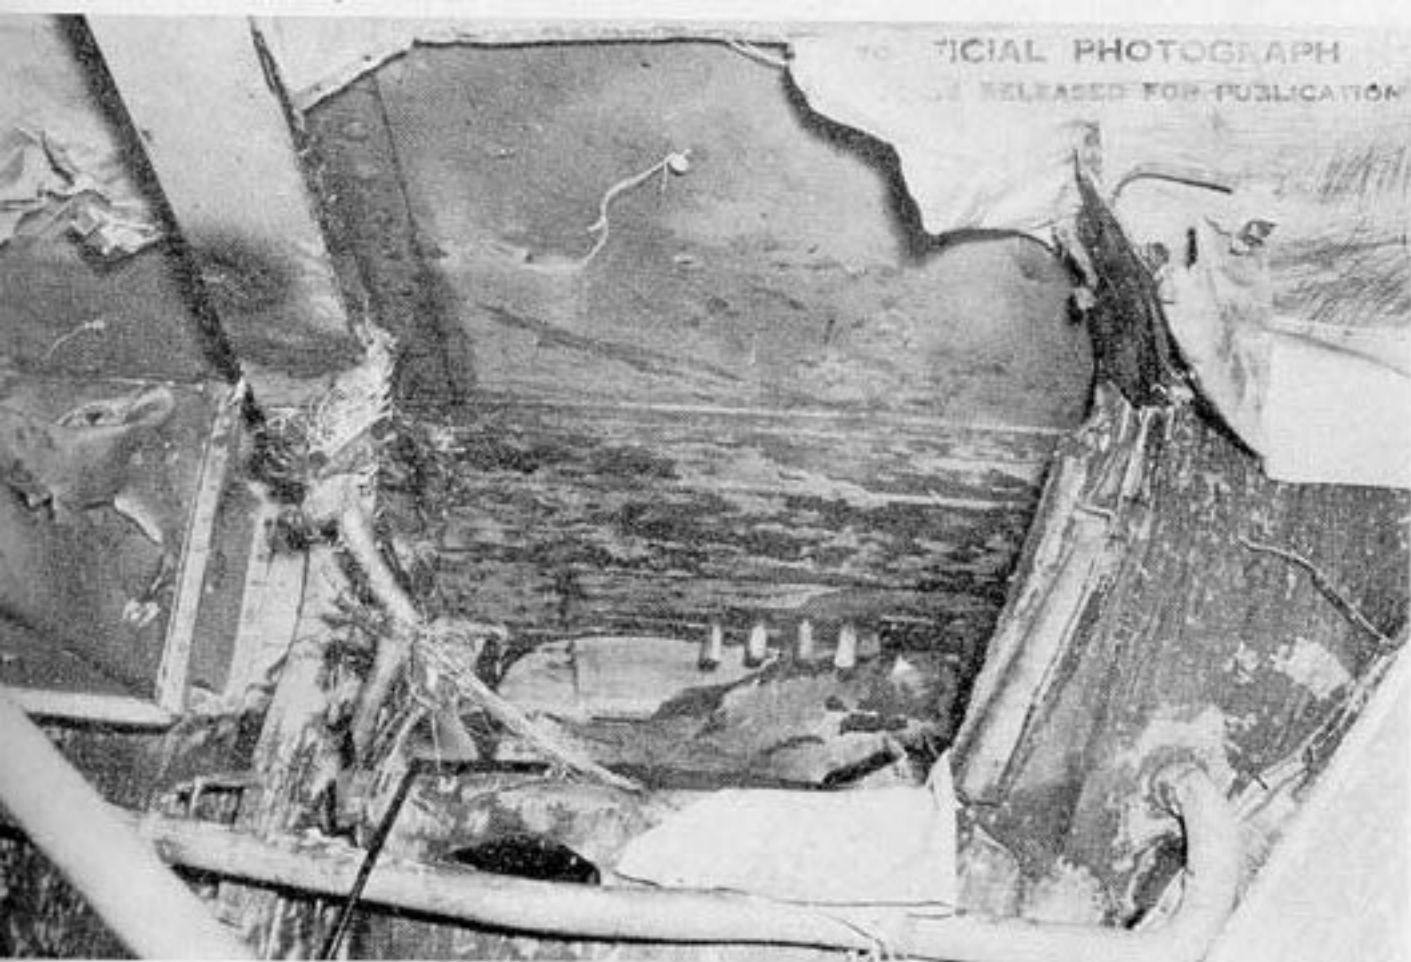
Photo 2: Hit No. 2. Looking forward at underside of main deck through hole in starboard side of bulkhead 31.

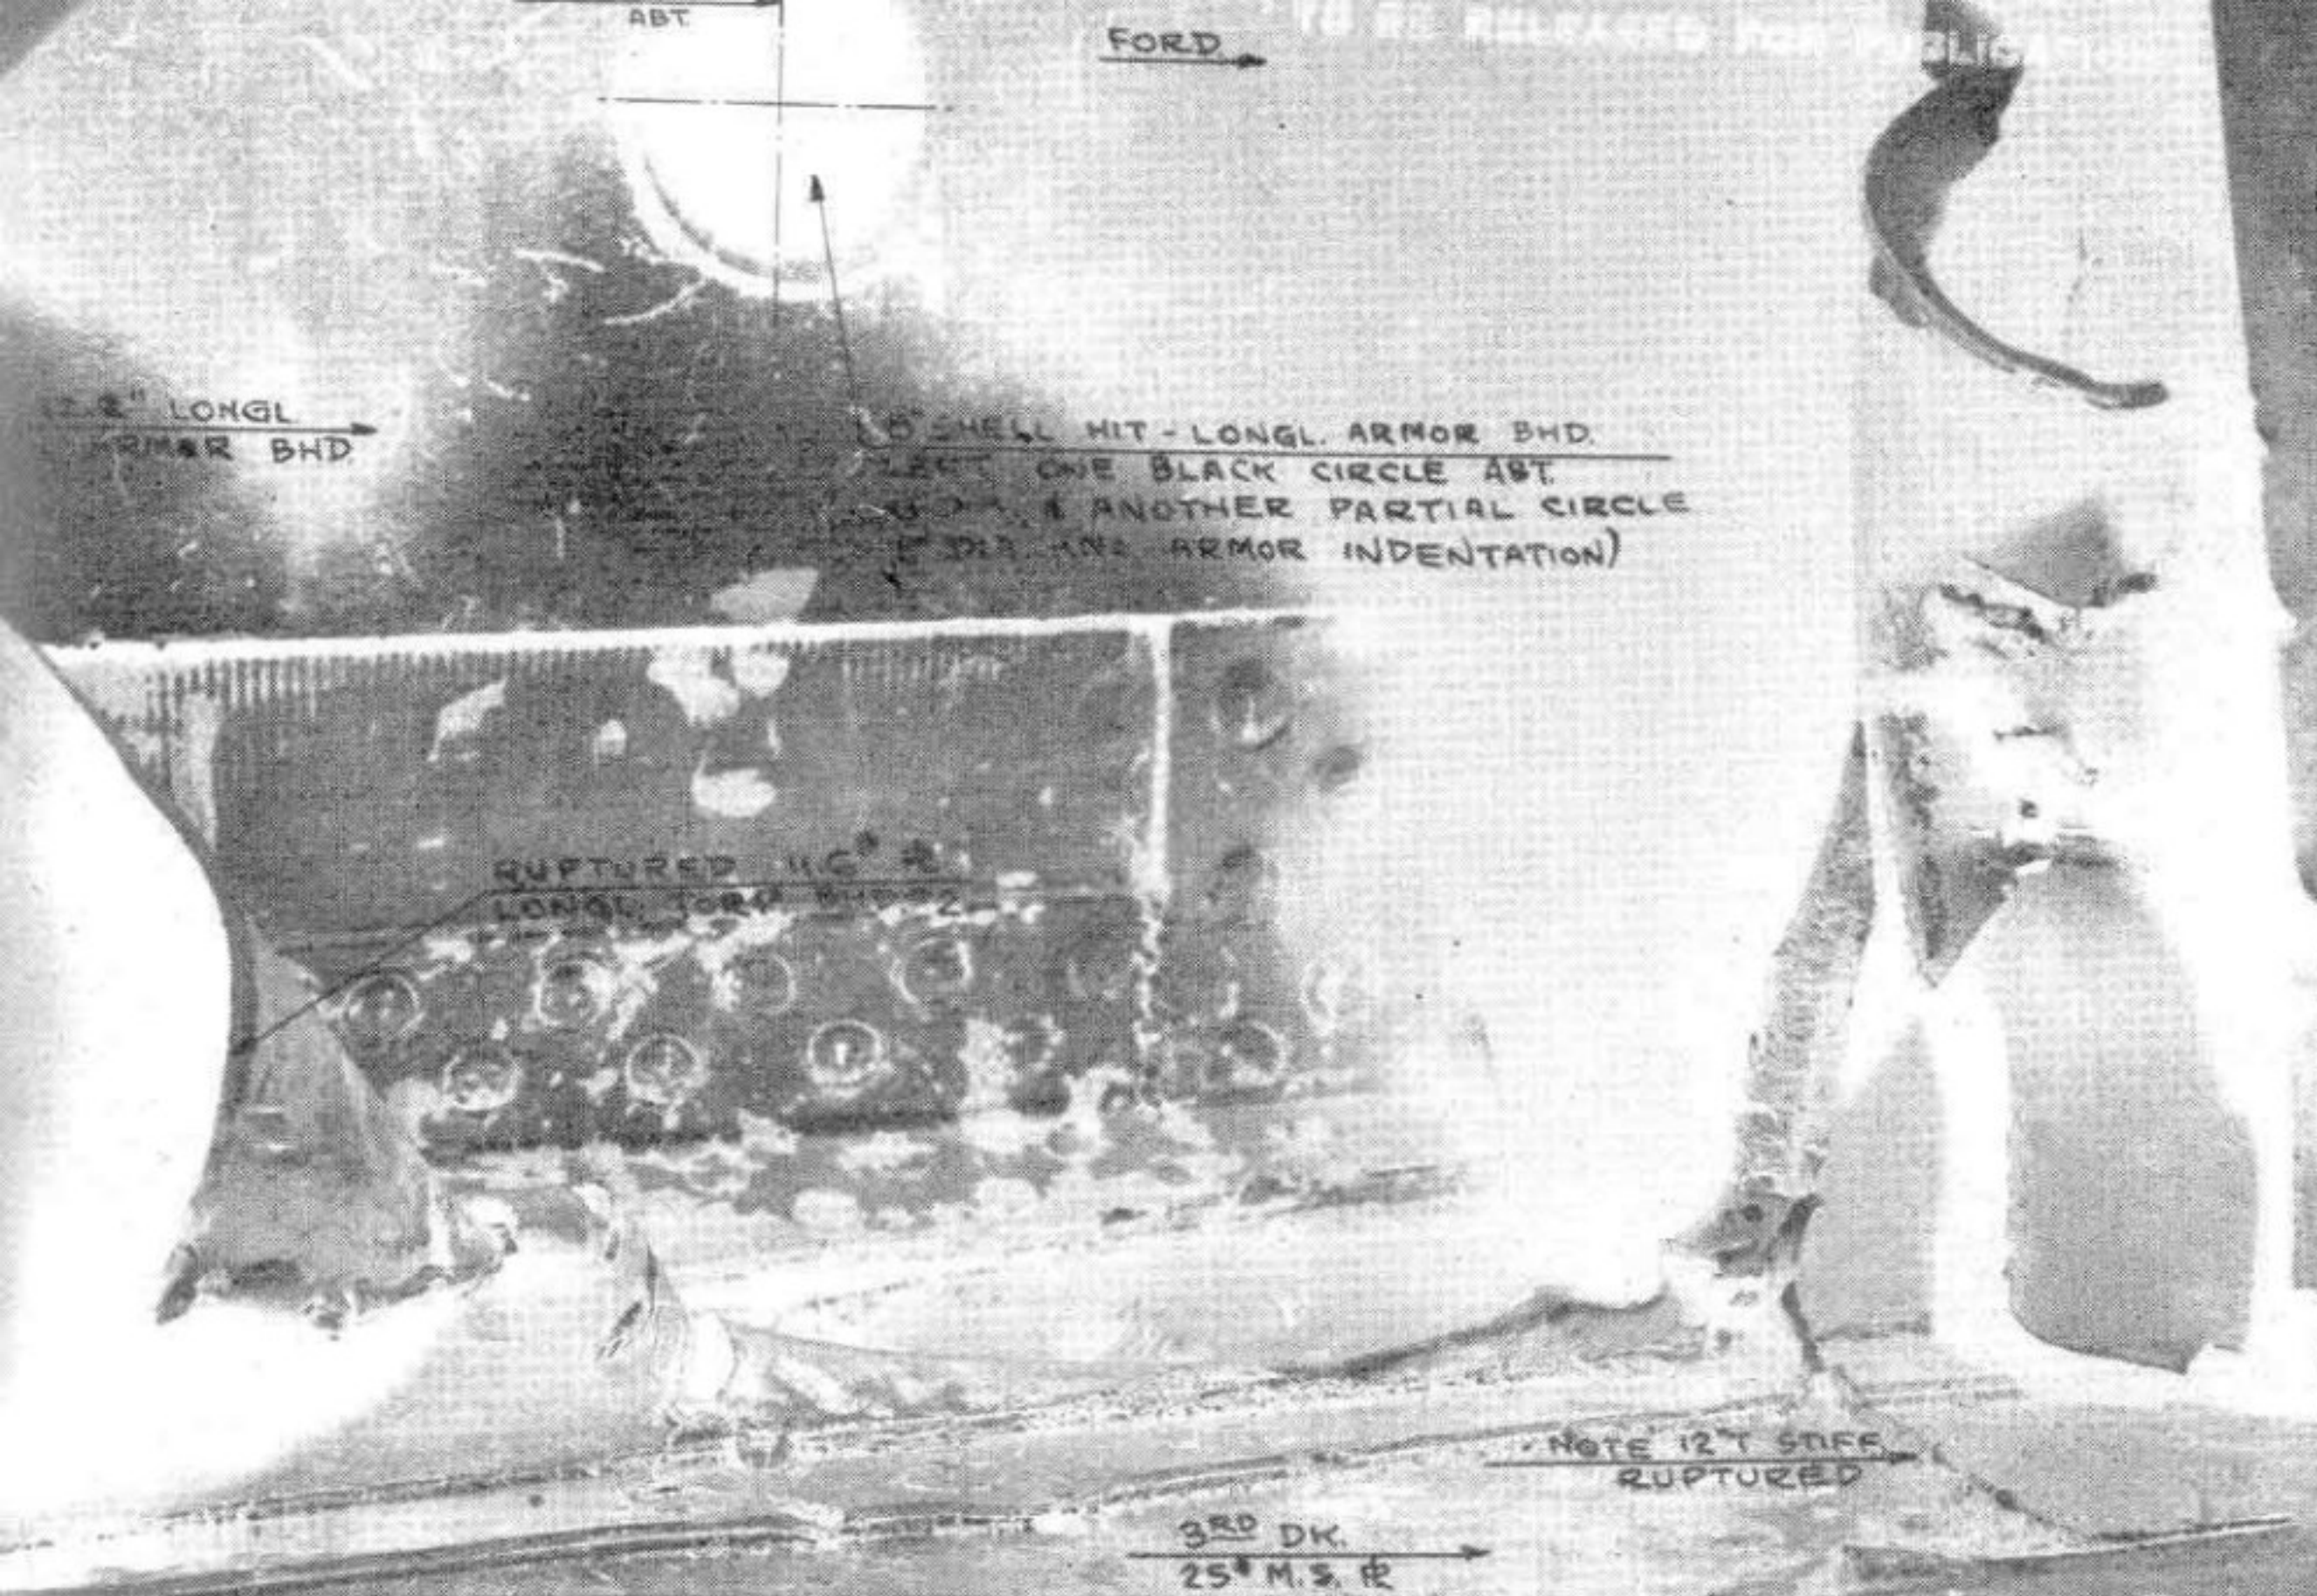
Photo 4: Hit No. 4. Looking inboard through hole in torpedo bulkhead No. 2 to the 12.2-inch longitudinal armor bulkhead. Note mark on armor left by projectile, third deck blown down and torpedo bulkhead blown outboard.

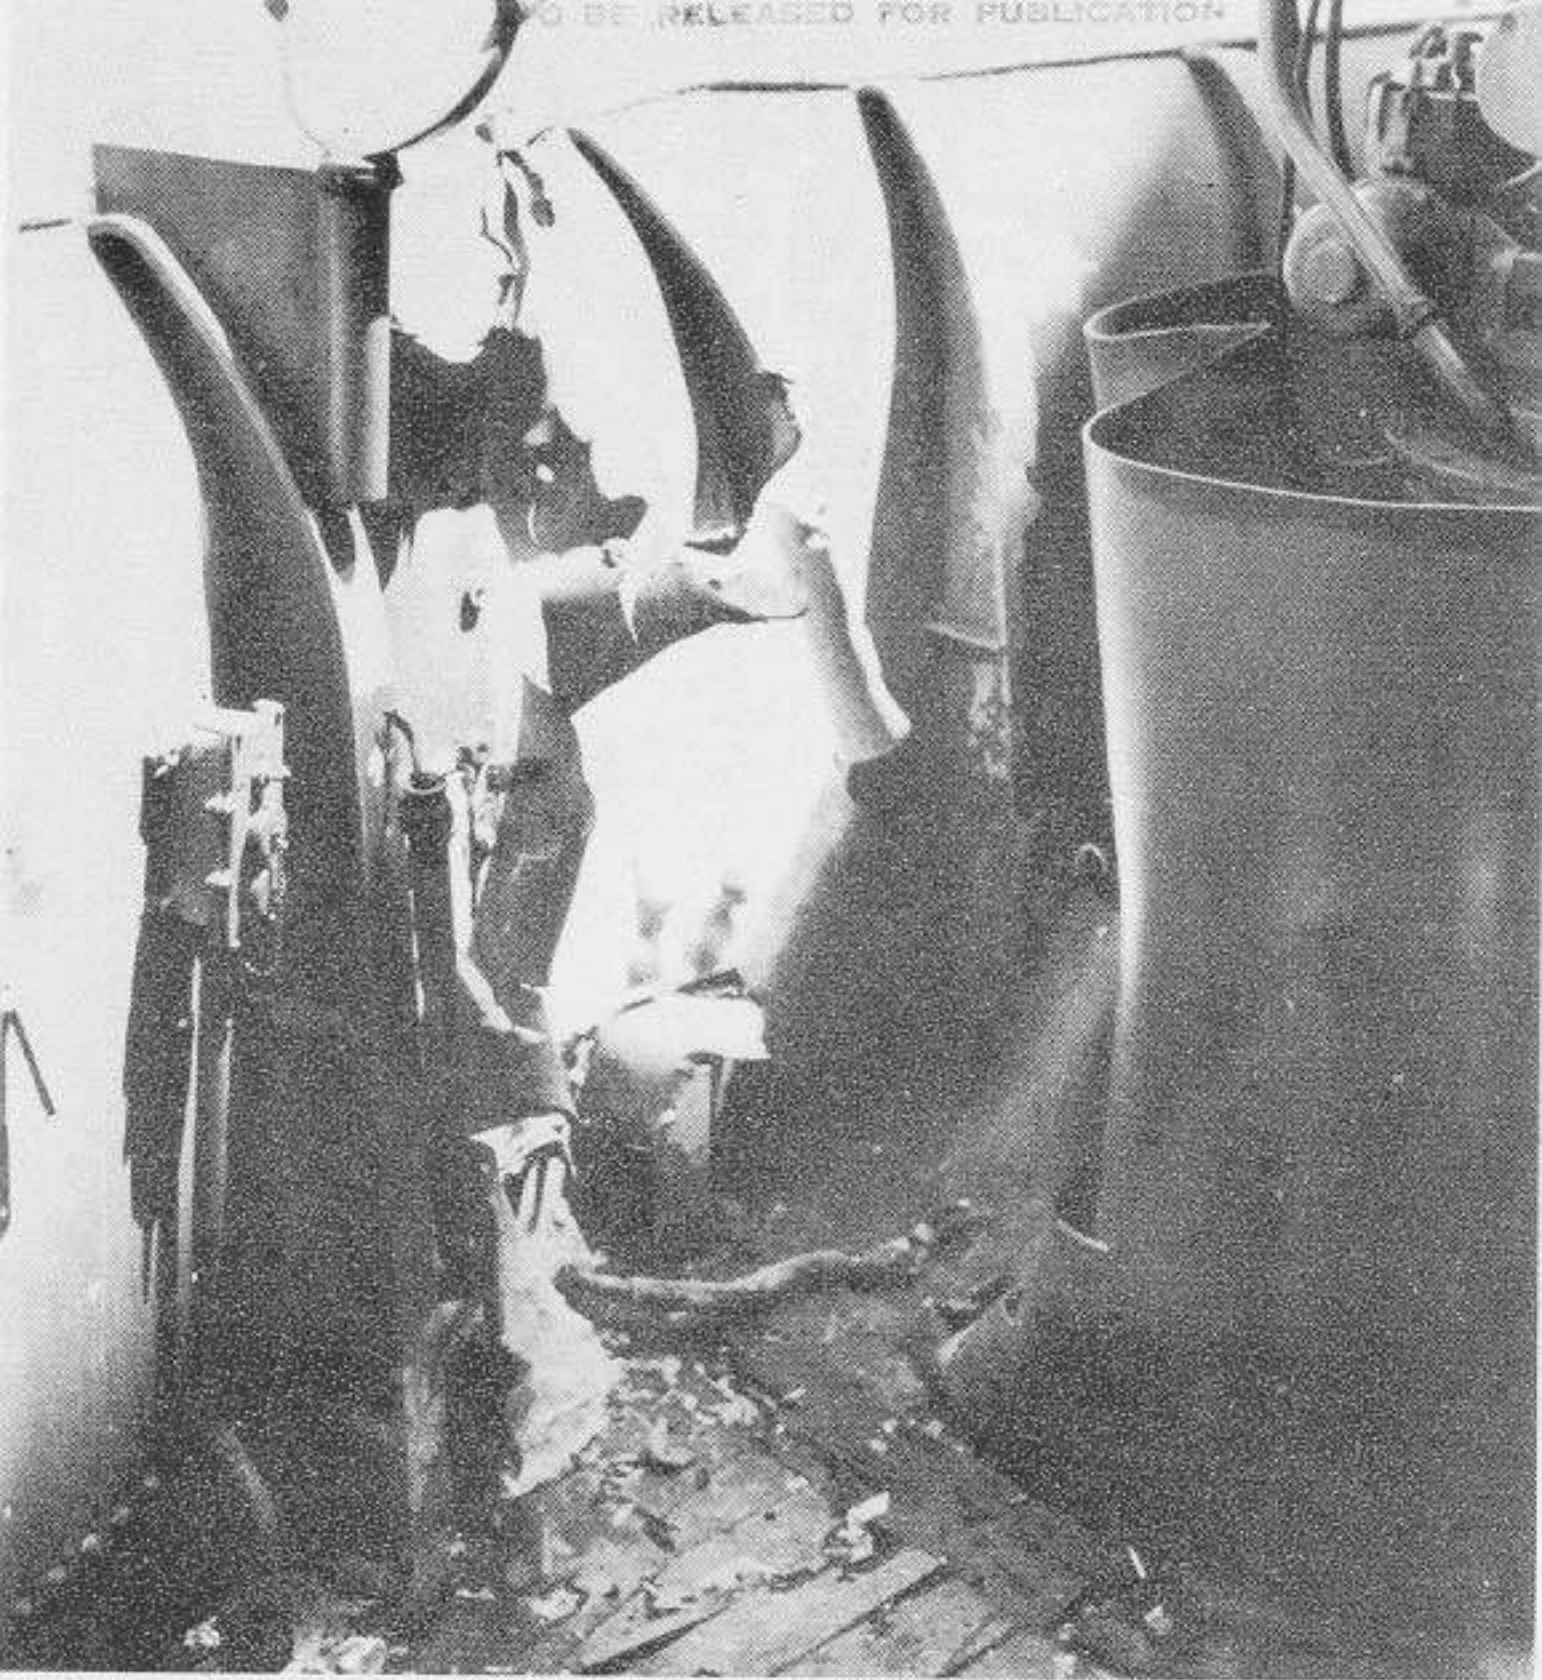
Photo 5: Hit No. 5. Damage to spray shield and splinter shield around 40mm director.

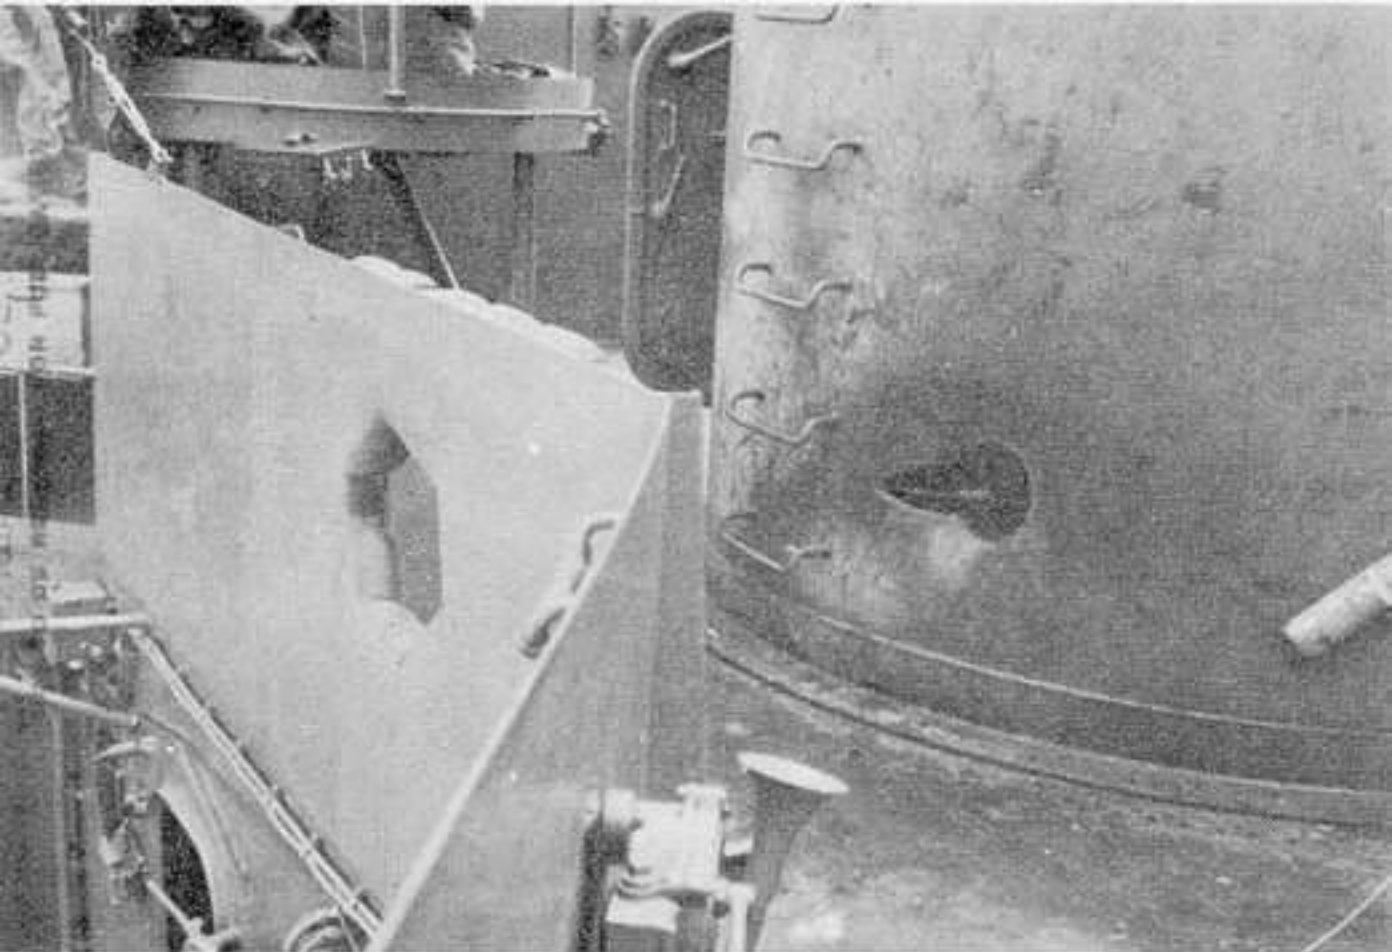
Photo 6: Hit No. 6. Projectile holes through starboard splinter shield and into 5-inch secondary battery director foundation.

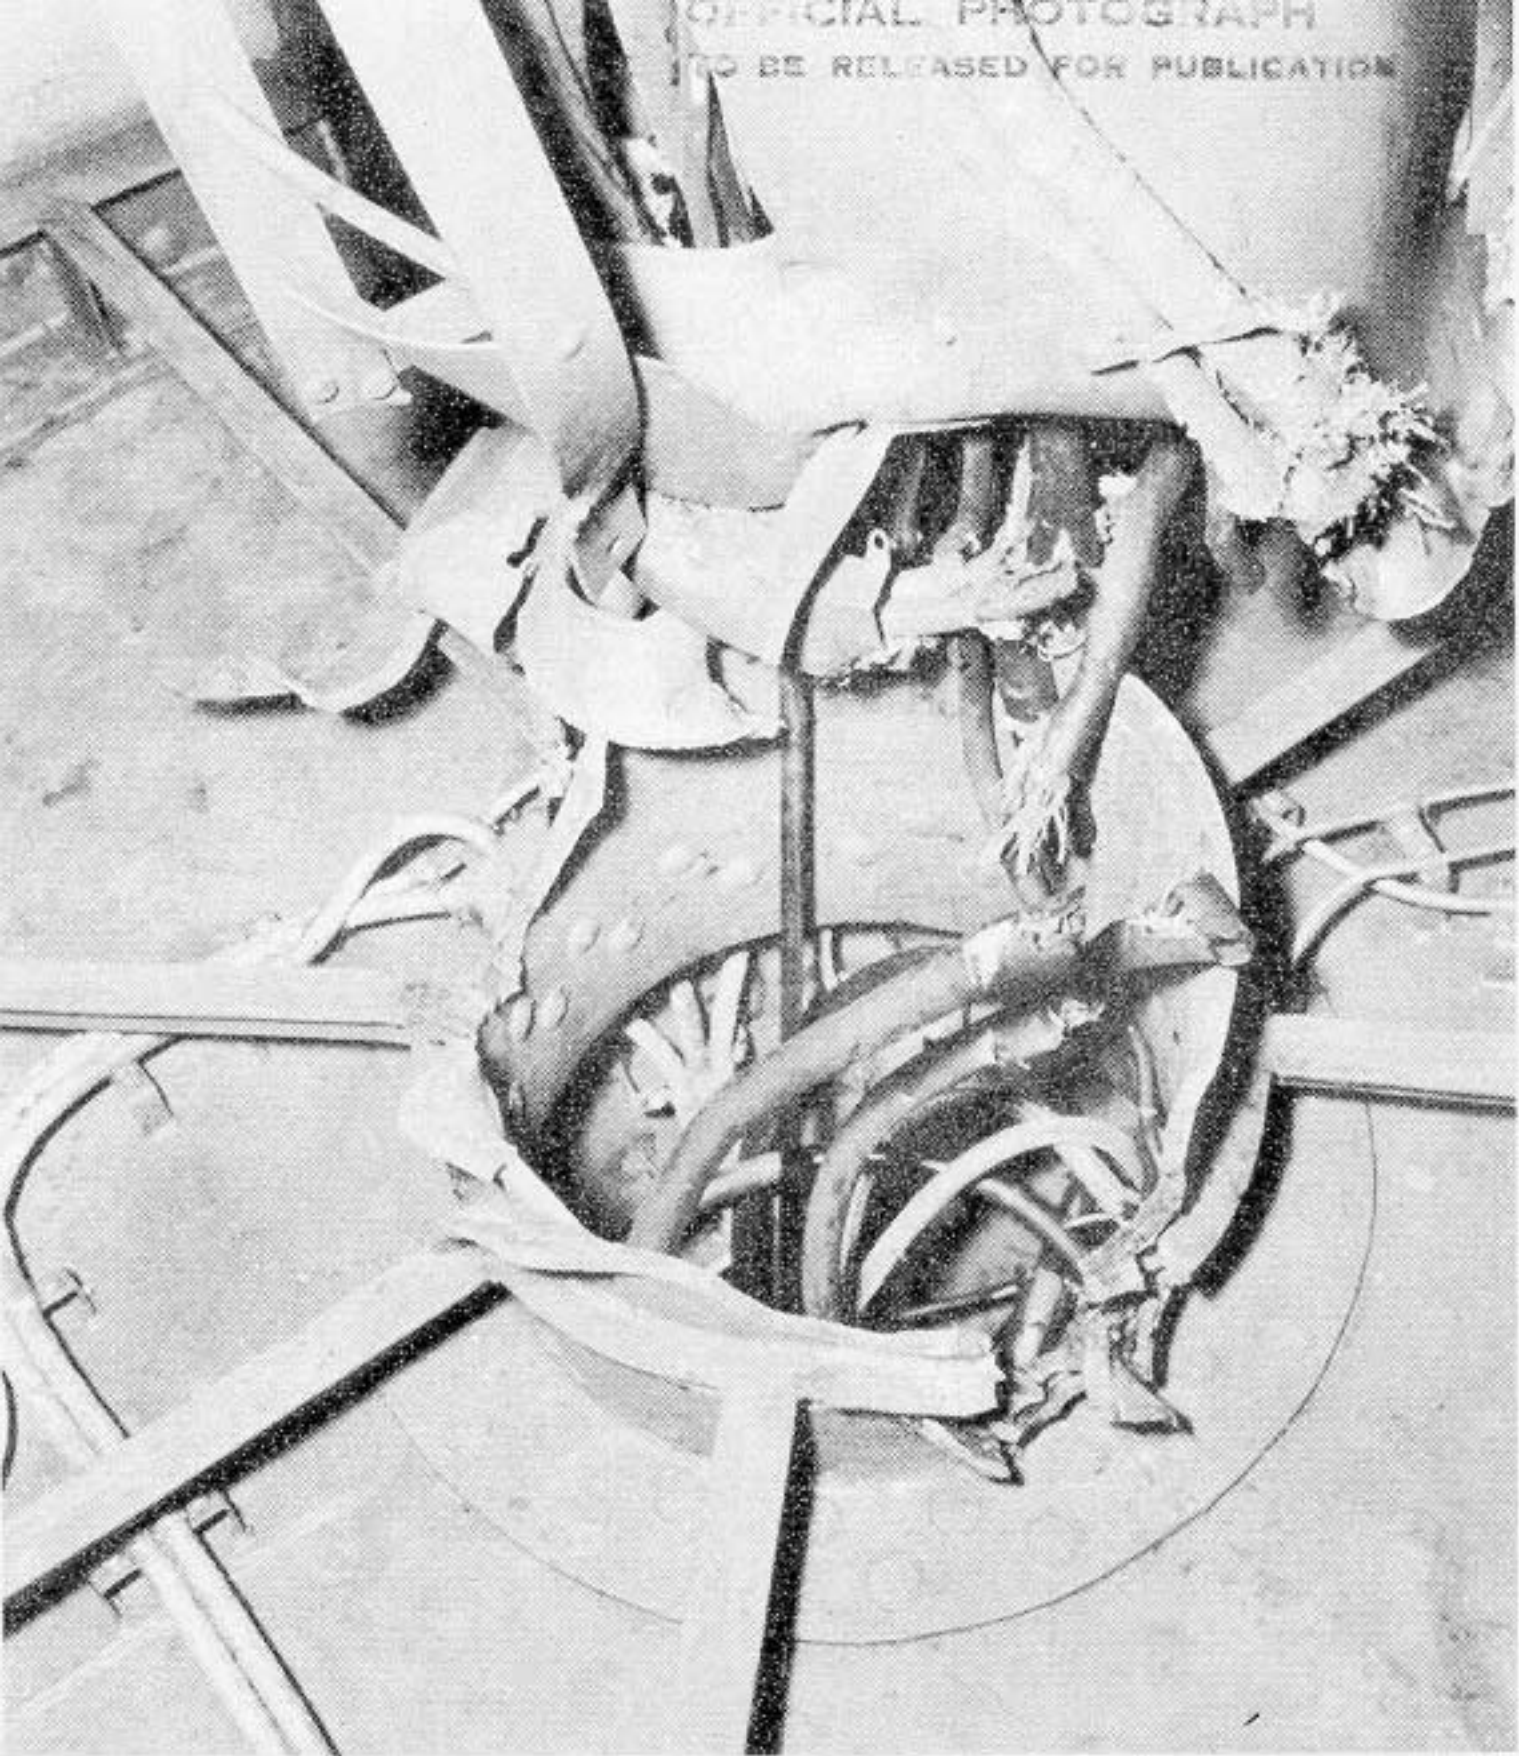
Photo 7: Center column of 5-inch secondary battery director destroyed by hit No. 6.

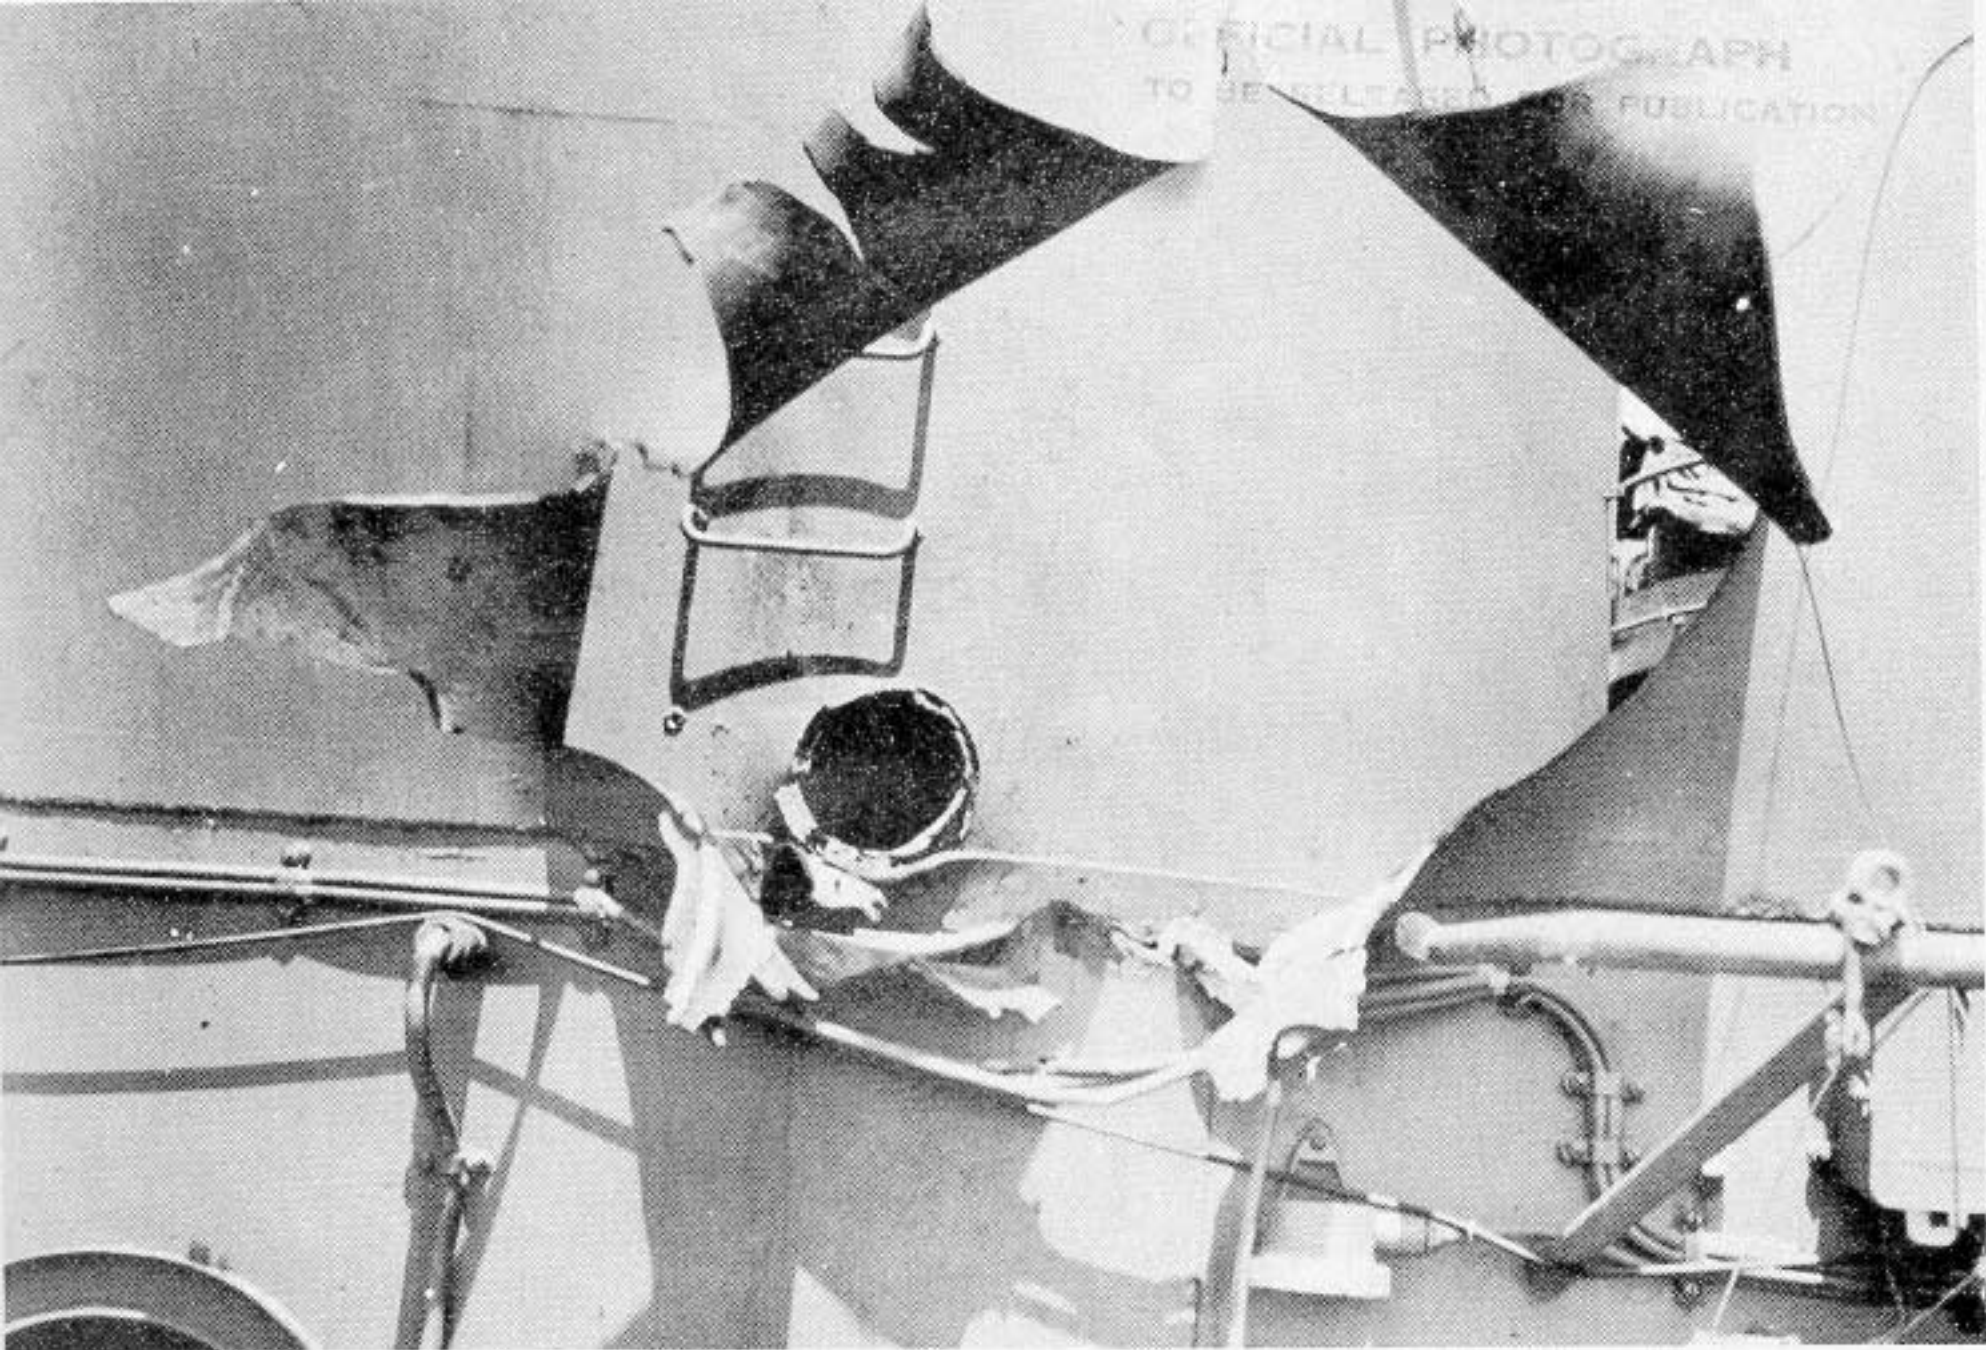
Photo 8: Exit hole of hit No. 6 in port side of 5-inch secondary battery director foundation as viewed through hole in port splinter shield.

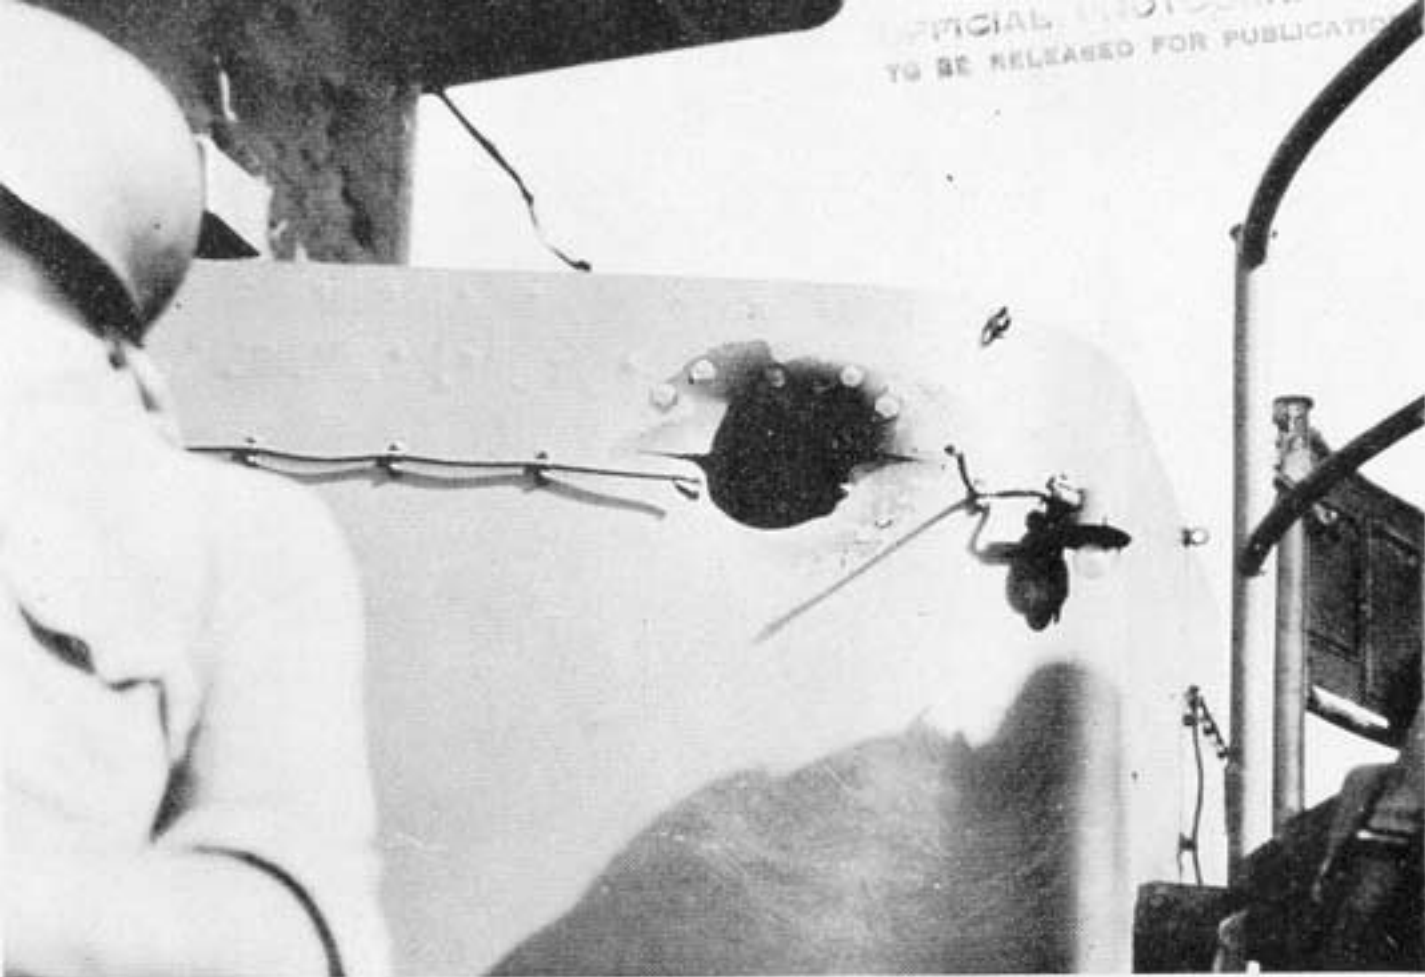
Photo 9: Entry hole of hit No. 7 in starboard side of 1.1-inch clipping room.

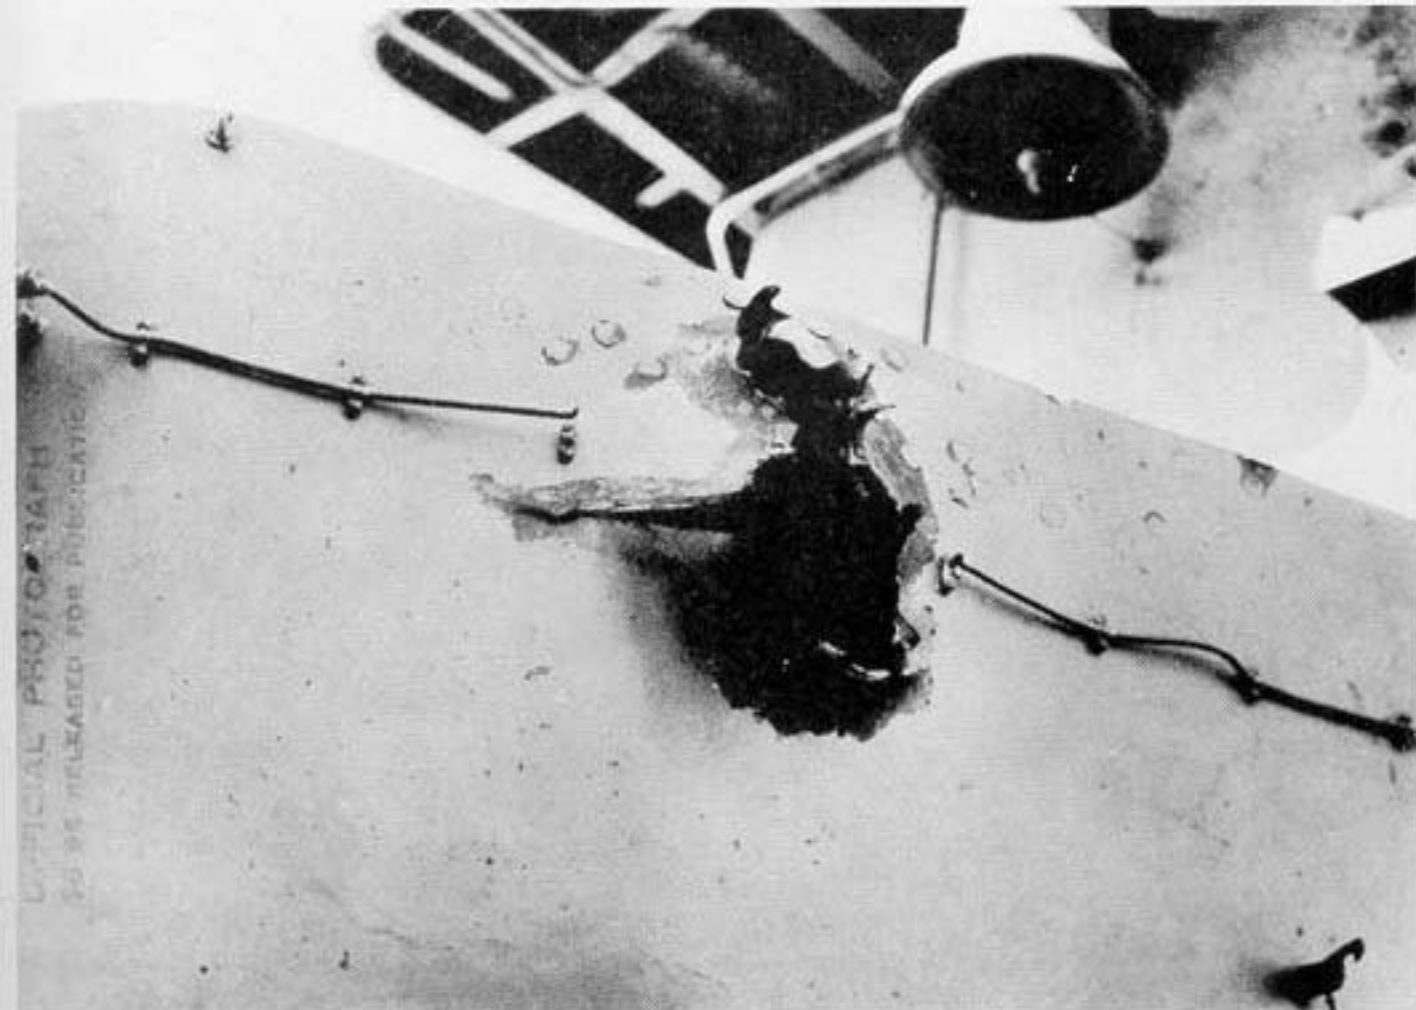
Photo 10: Exit hole of hit No. 7 port side of 1.1-inch clipping room.

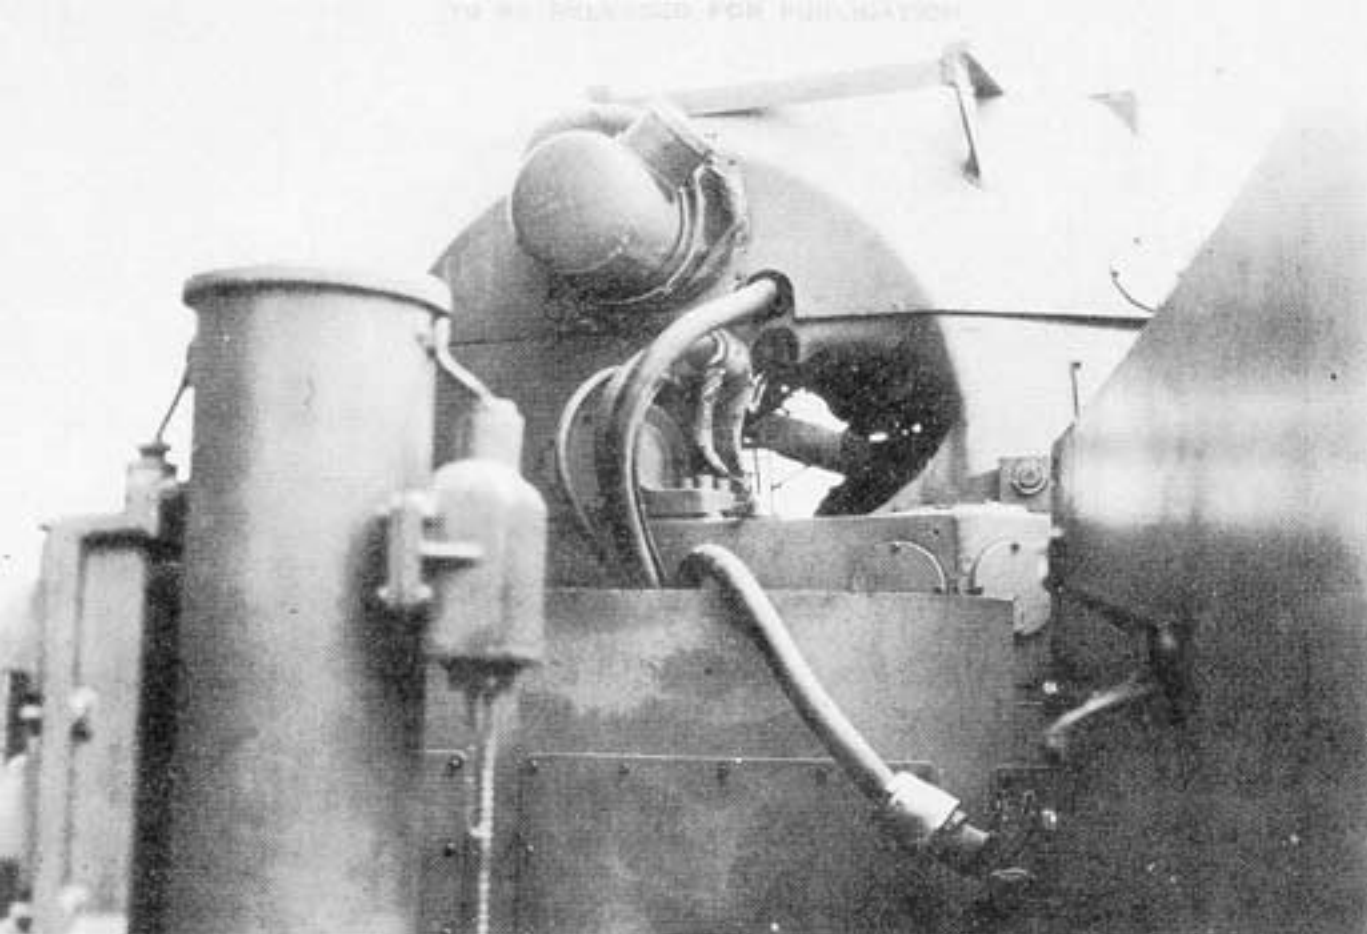
Photo 11: Hit No. 8. Hole through Mk. 45 1.1-inch director.

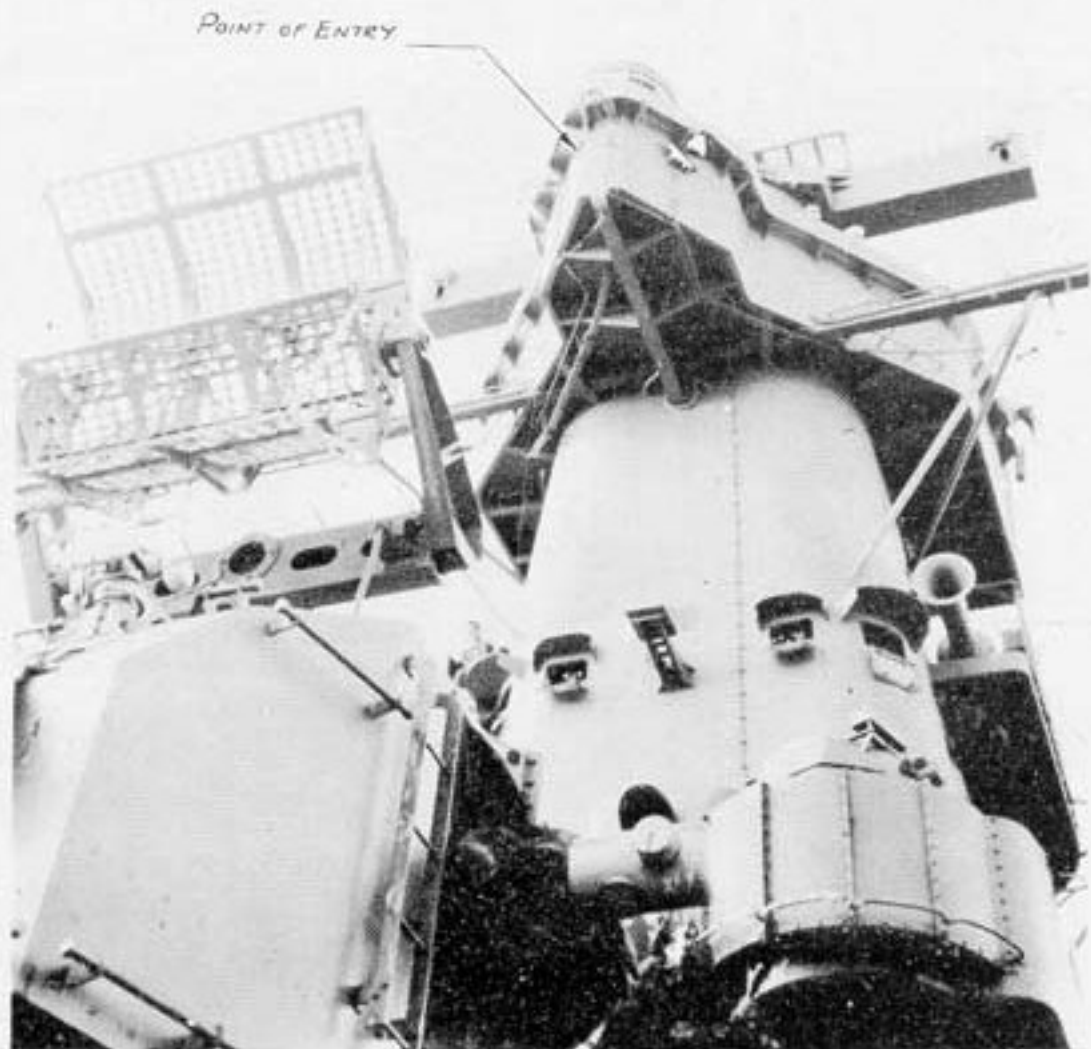
Photo 12: Exit holes of hit No. 9 on port side of wind and spray shield around air defense forward. Entry hole on starboard side of spray shield can also be seen.

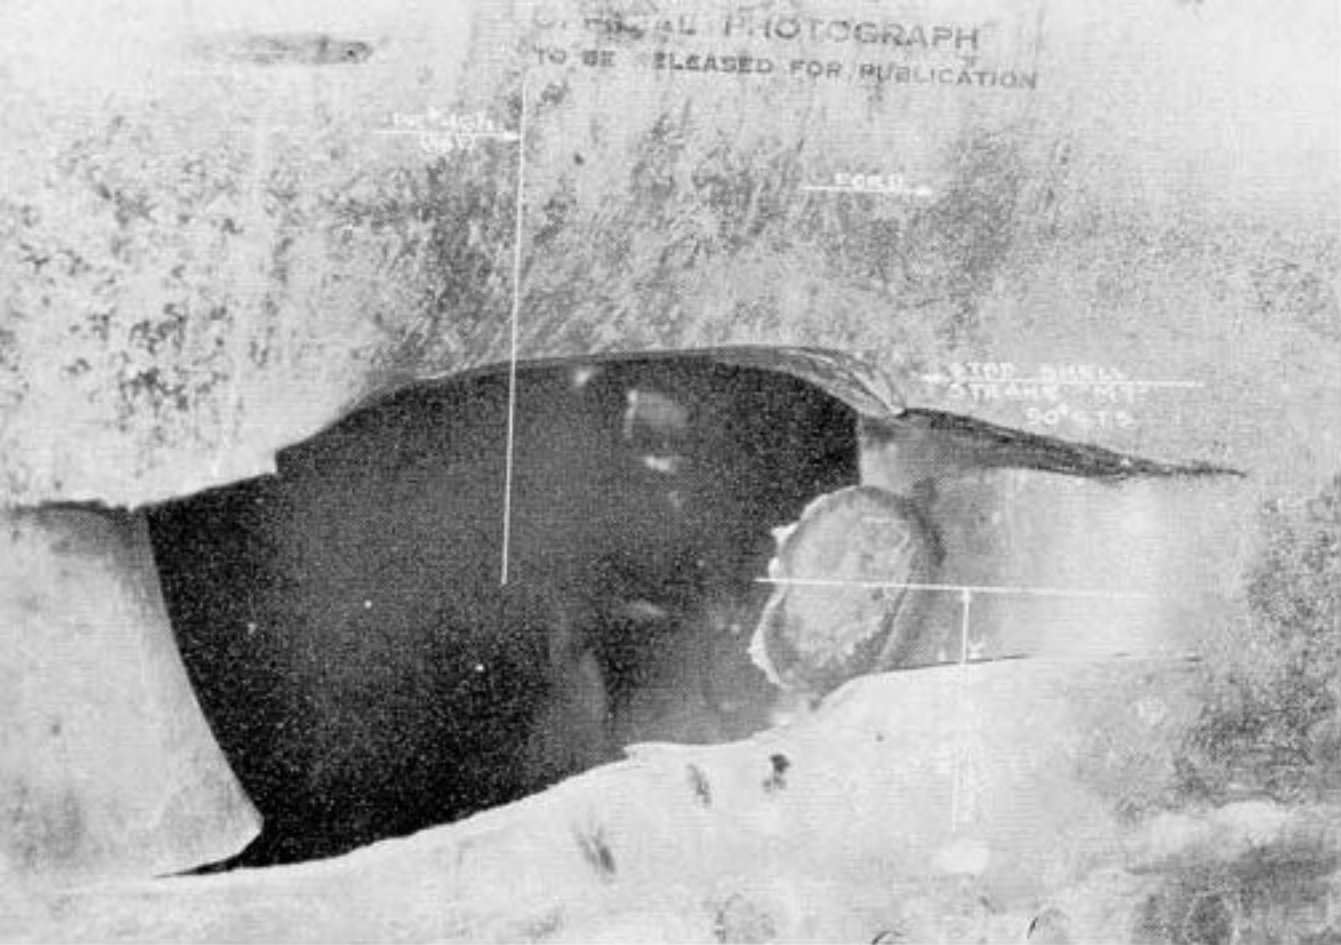
Photo 3: Hit No. 4. Projectile entry hole at frame 46-1/2.
