# U. S. S. SOUTH DAKOTA (BB57)

## GUNFIRE DAMAGE

BATTLE OF GUADALCANAL  
14-15 NOVEMBER, 1942

WAR DAMAGE REPORT No. 57

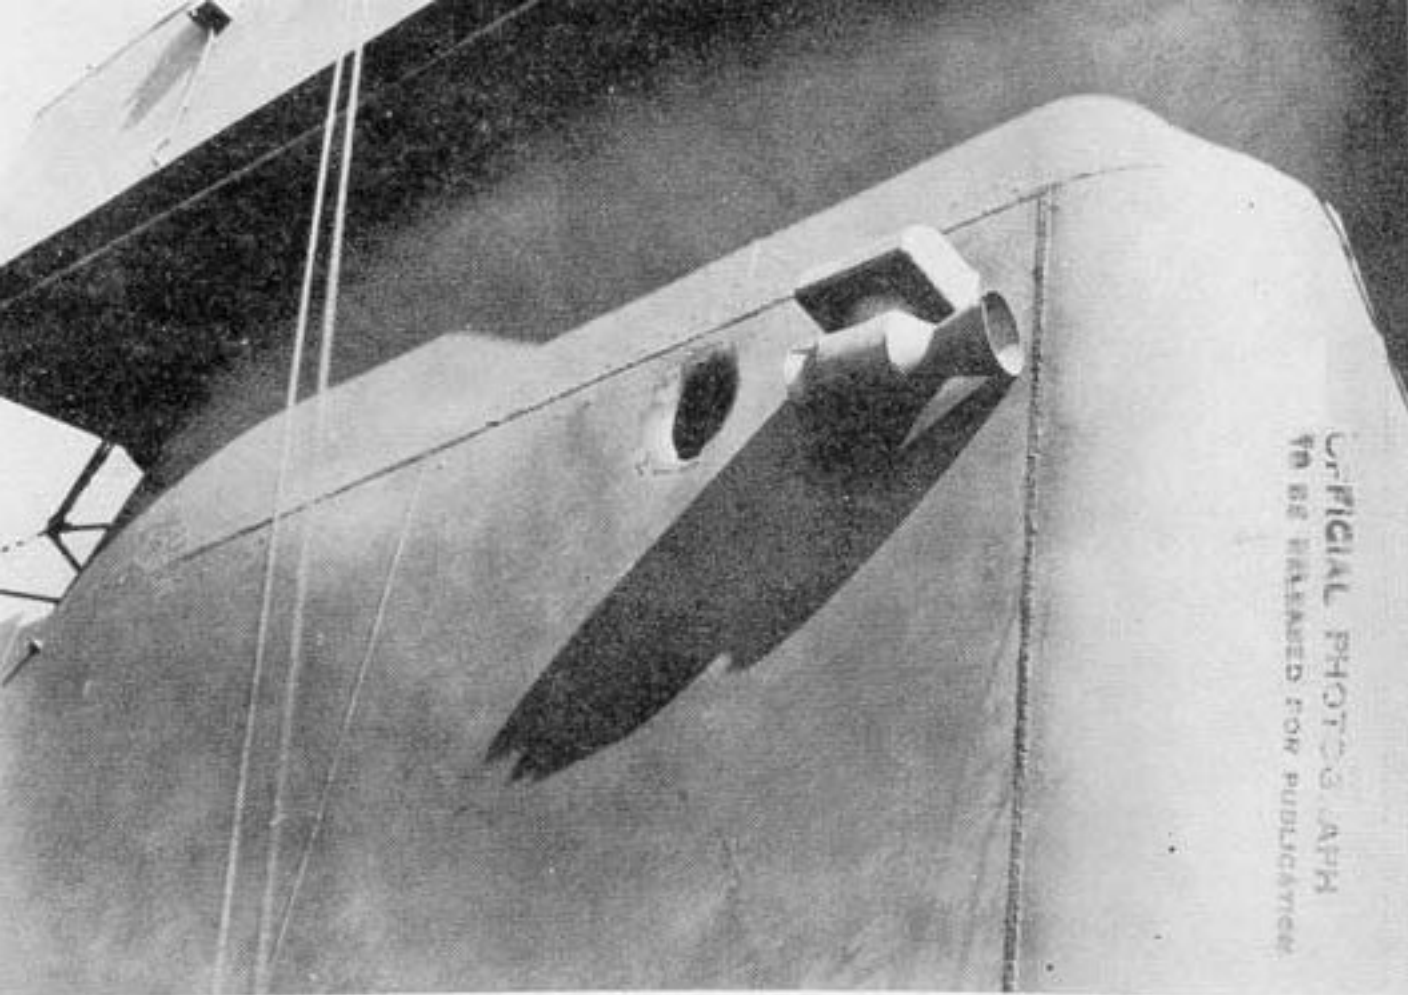
Photo 13: Point of entry of hit No. 10 in starboard longitudinal bulkhead.

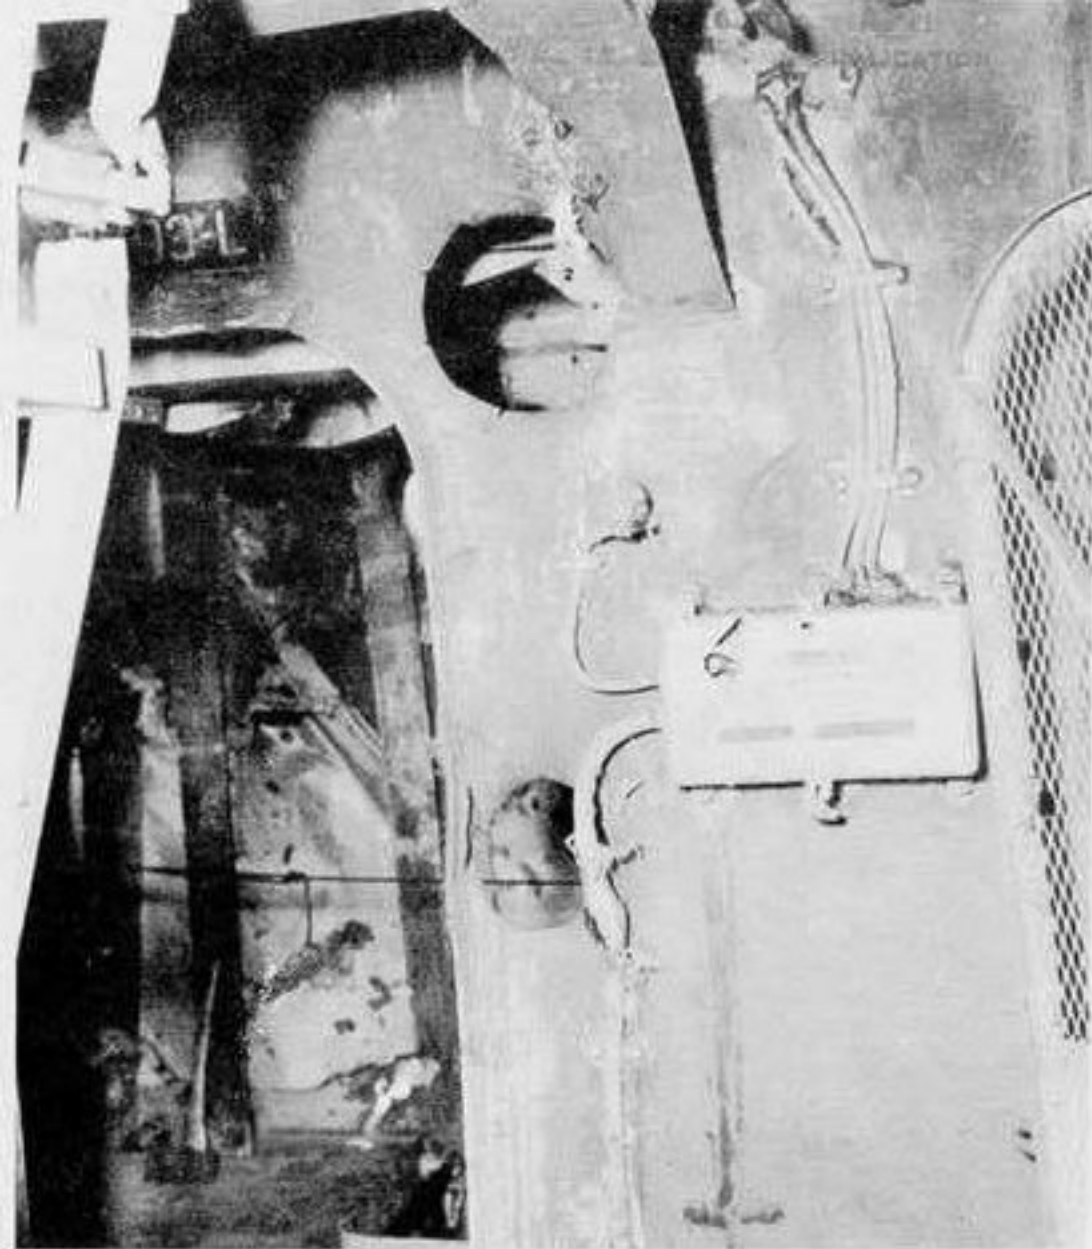
Photo 14: Hit No. 10. Holes in centerline bulkhead.

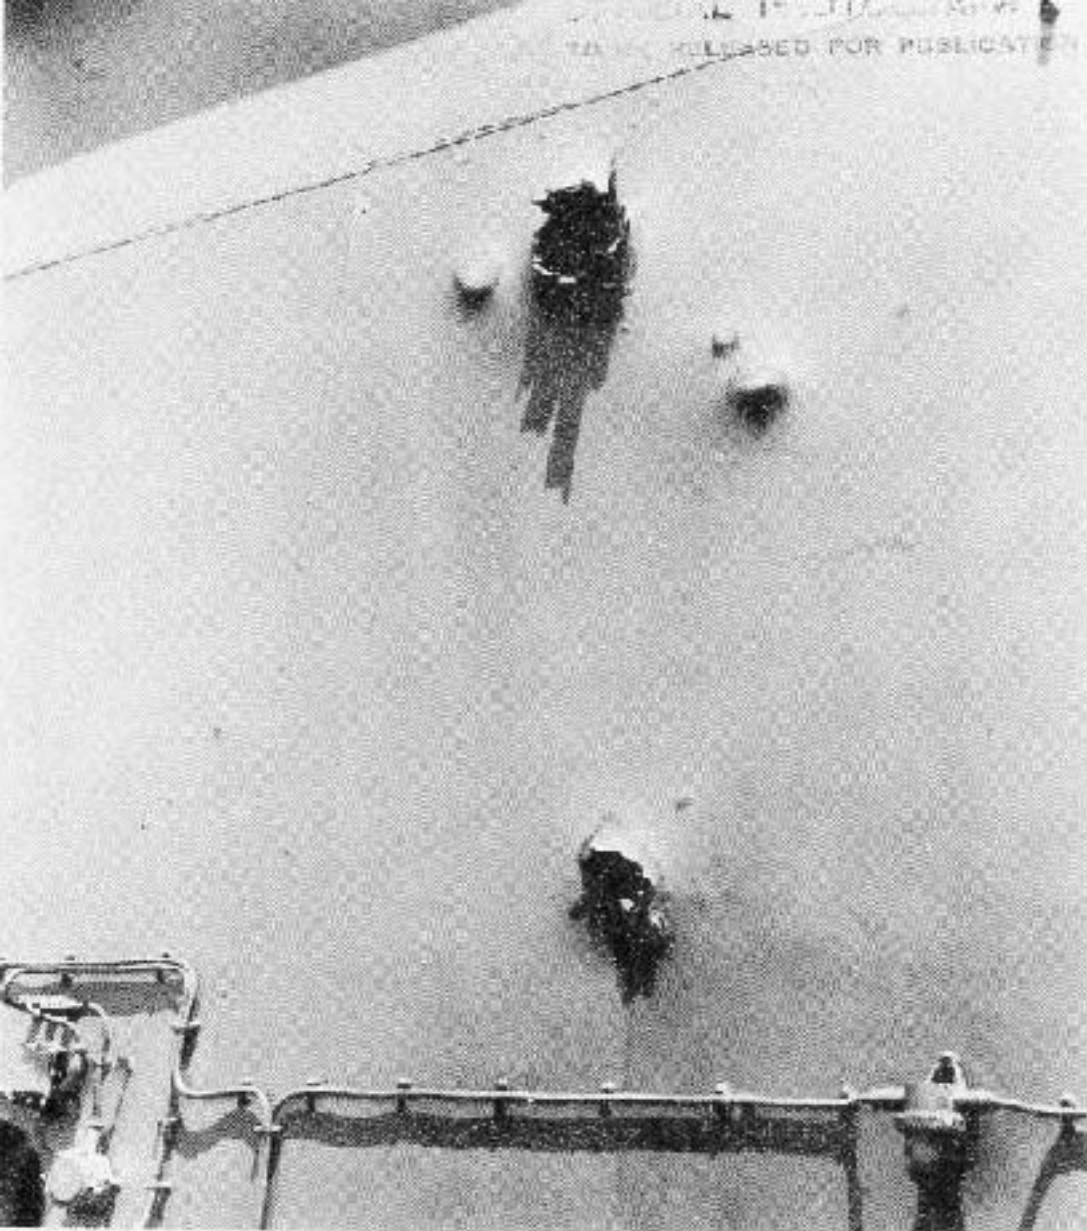
Photo 15: Hit No. 10. Holes in port longitudinal culkhead.

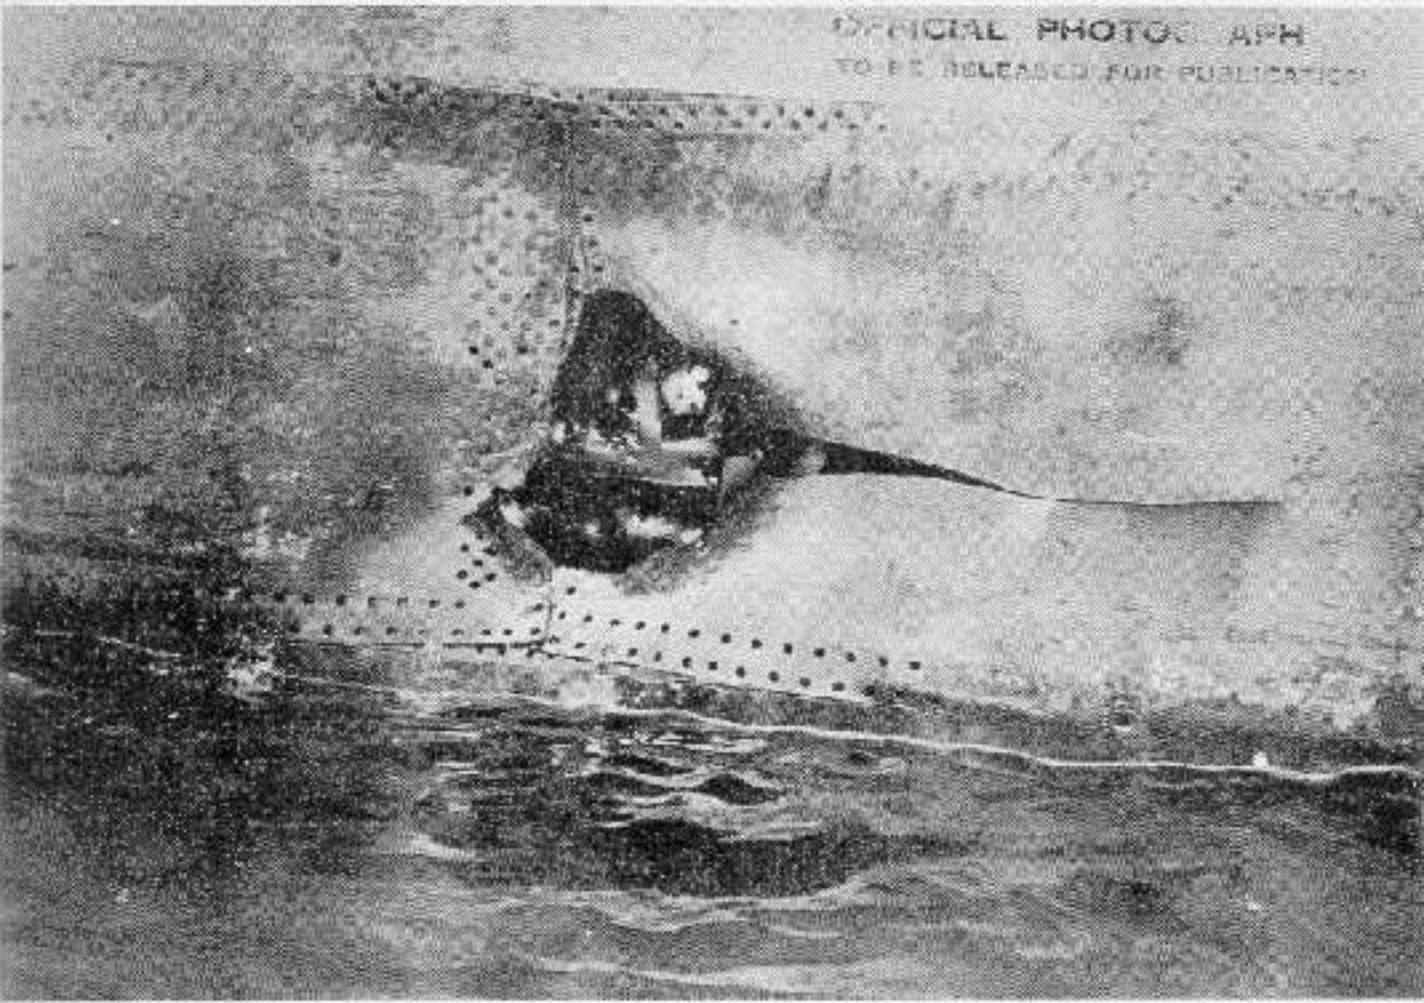
Photo 16: Hit No. 11 on starboard shell. Note fragment holes in torpedo bulkhead No. 2.

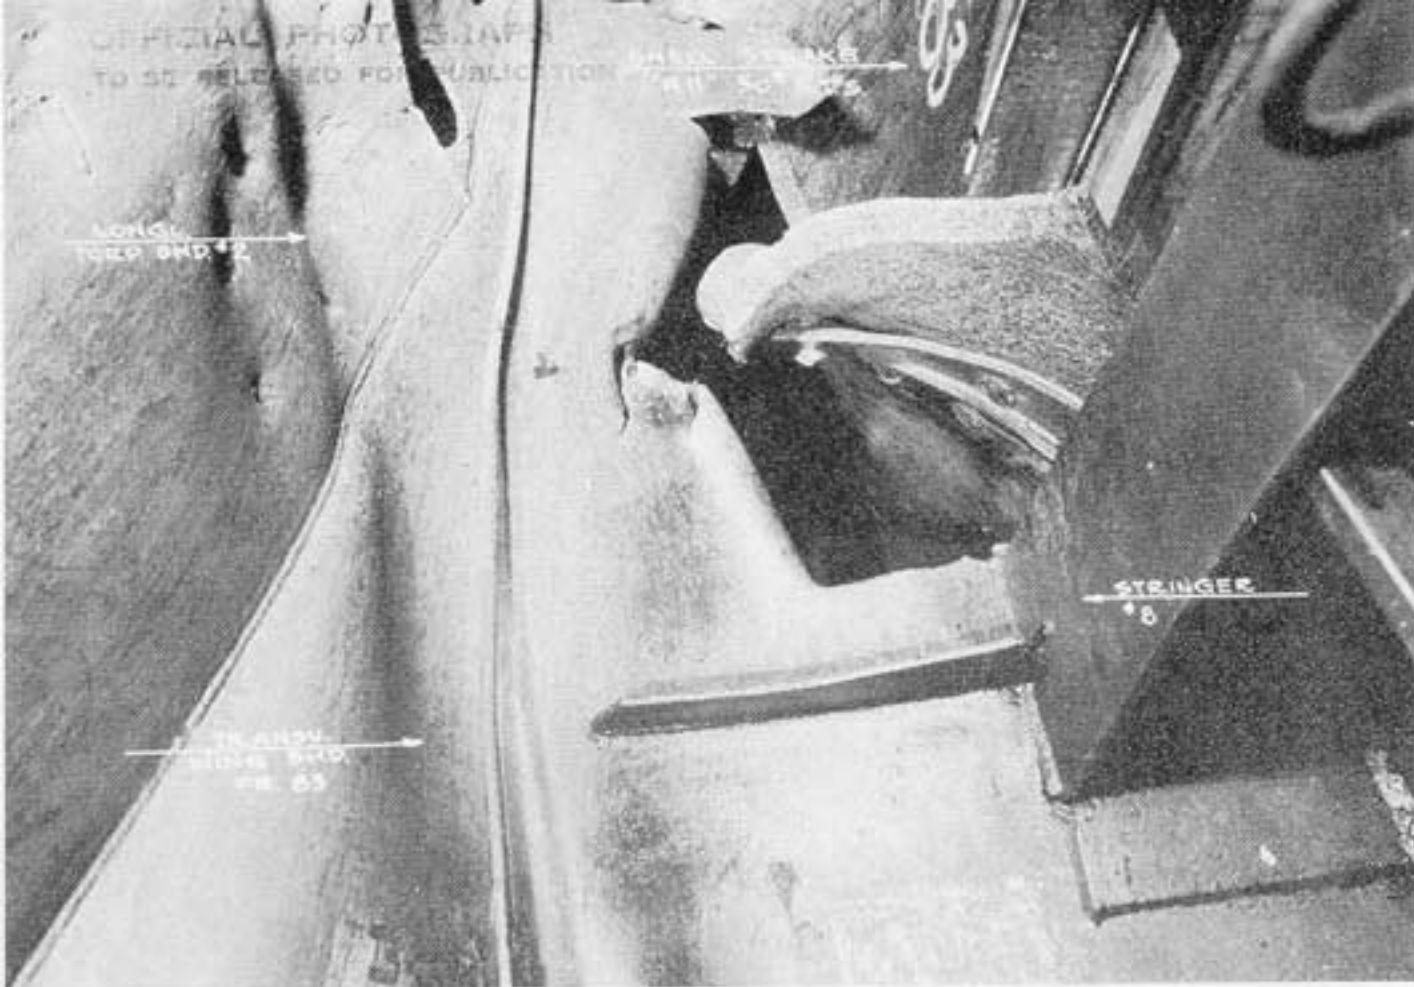
Photo 17: Hit No. 11. Damage to bulkhead 83.

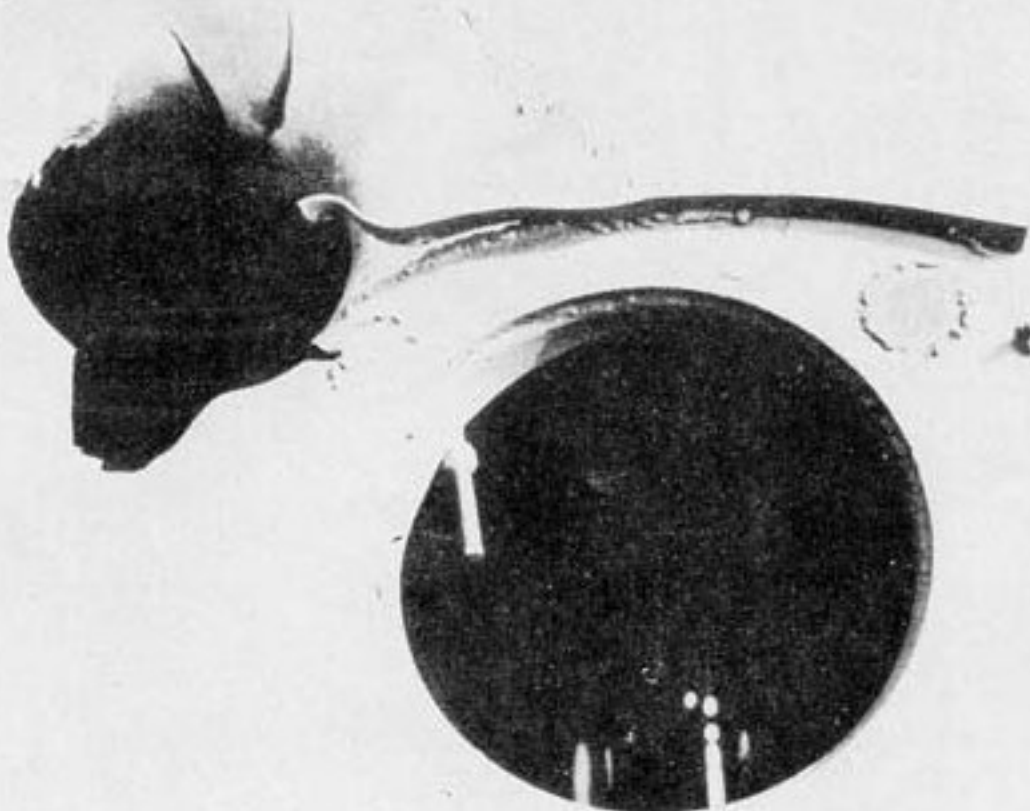
Photo 18: Hit No. 12. Entry hole in starboard longitudinal structural bulkhead.

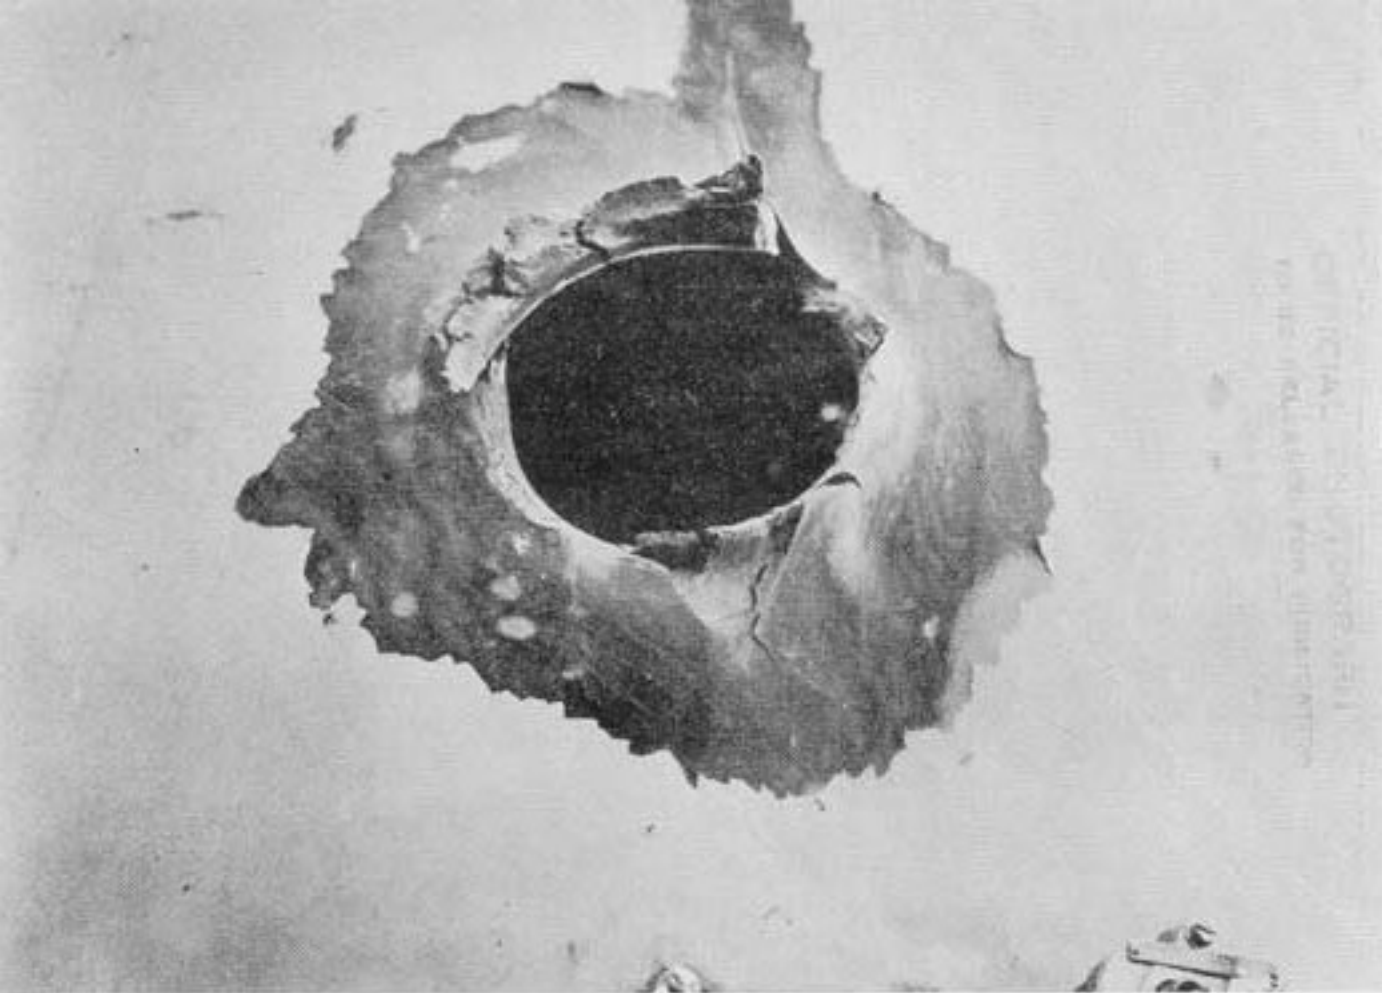
Photo 19: Hit No. 12. Exit hole in port longitudinal structural bulkhead.

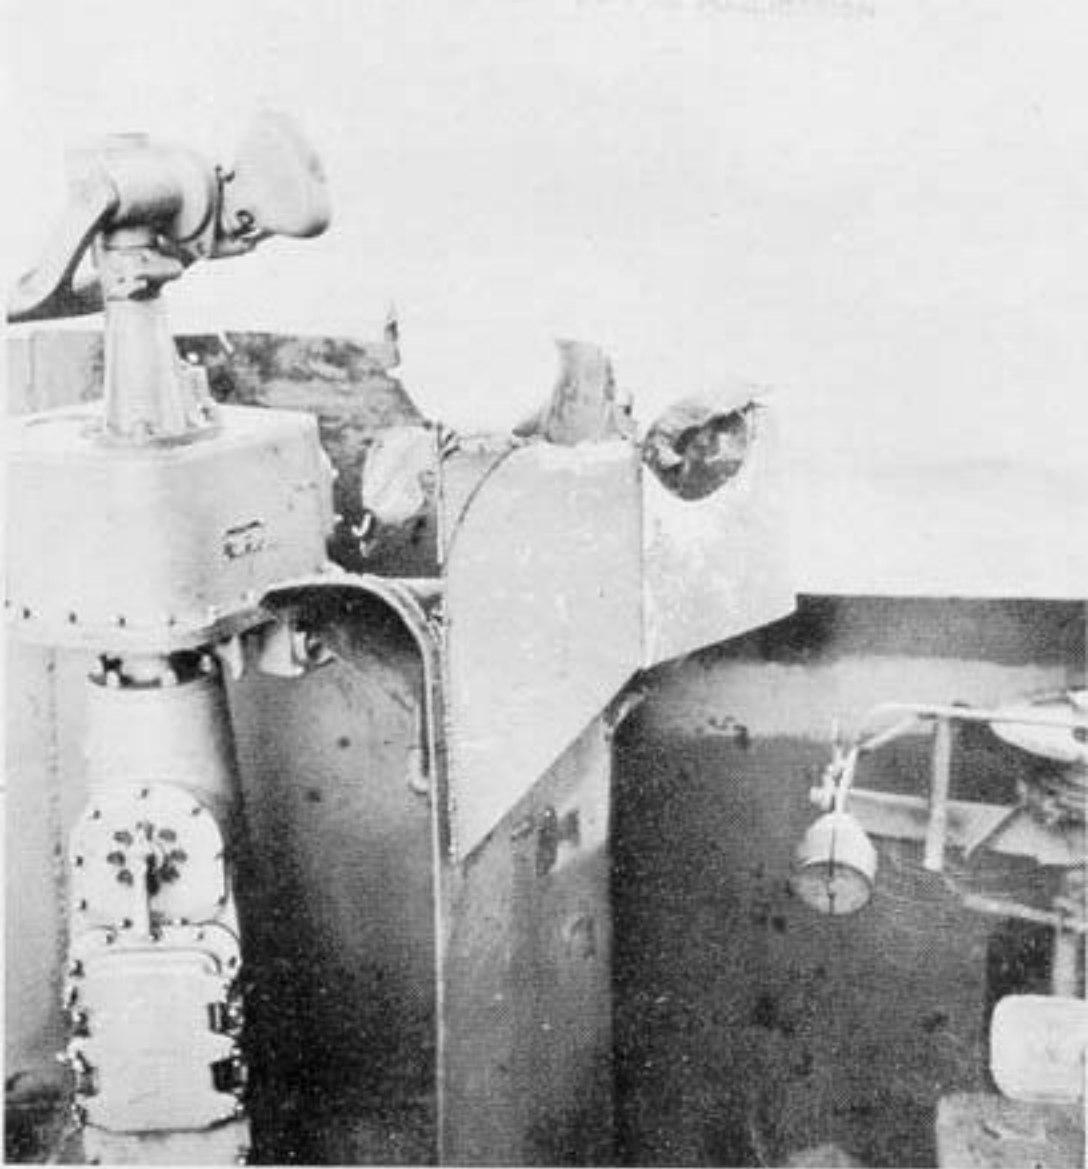
Photo 20: Hit No. 12 showing damage to wind and spray shield around port target designator.

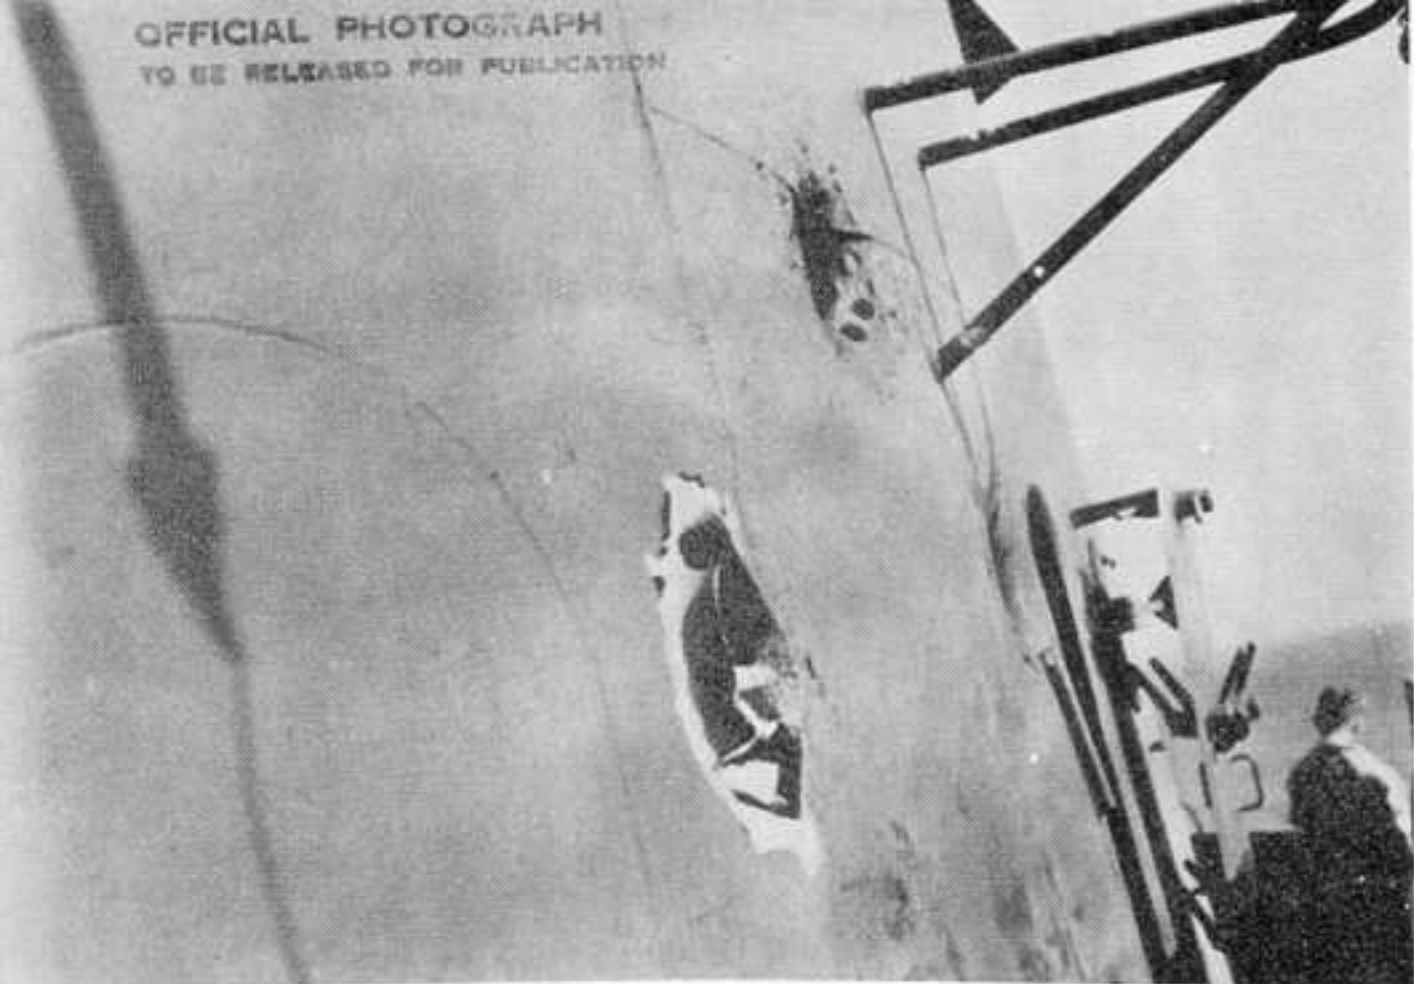
Photo 21: Hits Nos. 13, 14 and 15. Entry holes in starboard longitudinal structural bulkhead.

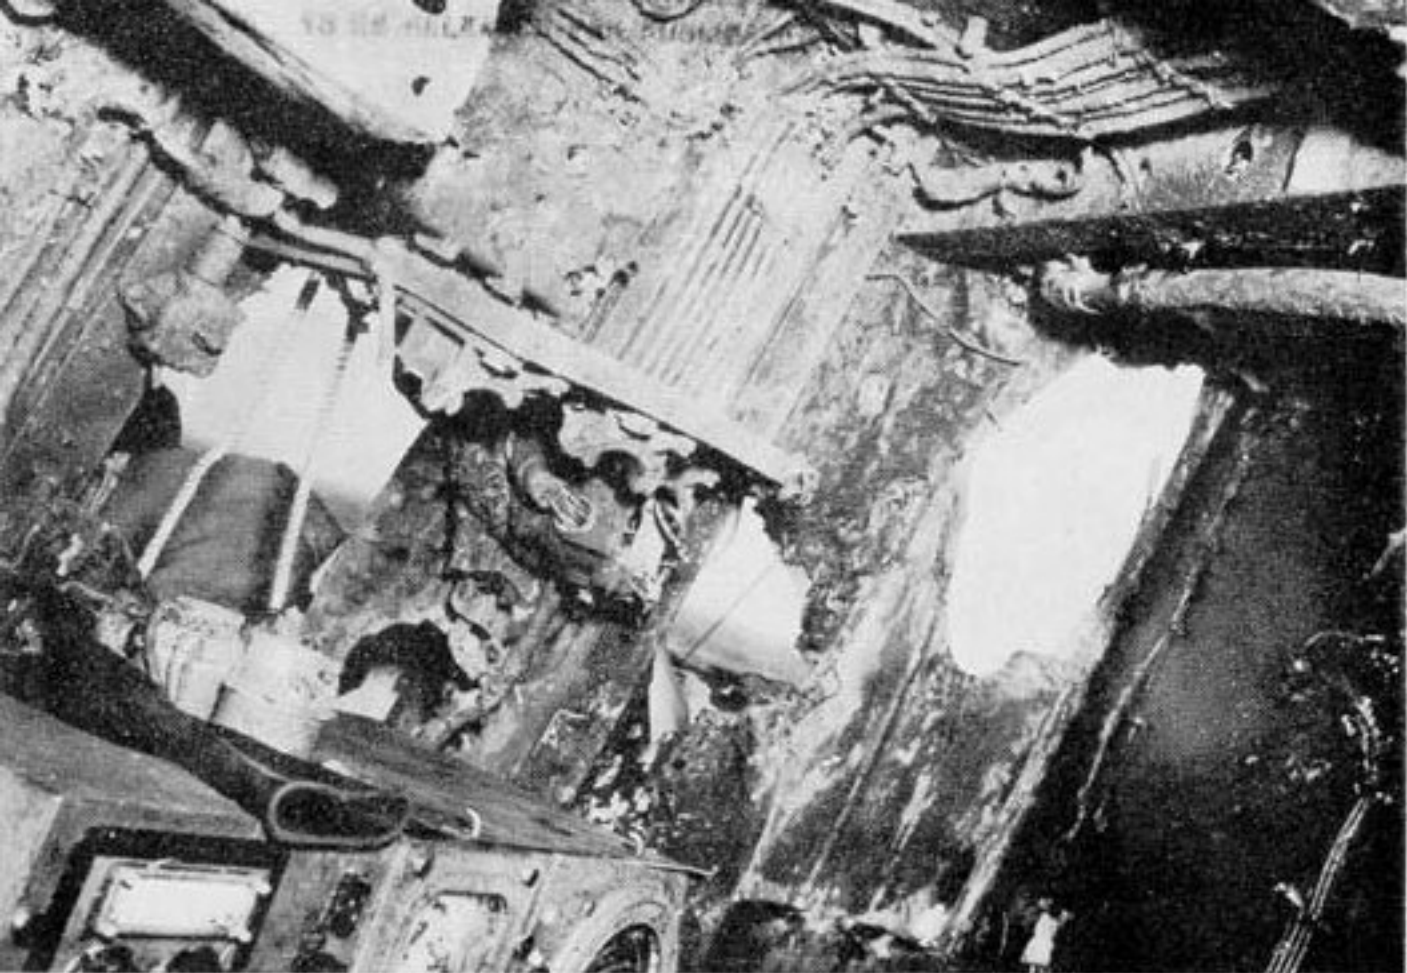
Photo 22: Hits Nos. 13 14 and 15. Damage to port longitudinal structural bulkhead looking from radar plot.

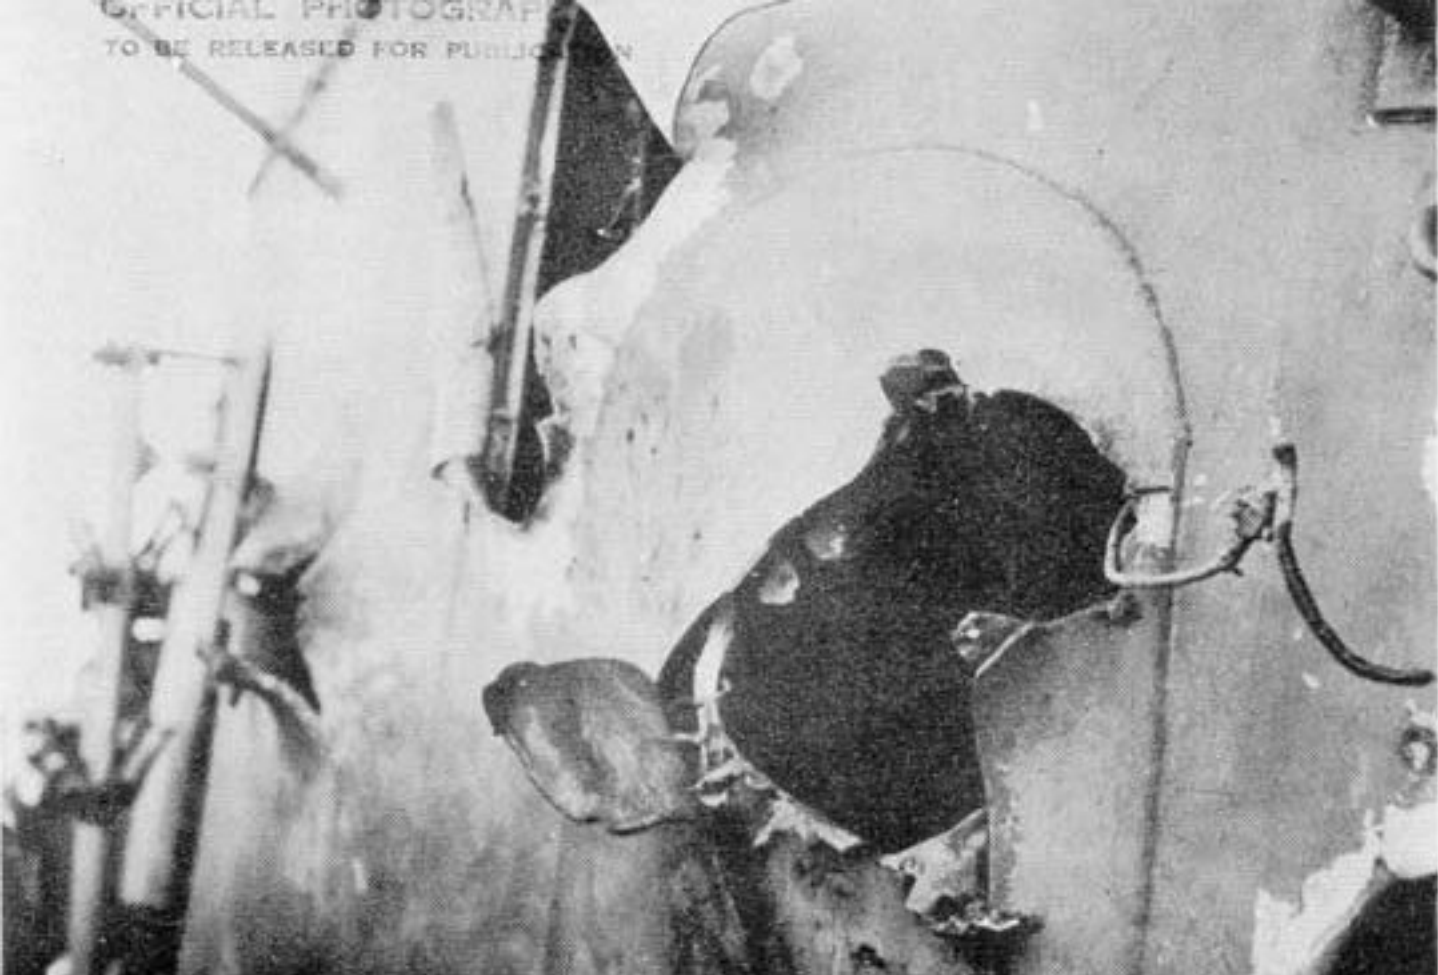
Photo 23: Outside view of damage to port longitudinal structural bulkhead from hits Nos. 13, 14 and 15.

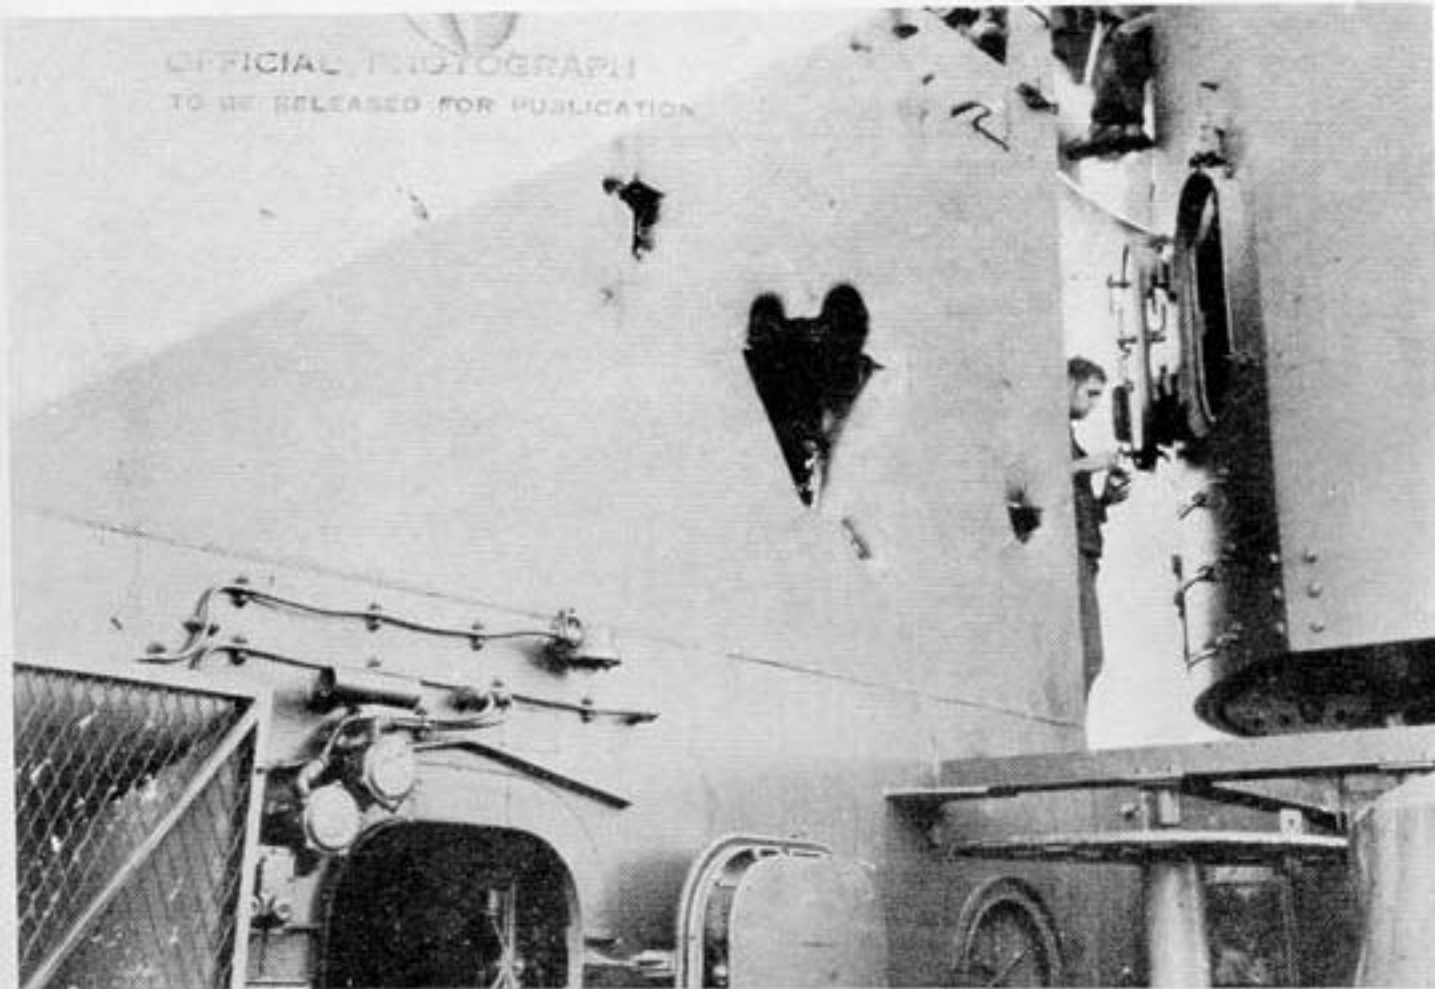
Photo 24: Hits Nos. 16, 17 and 18 on starboard side of  
W.R.S.R. 0203.

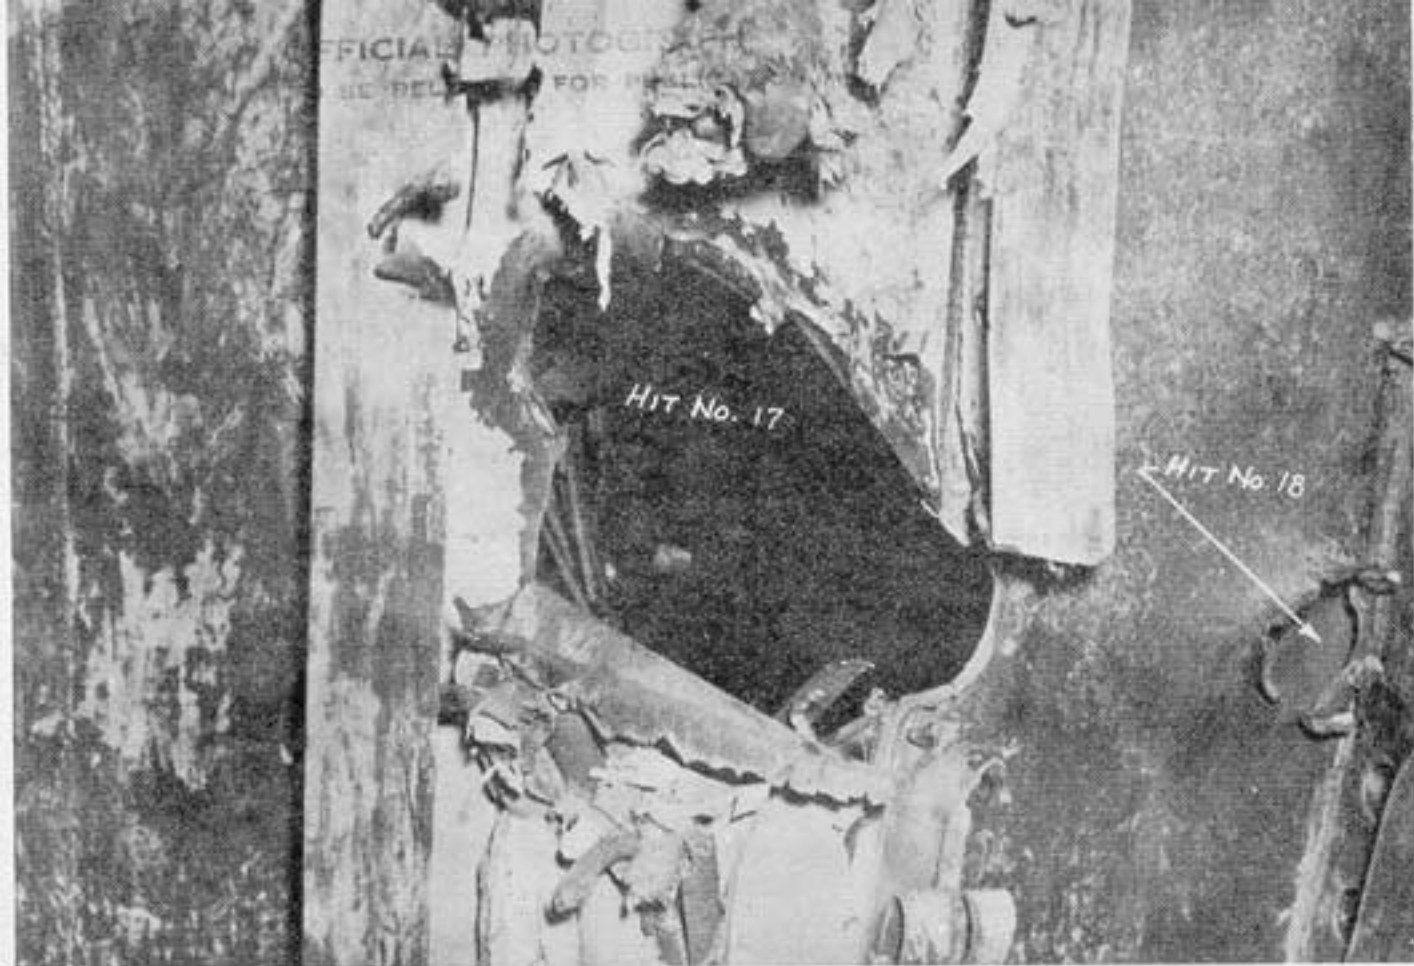
Photo 25: Hits Nos. 17 and 18 on structural bulkhead 9 feet to starboard of centerline.

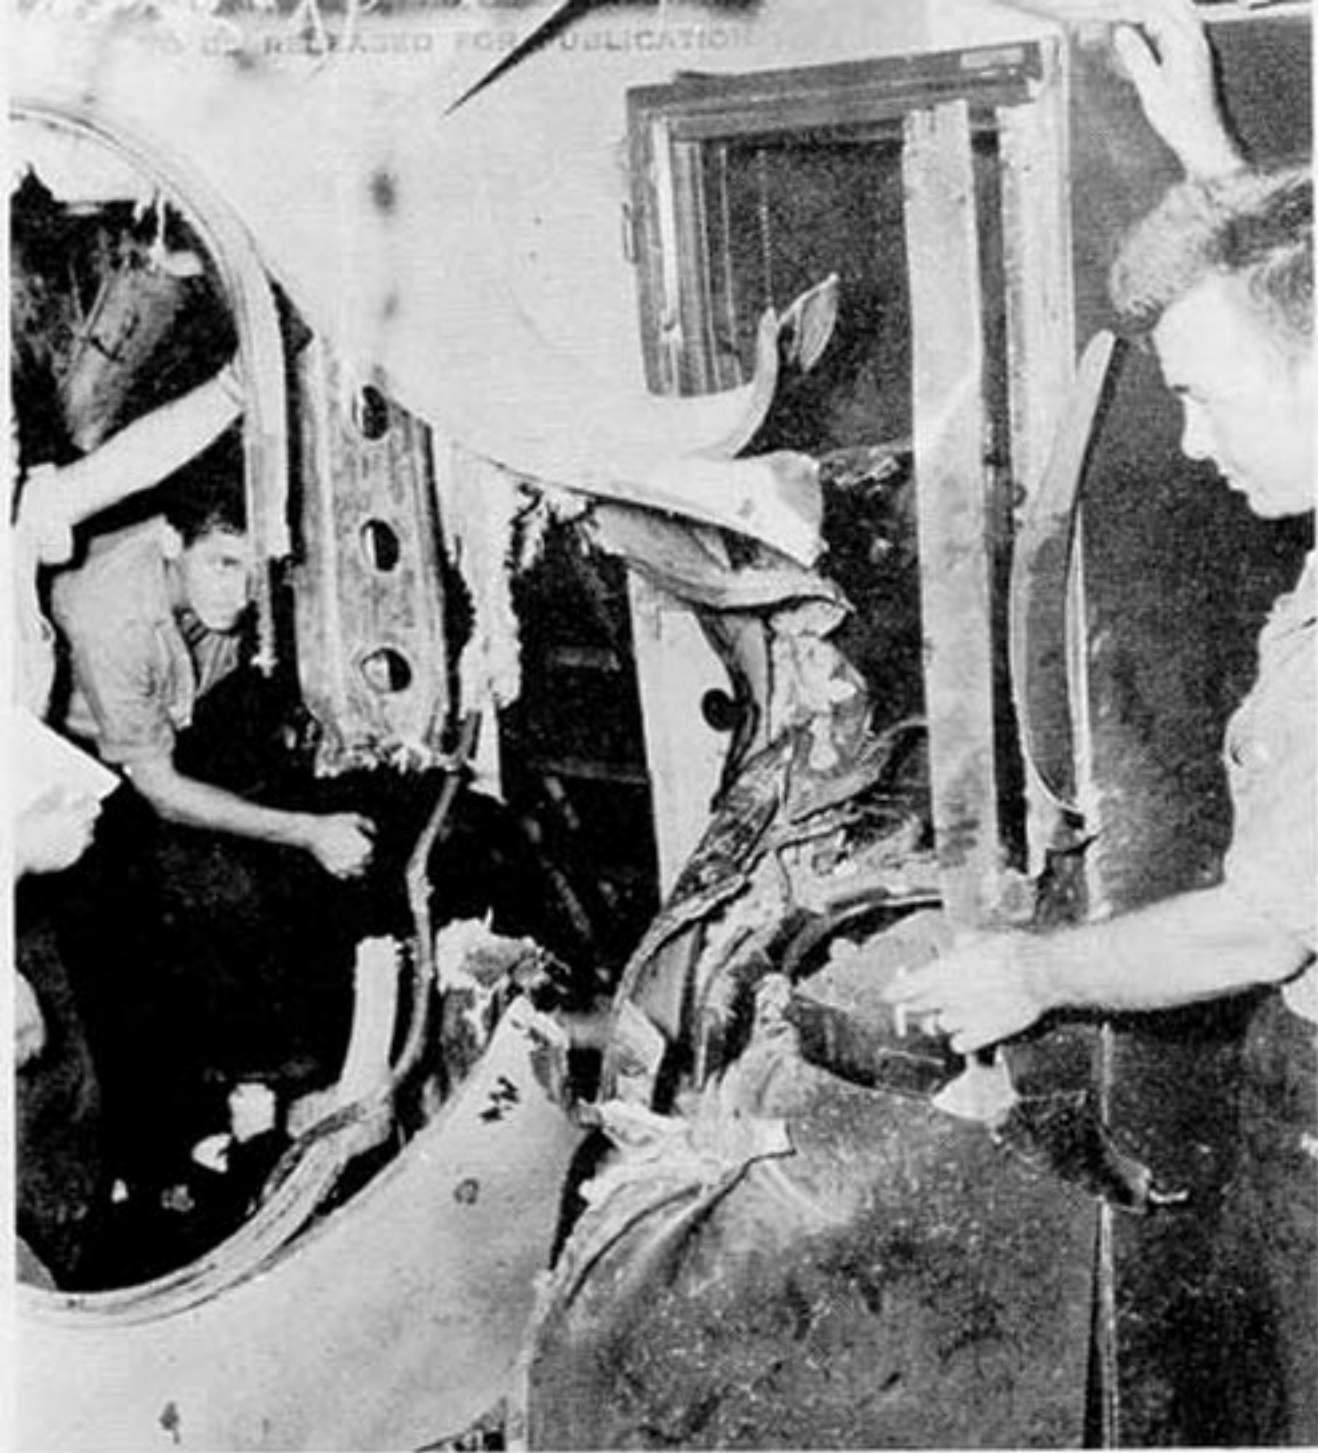
Photo 26: Hit No. 17 on structural bulkhead 9 feet to port of centerline. Note damage to safe.

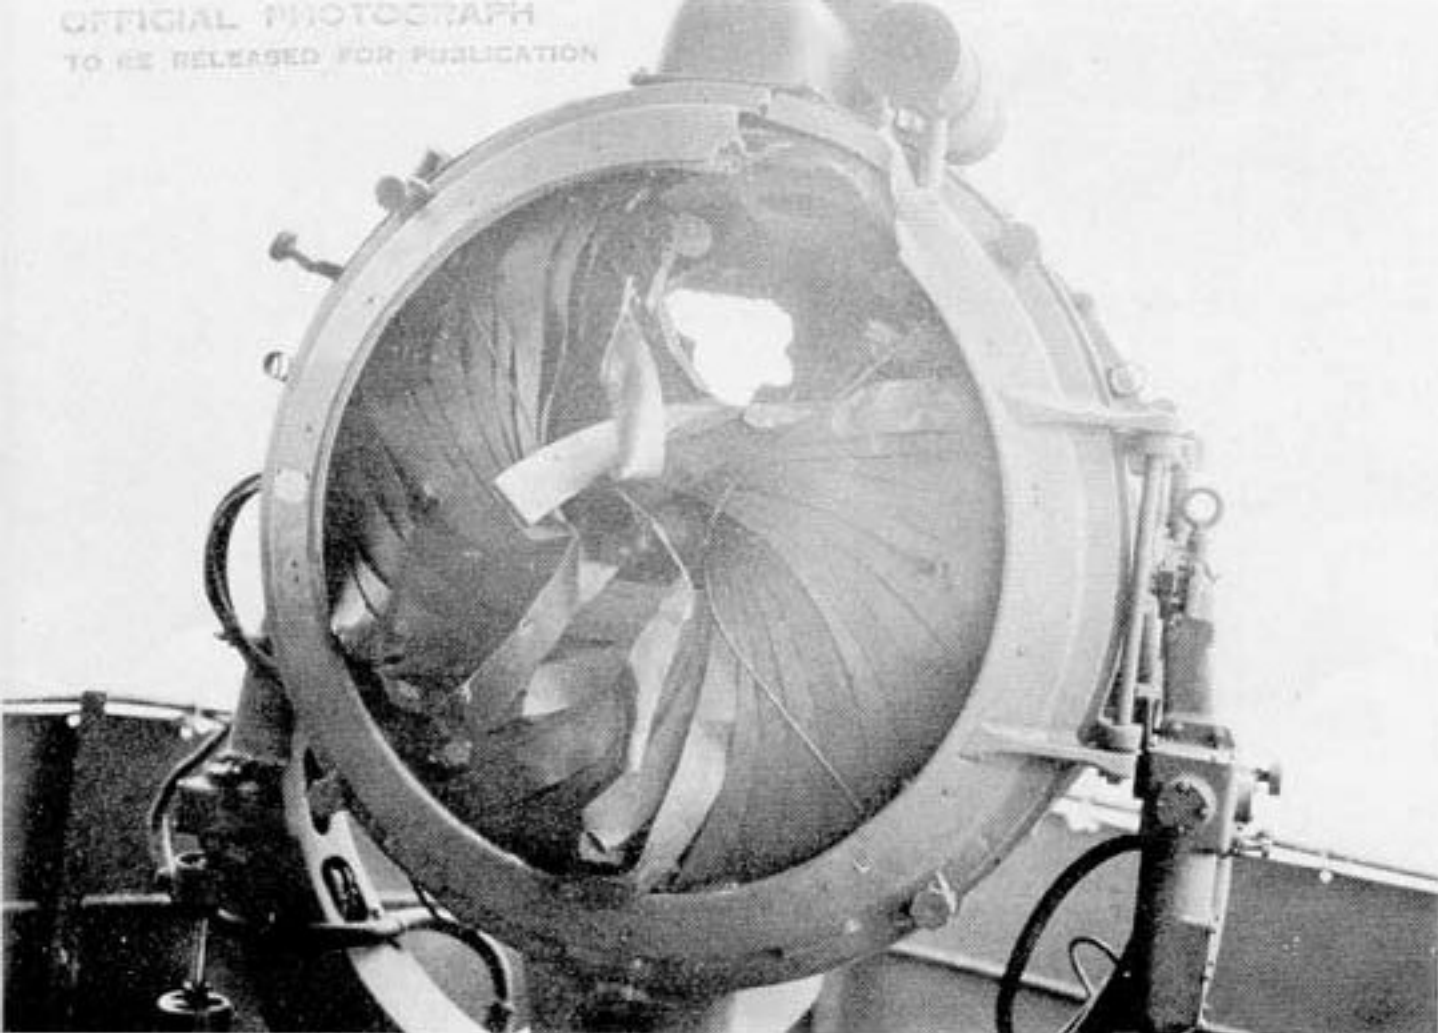
Photo 28: Hit No. 19. Damage to searchlight No. 3.

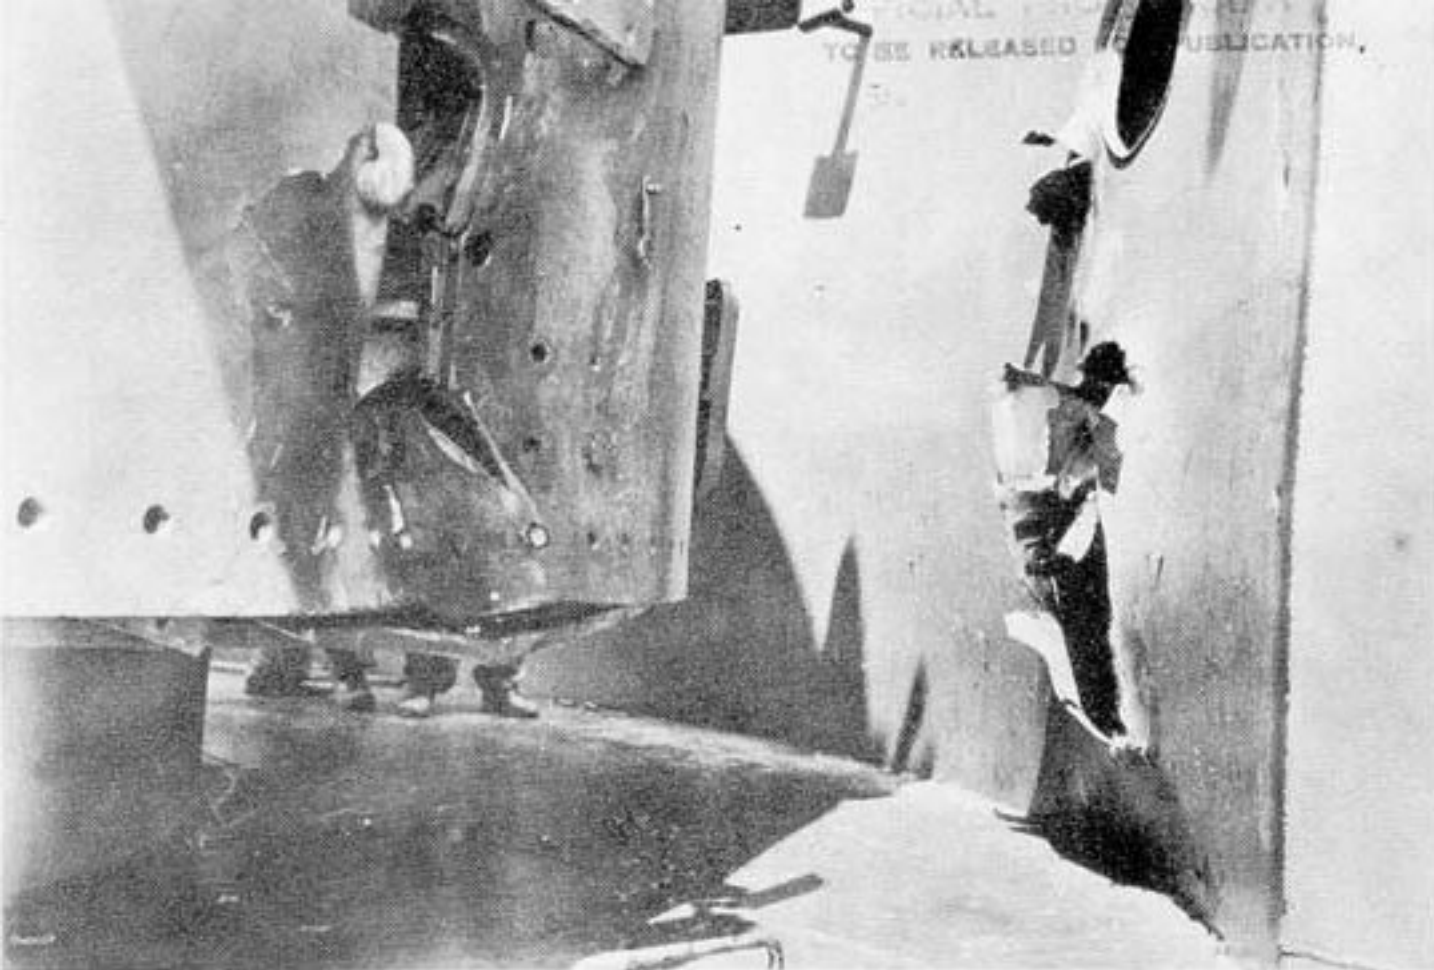
Photo 27: Hit No. 17. Port longitudinal structural bulkhead. Note damage to 5-inch mount No. 2 which stopped this projectile.
