# U. S. S. SOUTH DAKOTA (BB57)

## GUNFIRE DAMAGE

BATTLE OF GUADALCANAL  
14-15 NOVEMBER, 1942

WAR DAMAGE REPORT No. 57

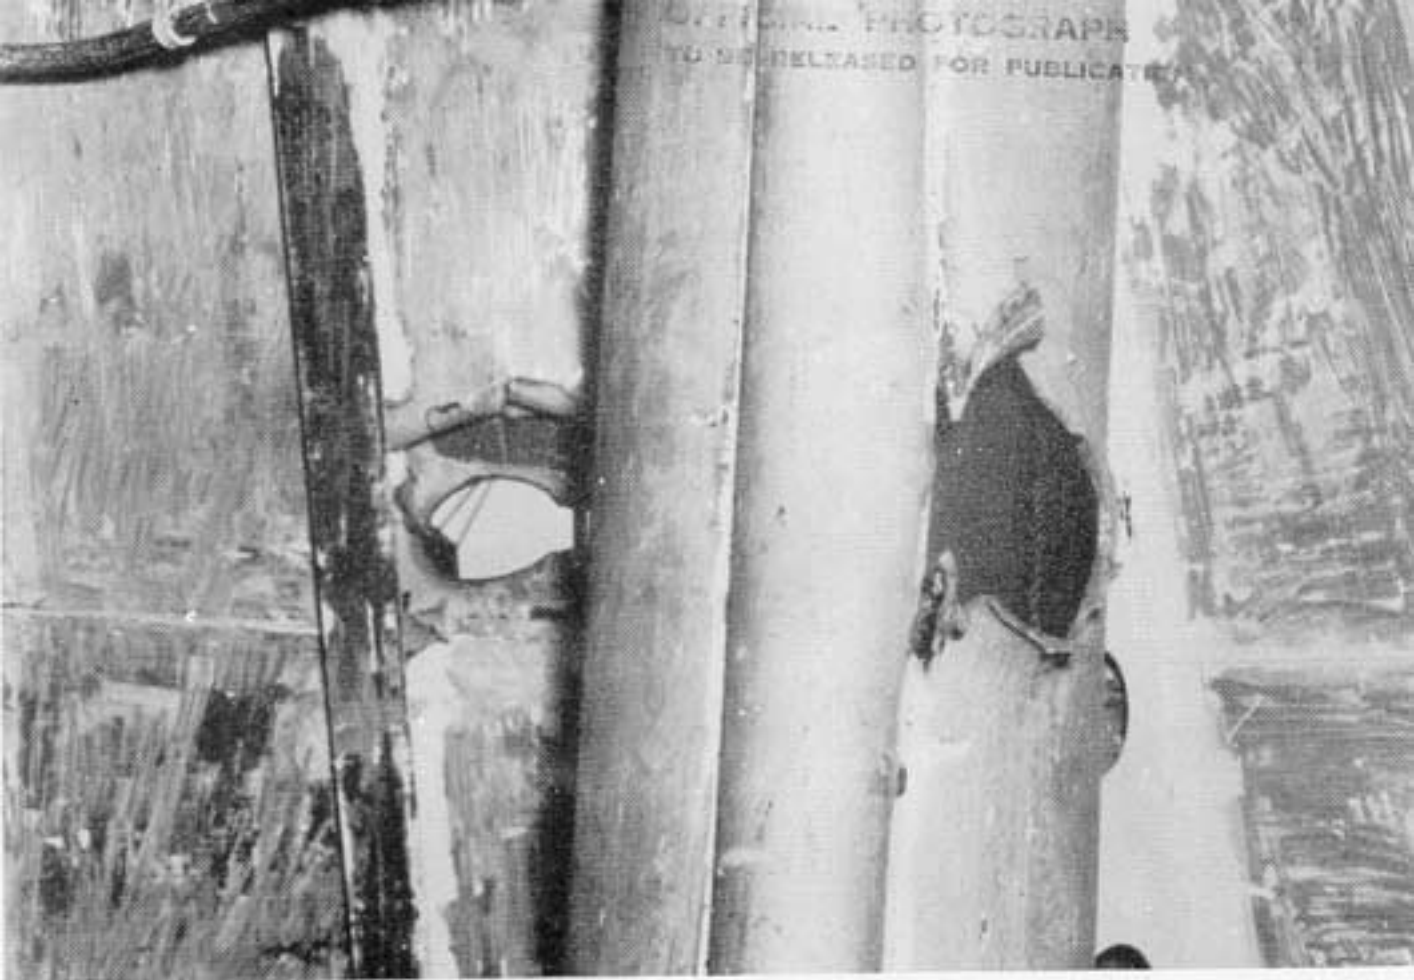
Photo 29: Hit No. 22. Hole in starboard structural bulk-head and foremast housing in battle dressing room.

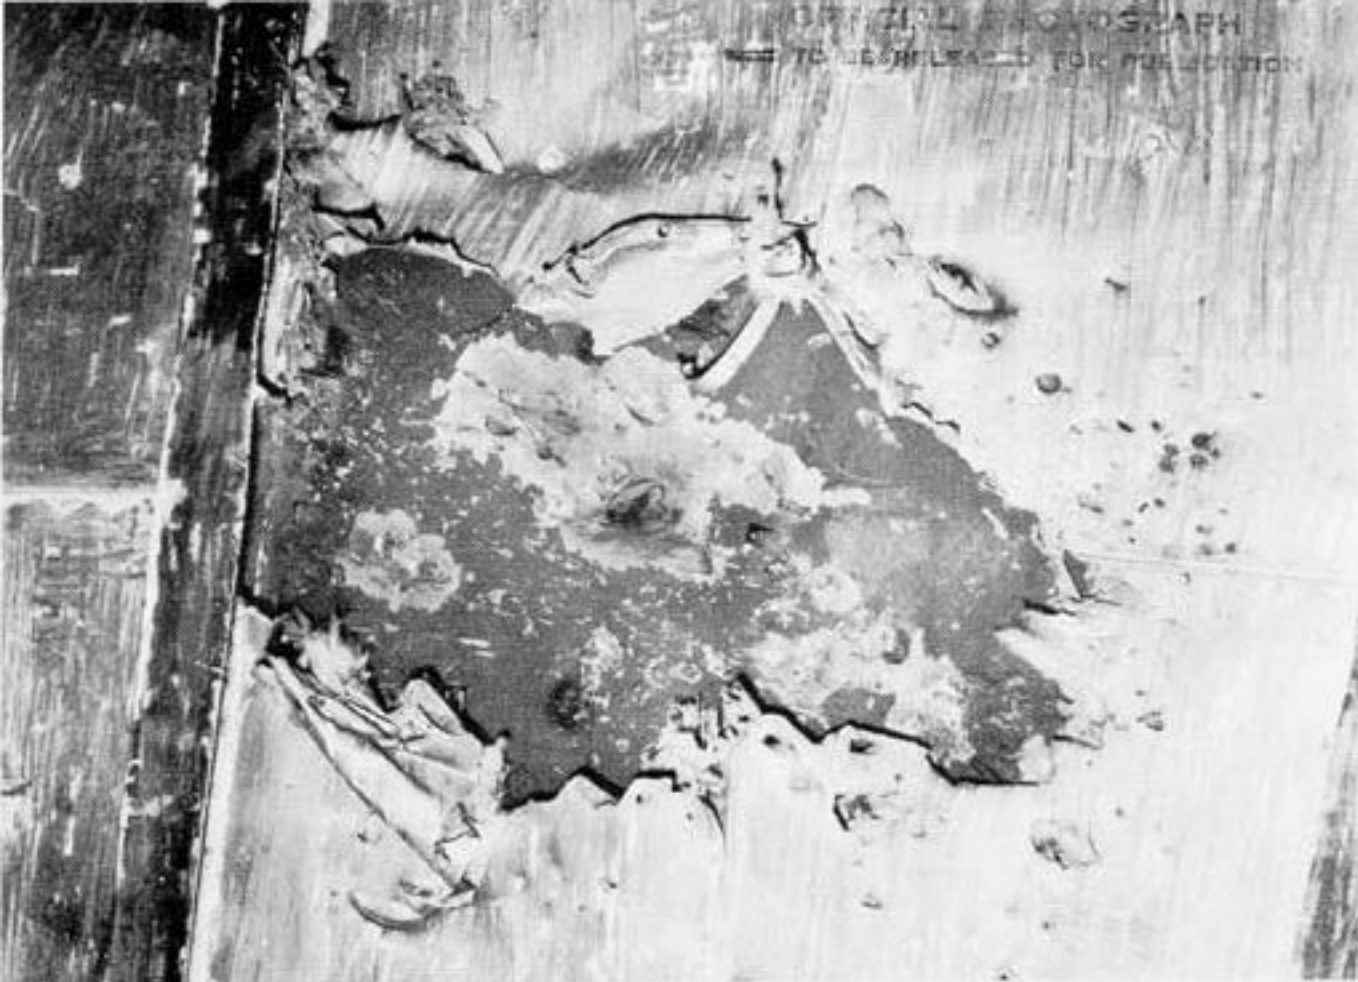
Photo 30: Hit No. 22. Damage to port structural bulkhead in battle dressing room.

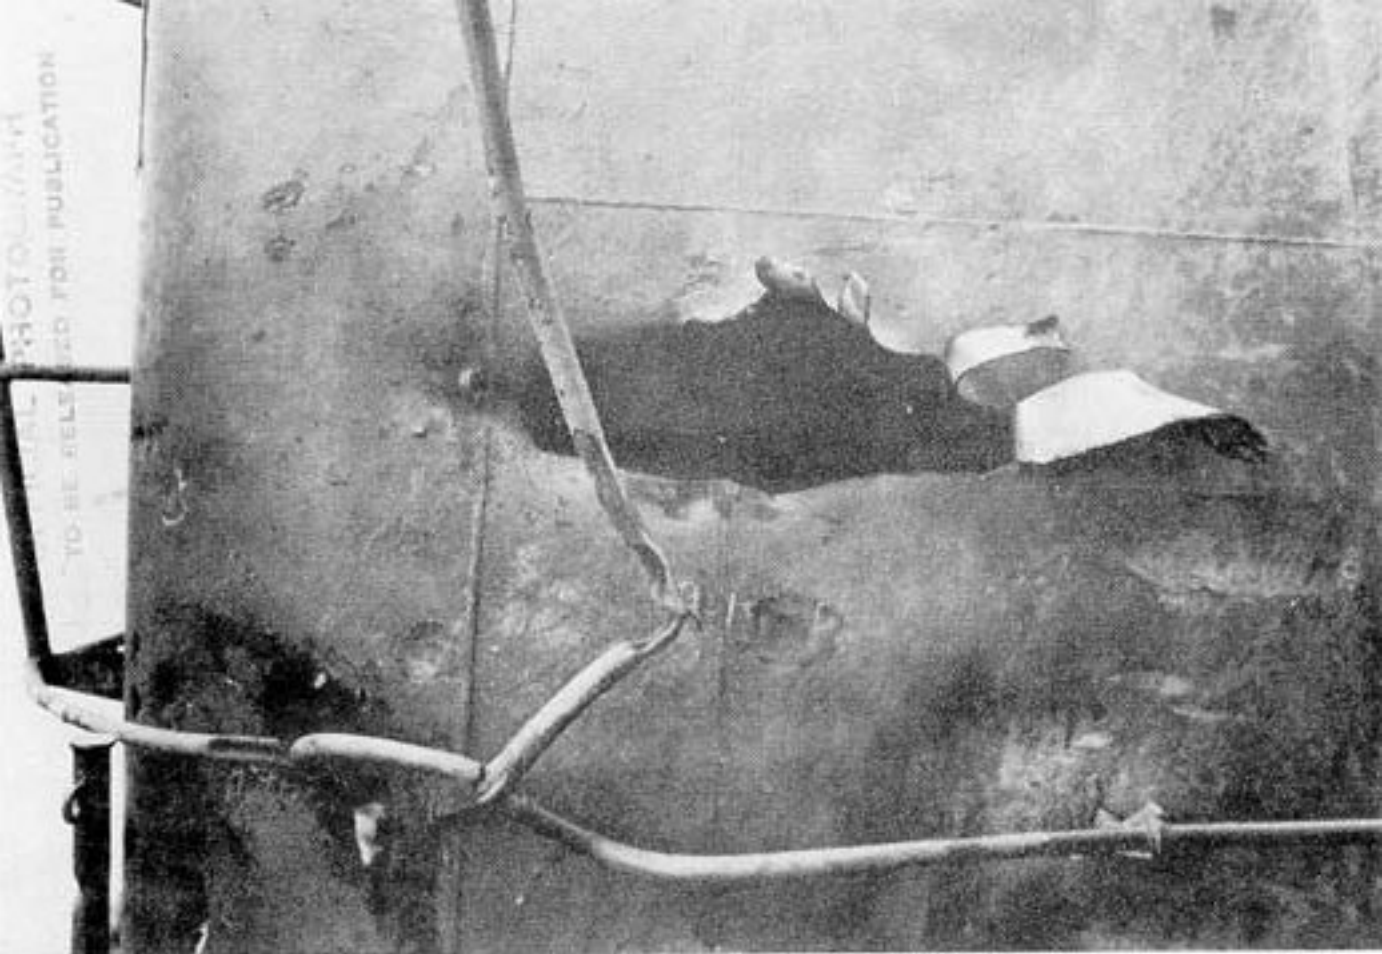
Photo 31: Hit No. 23. Damage to starboard side of stack hood.

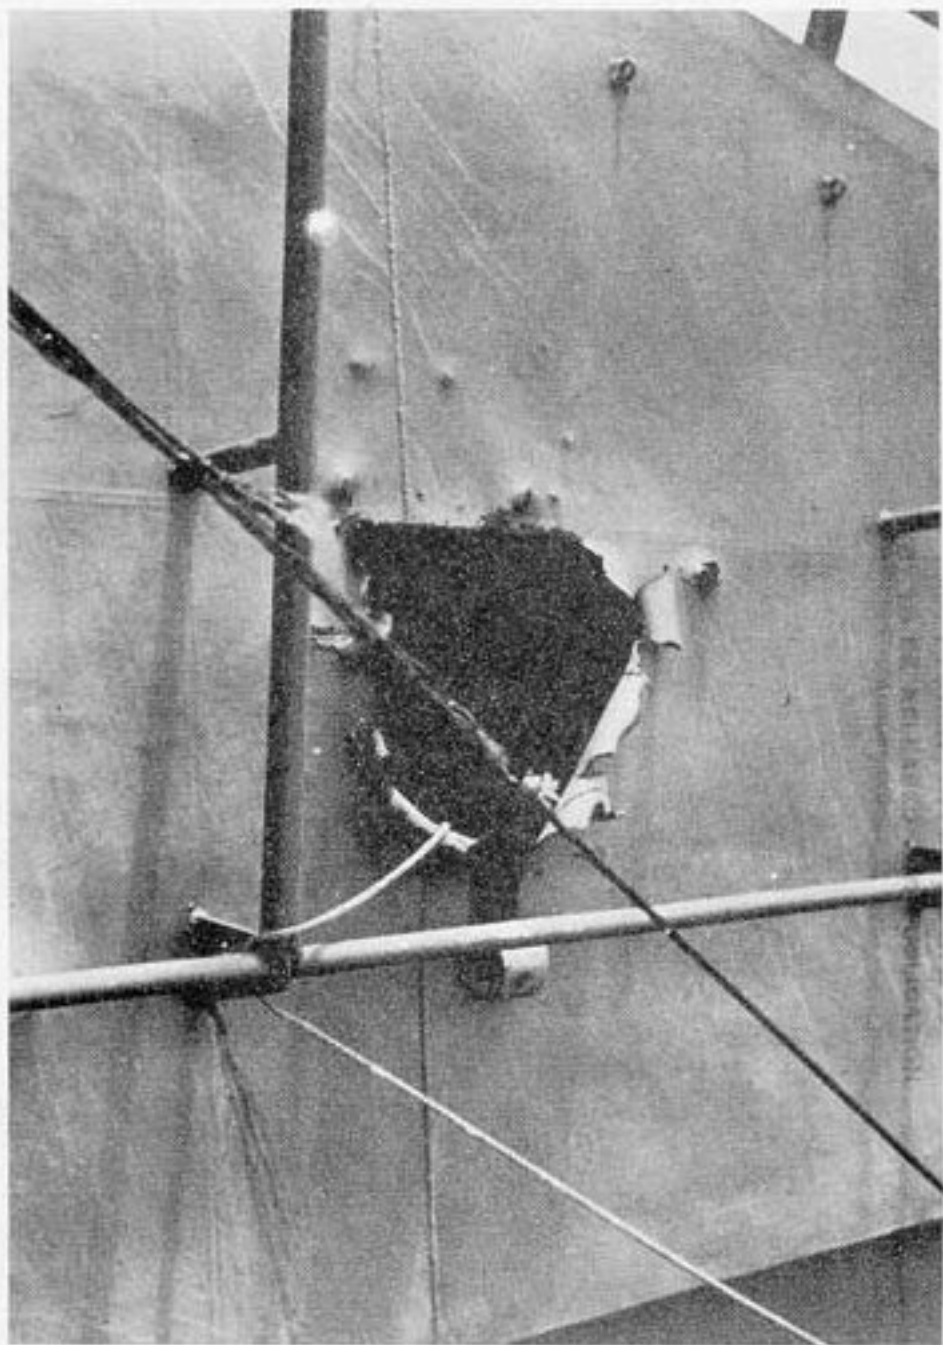
Photo 32: Hit No. 23. Damage to port side of stack hood.

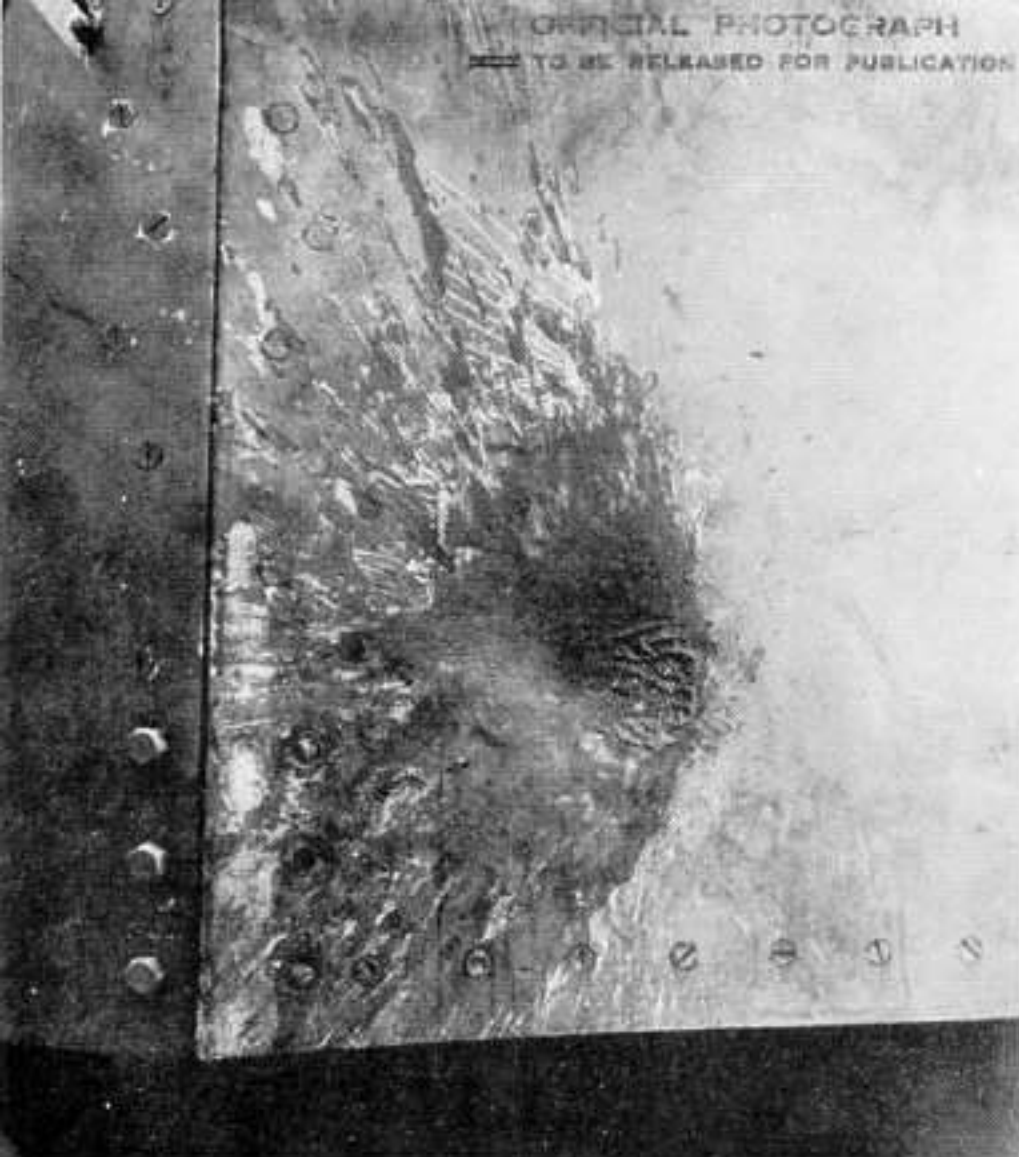
Photo 33: Hit No. 24. Damage to 5-inch mount No. 5 from glancing hit by 6-inch projectile.

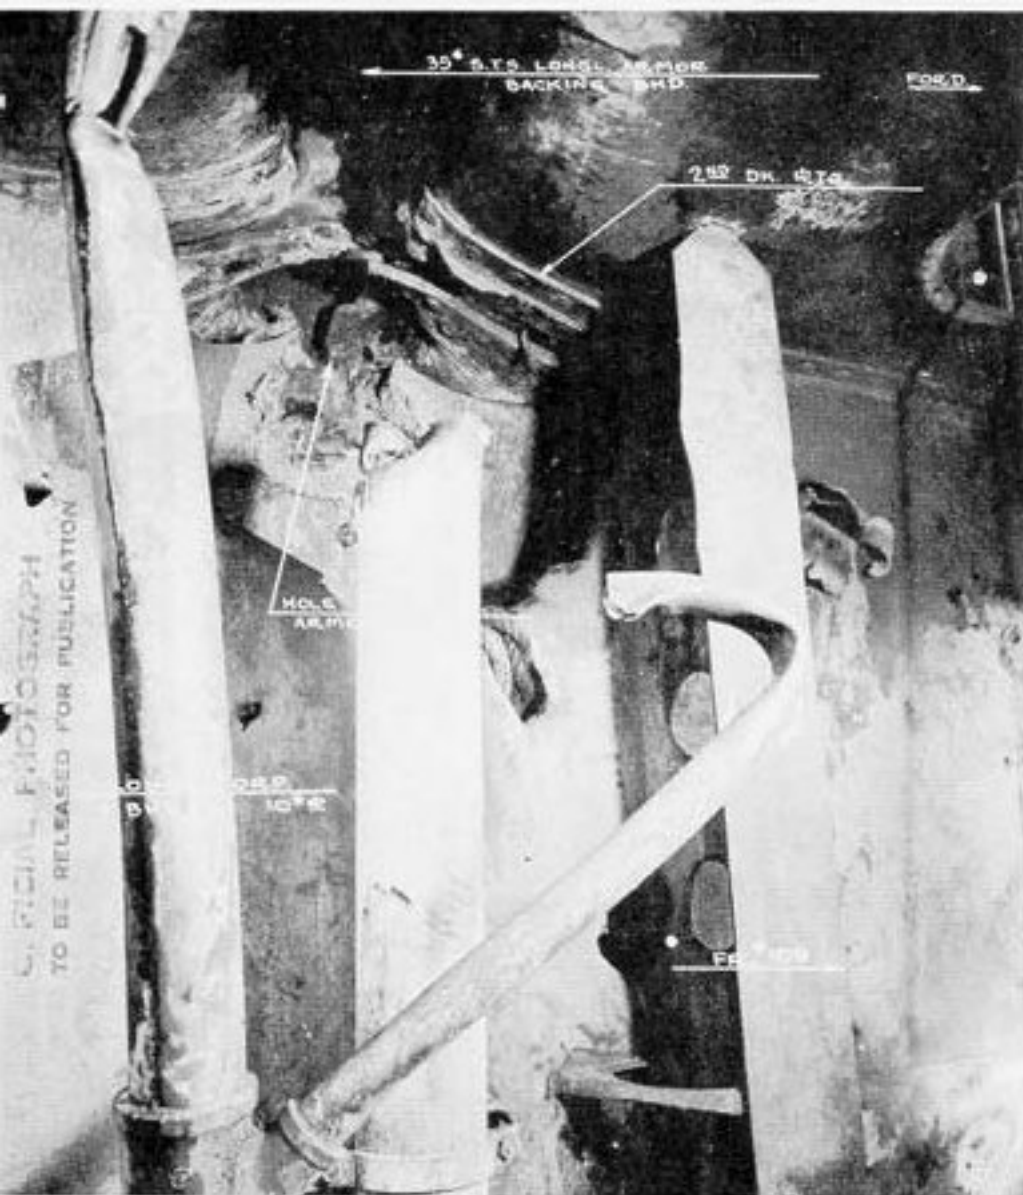
Photo 34: Hit No. 25. Damage to second deck and torpedo bulkhead No. 2.

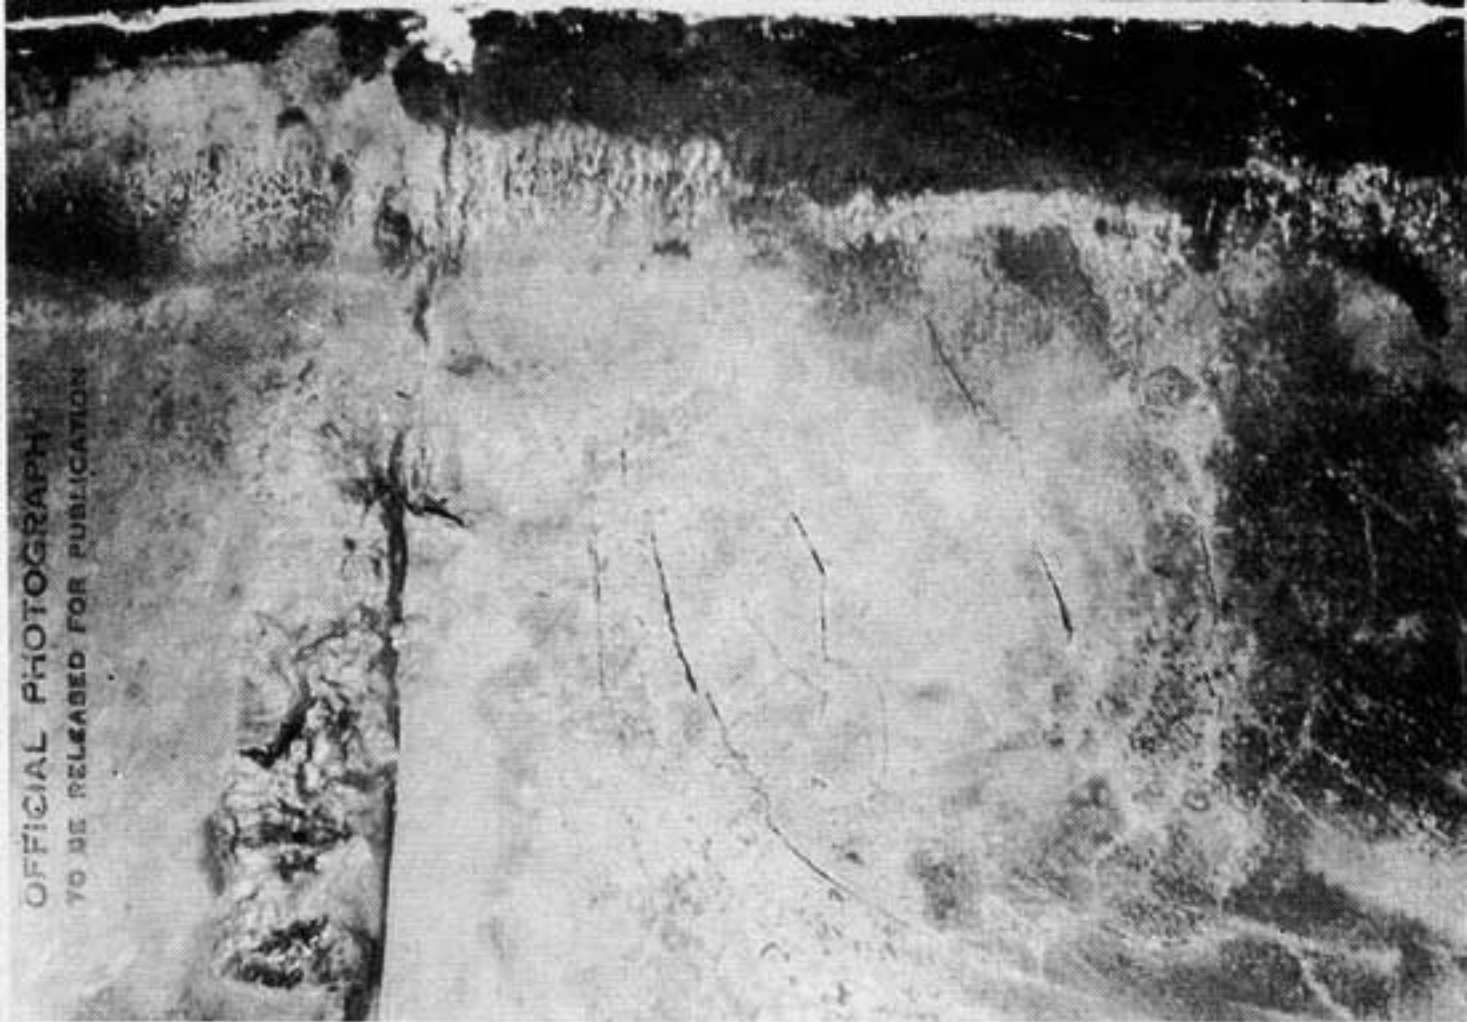
Photo 35: Hit No. 26. Point of impact of projectile on barrette No. 3.

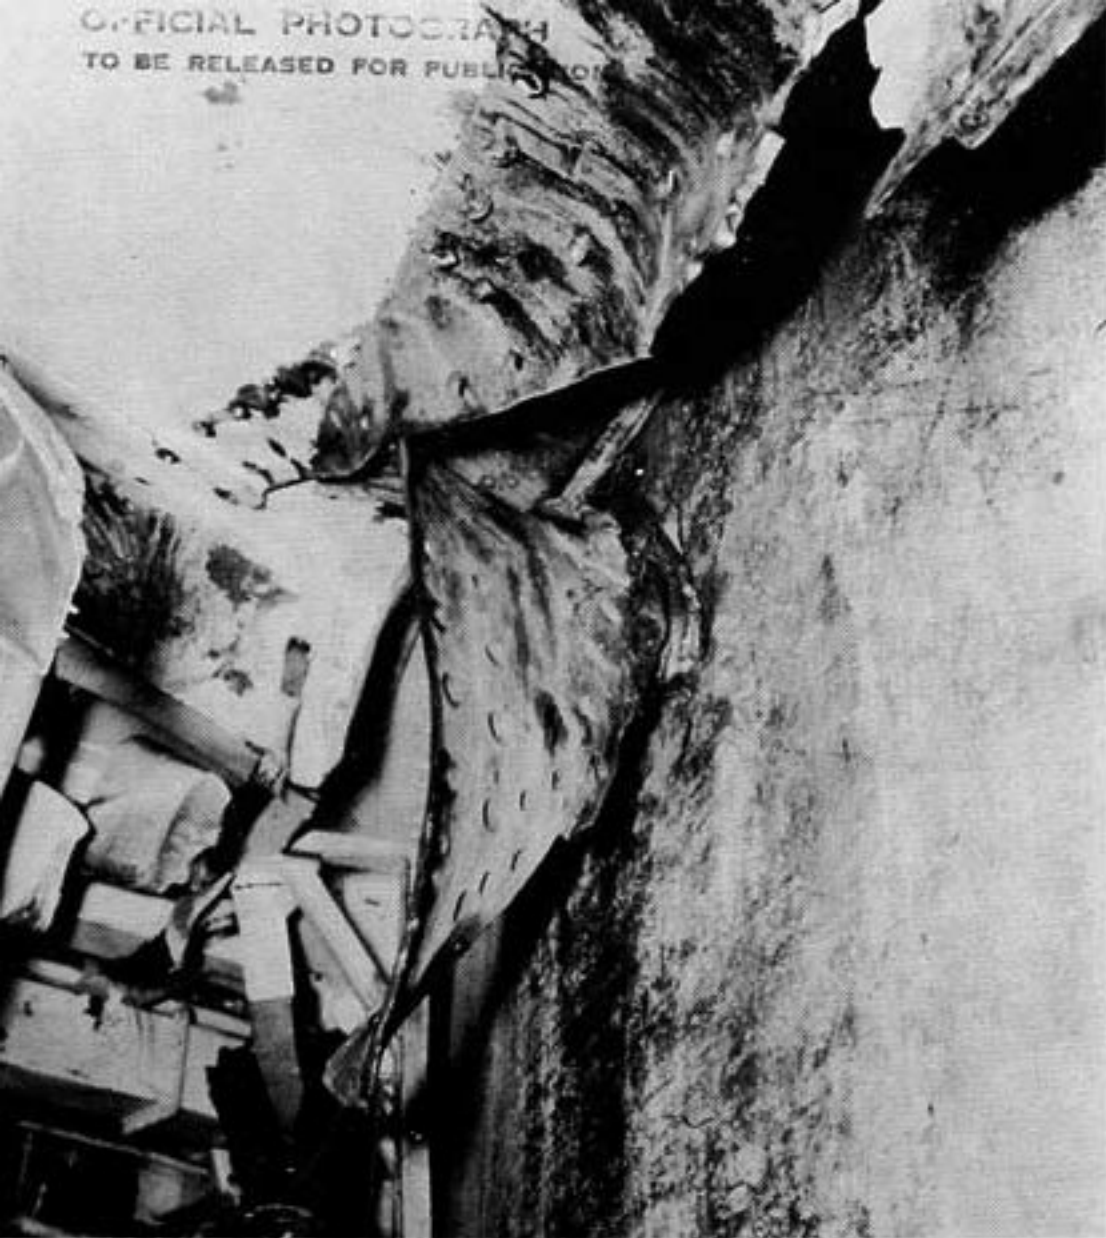
Photo 36: Hit No. 26. Damage to main deck around barbette.

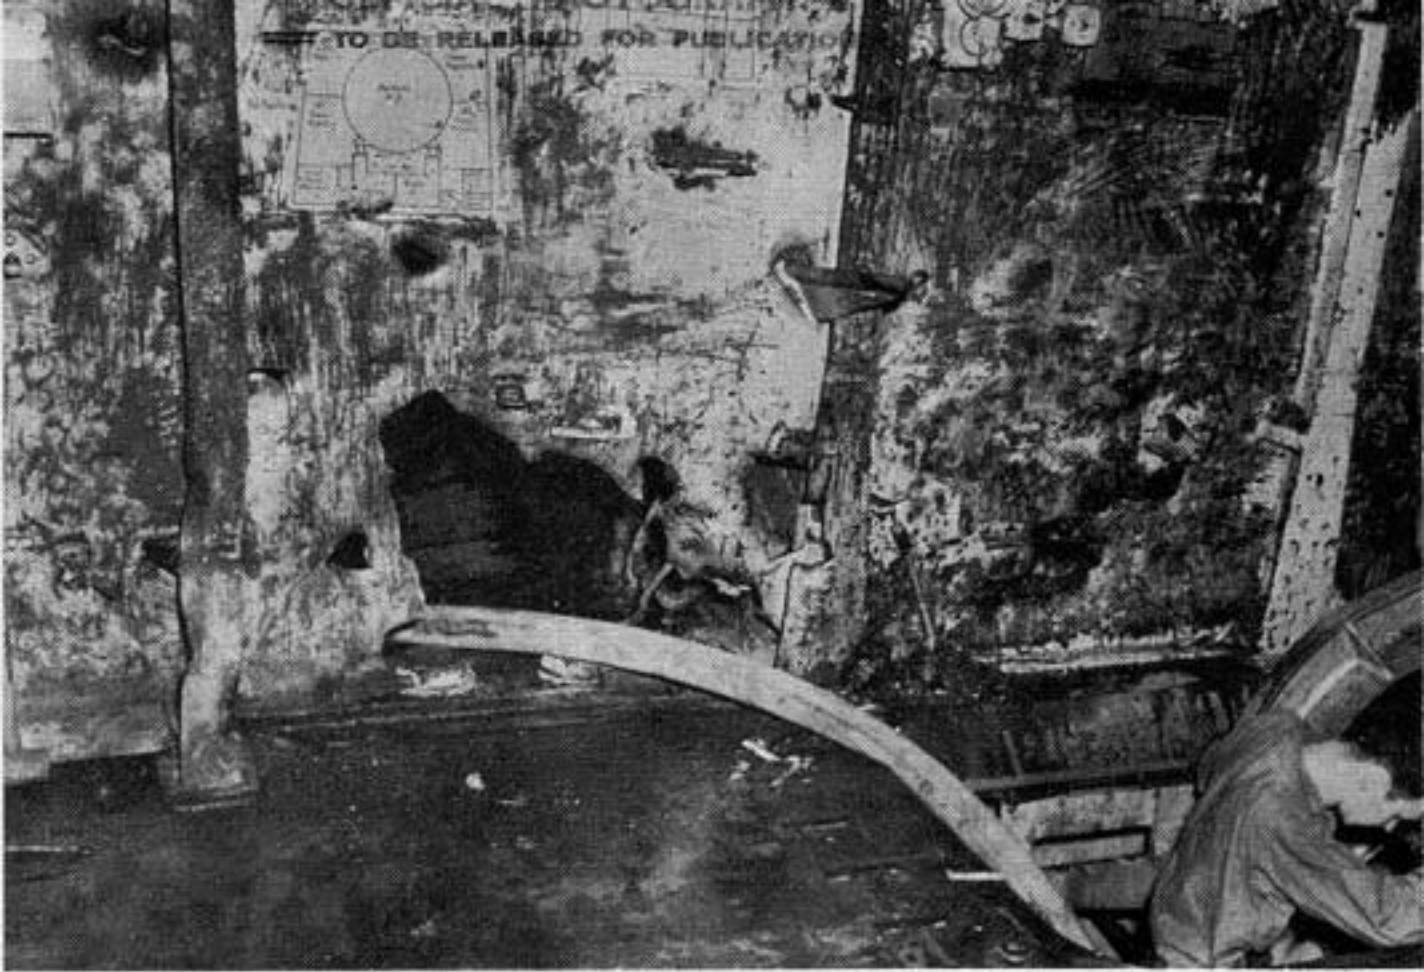
Photo 37: Hit No. 26. Damage to bulkhead 129 above second deck.

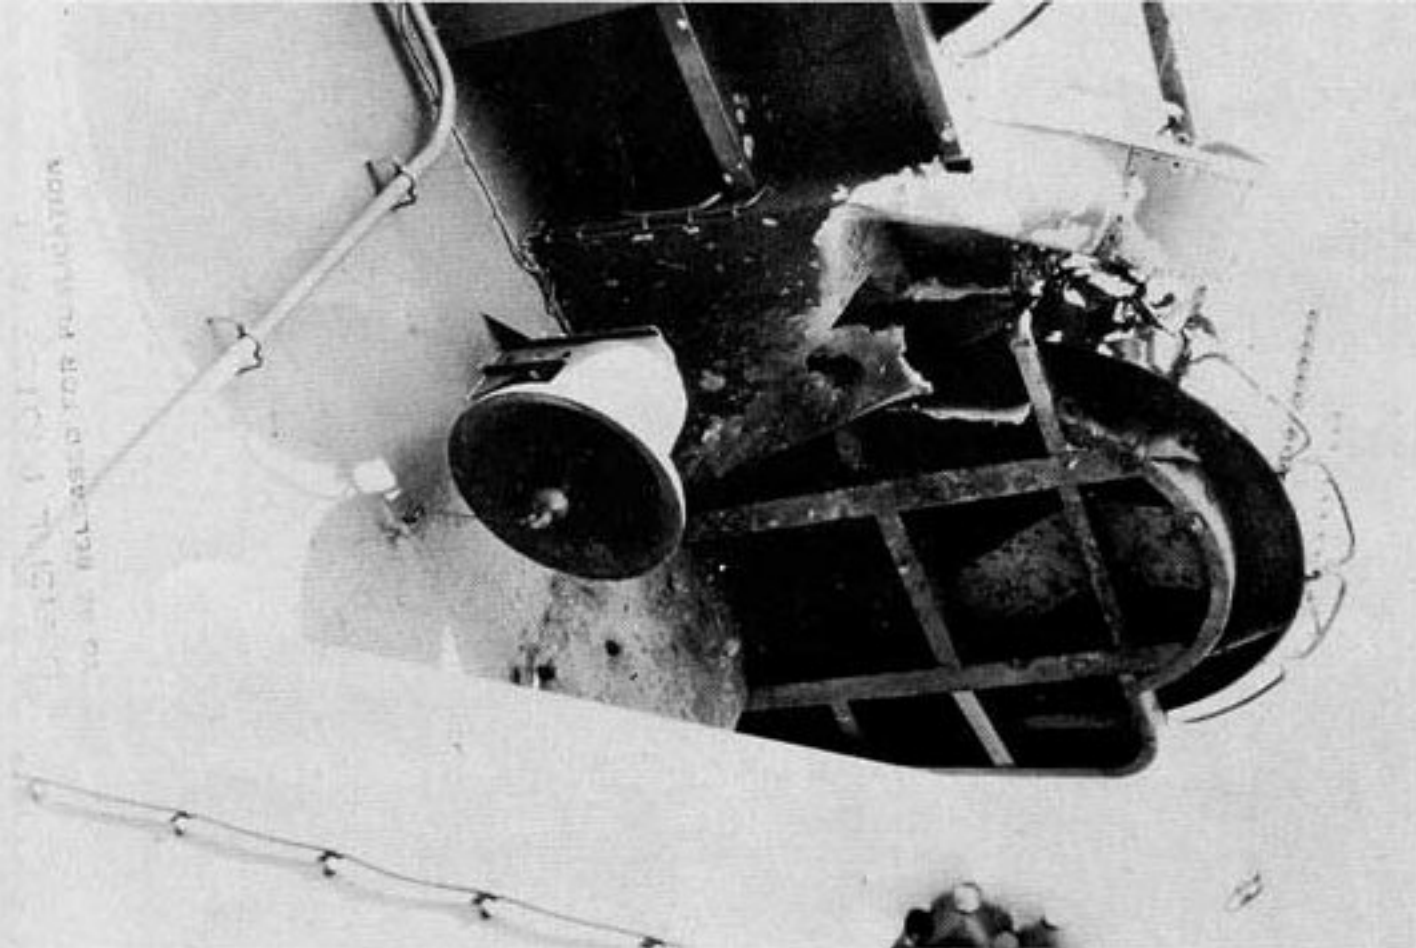
Photo 38: Damage to bulkhead 81 and radio direction finder foundation possibly from detonation of hit No. 7.

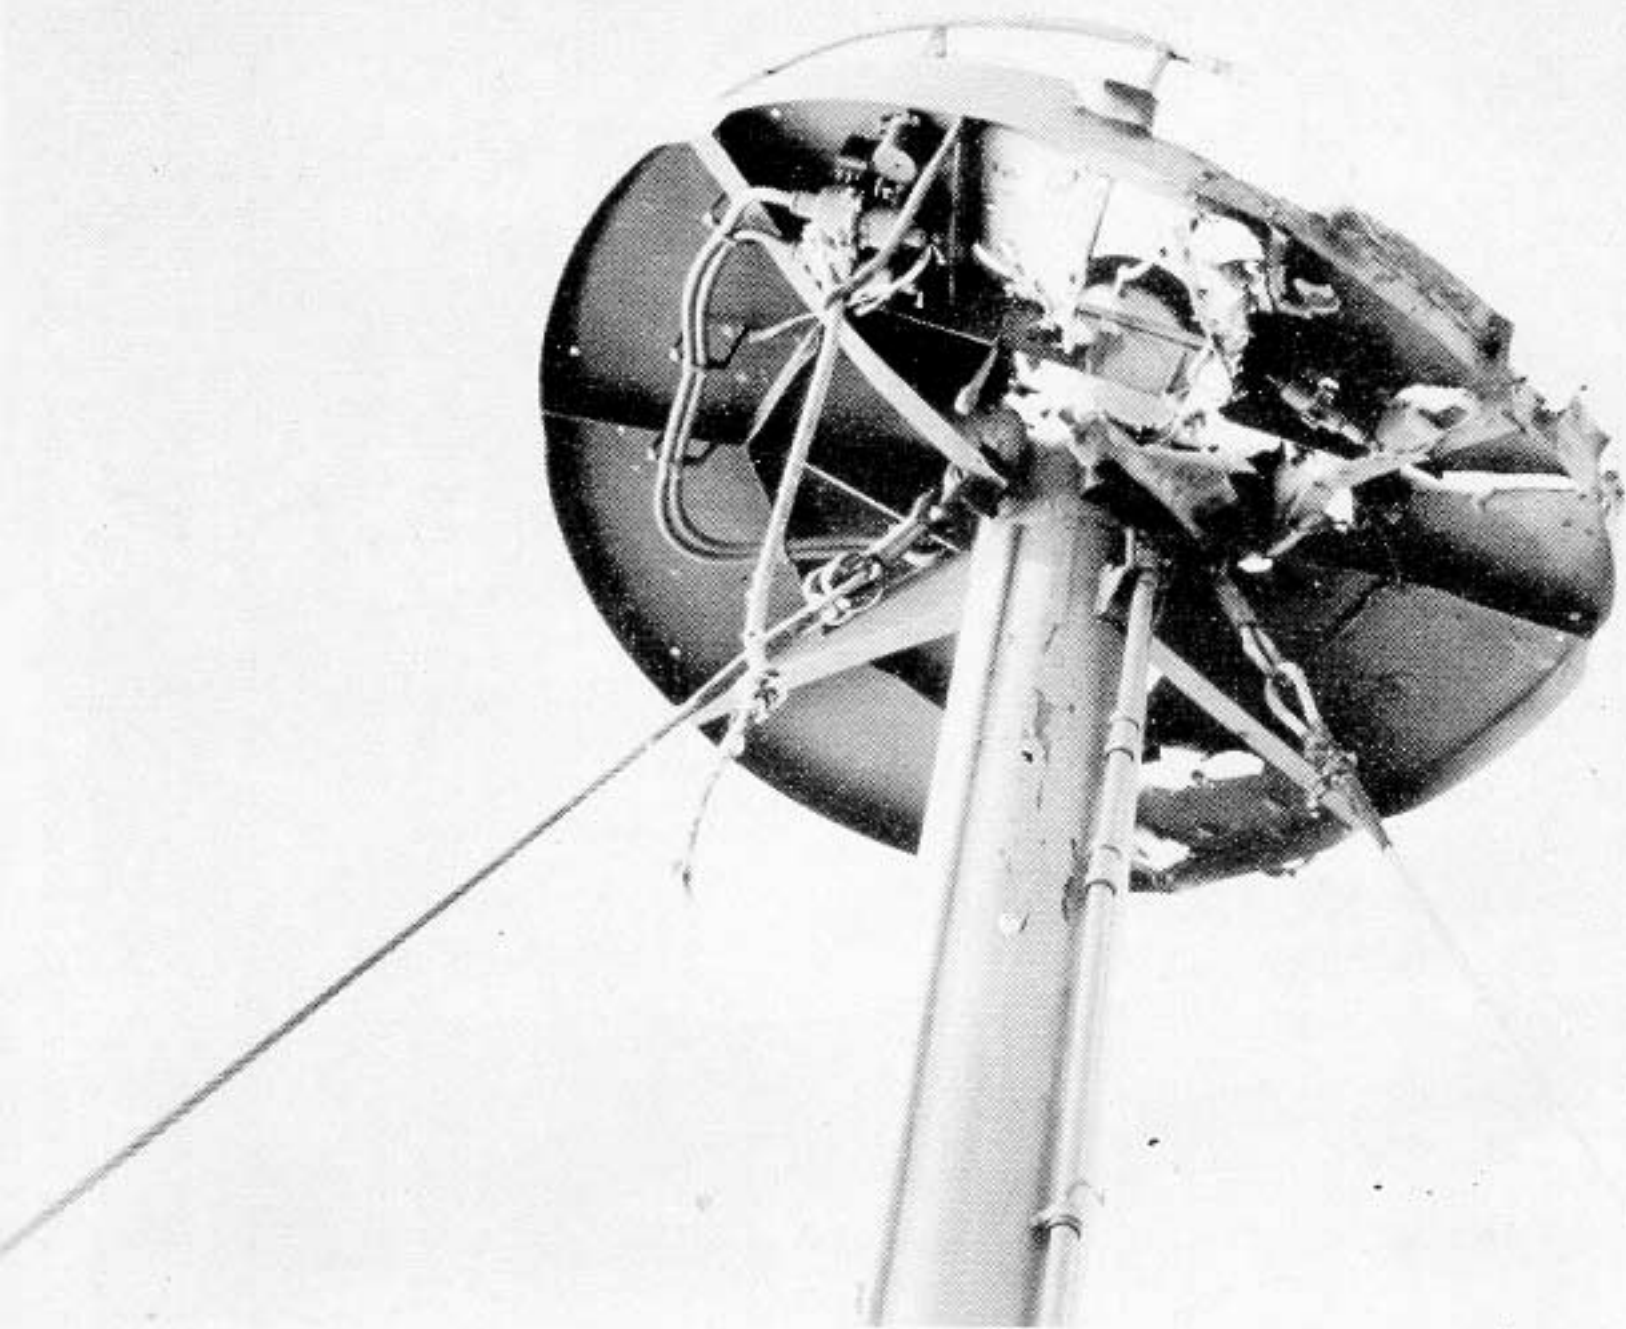
Photo 39: Damage to radar platform apparently from a projectile that detonated on contact.
