USS THRESHER

SSN-593

1963-1964 Search Photography

A collection of selected towed camera and R/V TRIESTE  
photographs taken in 1963 and 1964 during the search  
operations for USS THRESHER.

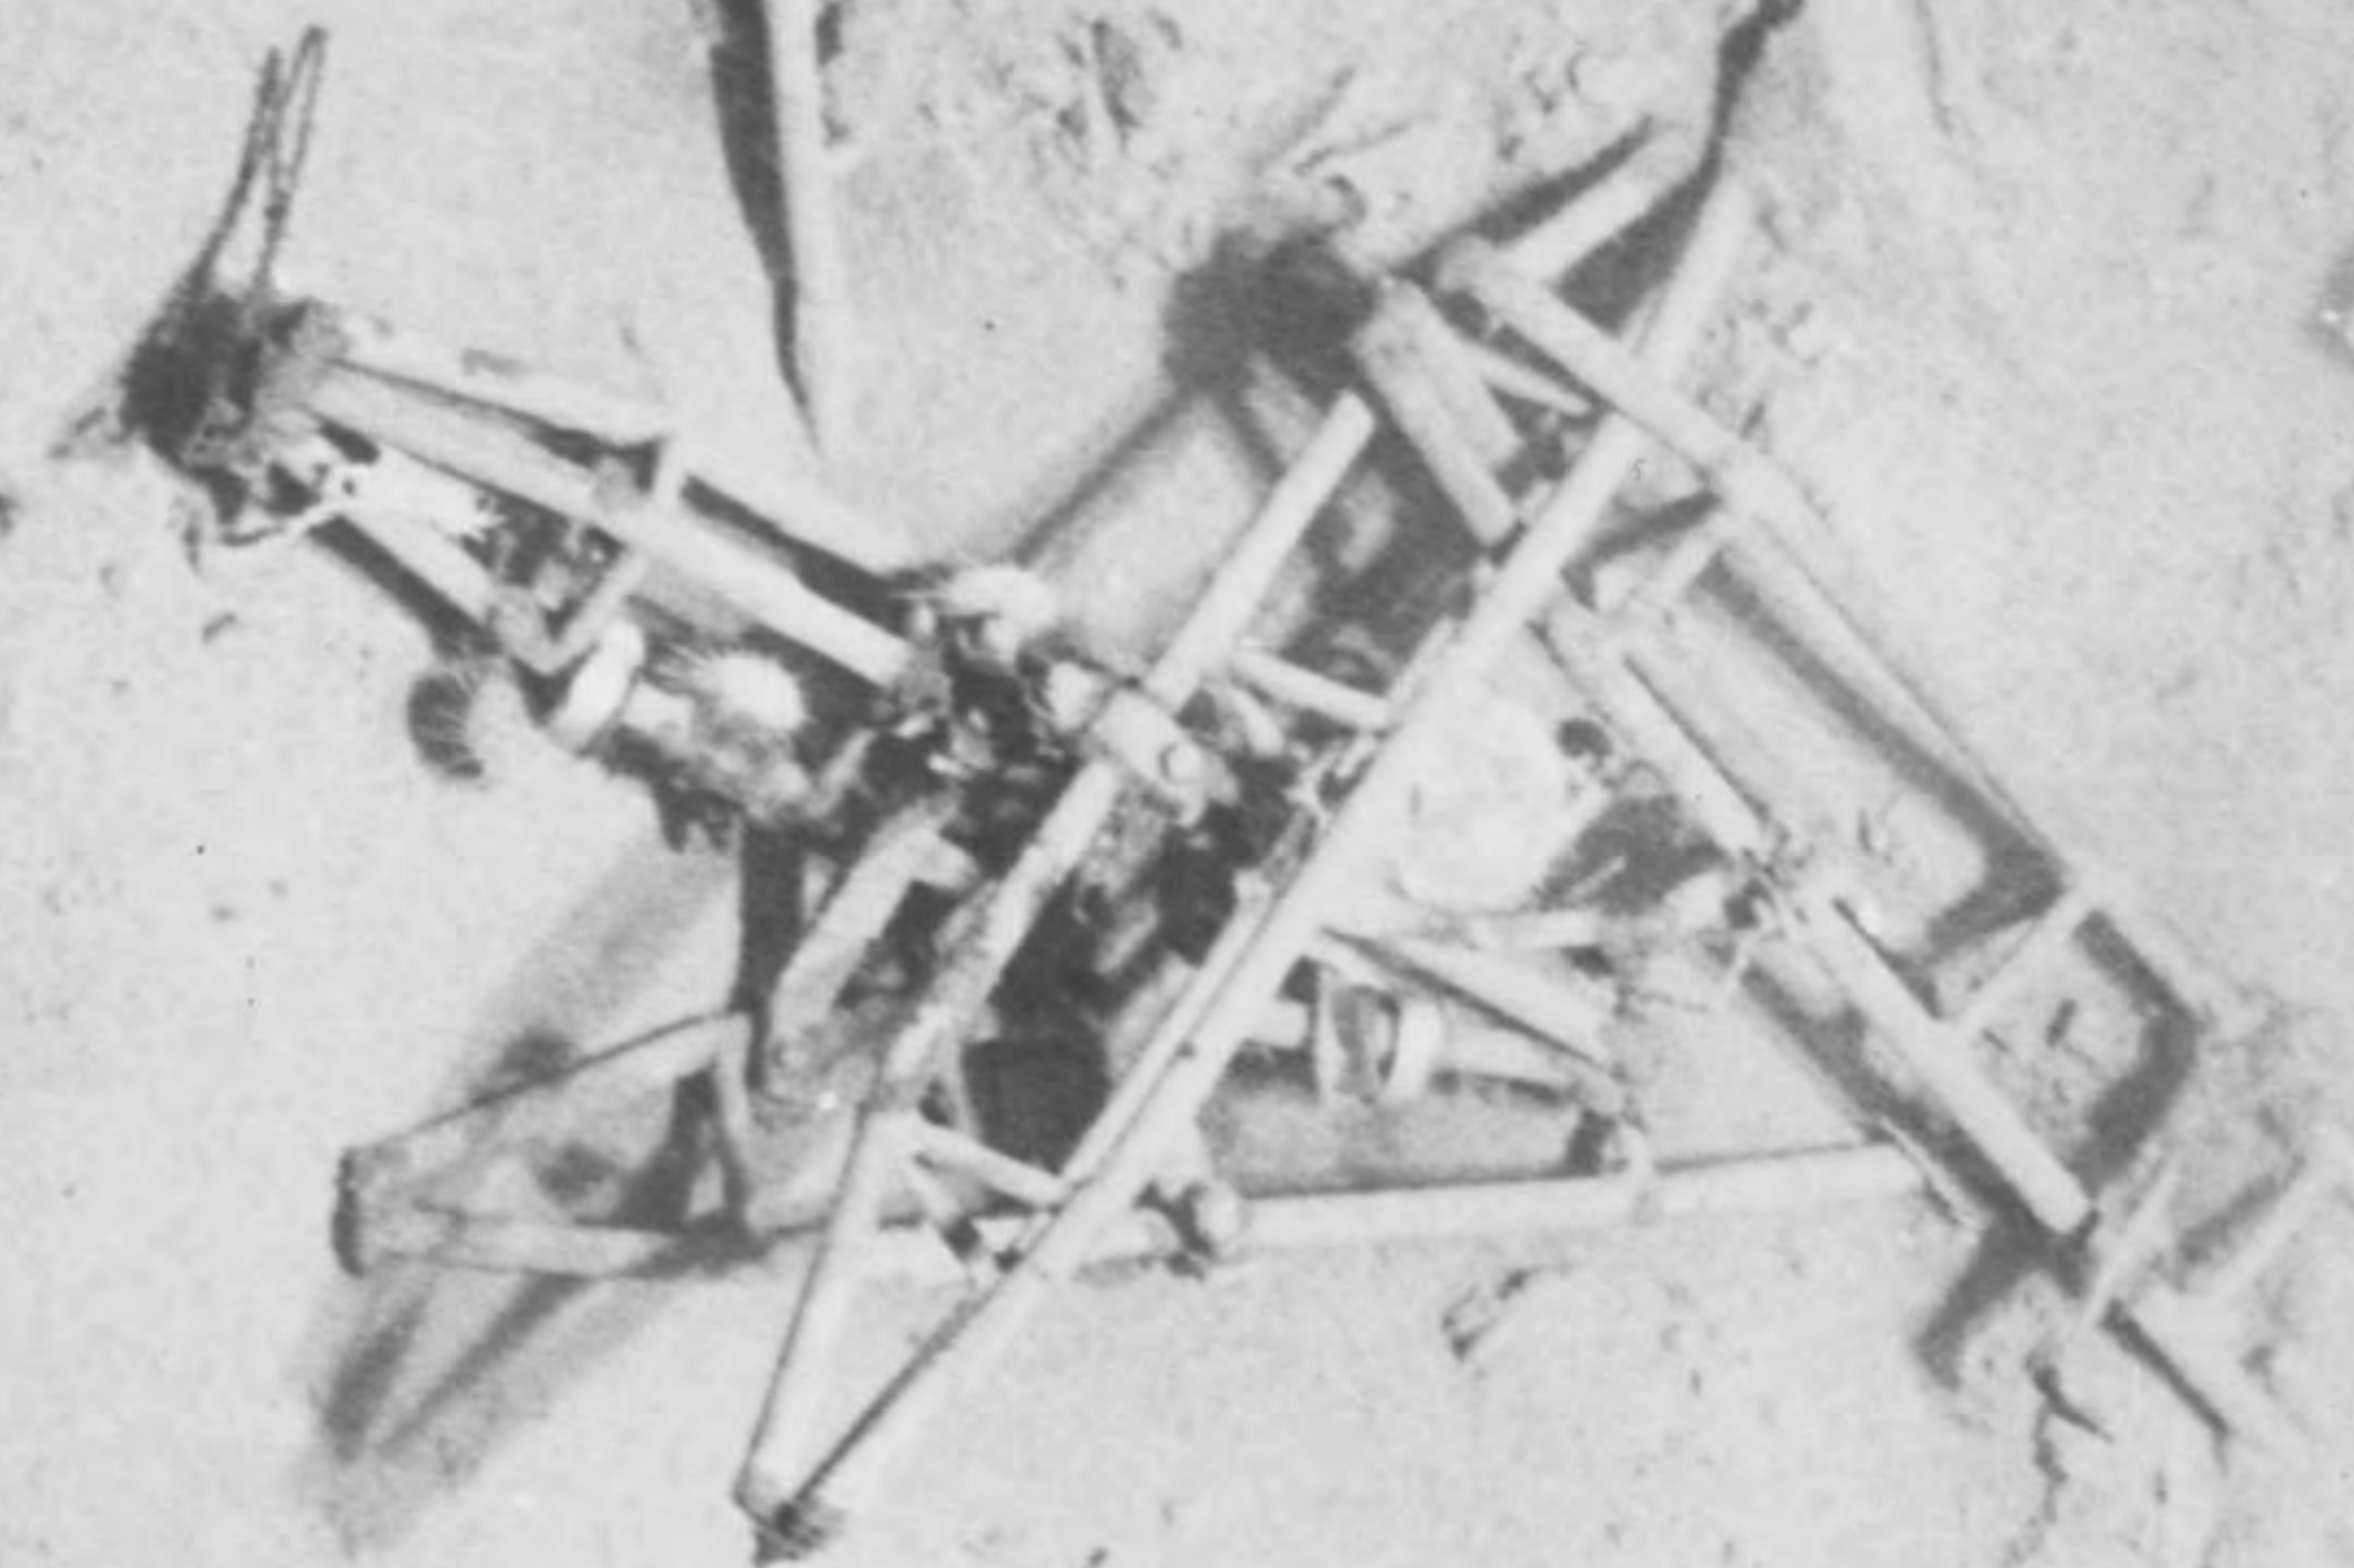
Section of bow outer hull  
(superstructure) plating,  
showing supporting webbing  
for the sonar dome. (Run  
#0020-C) (NRL/MIZAR)

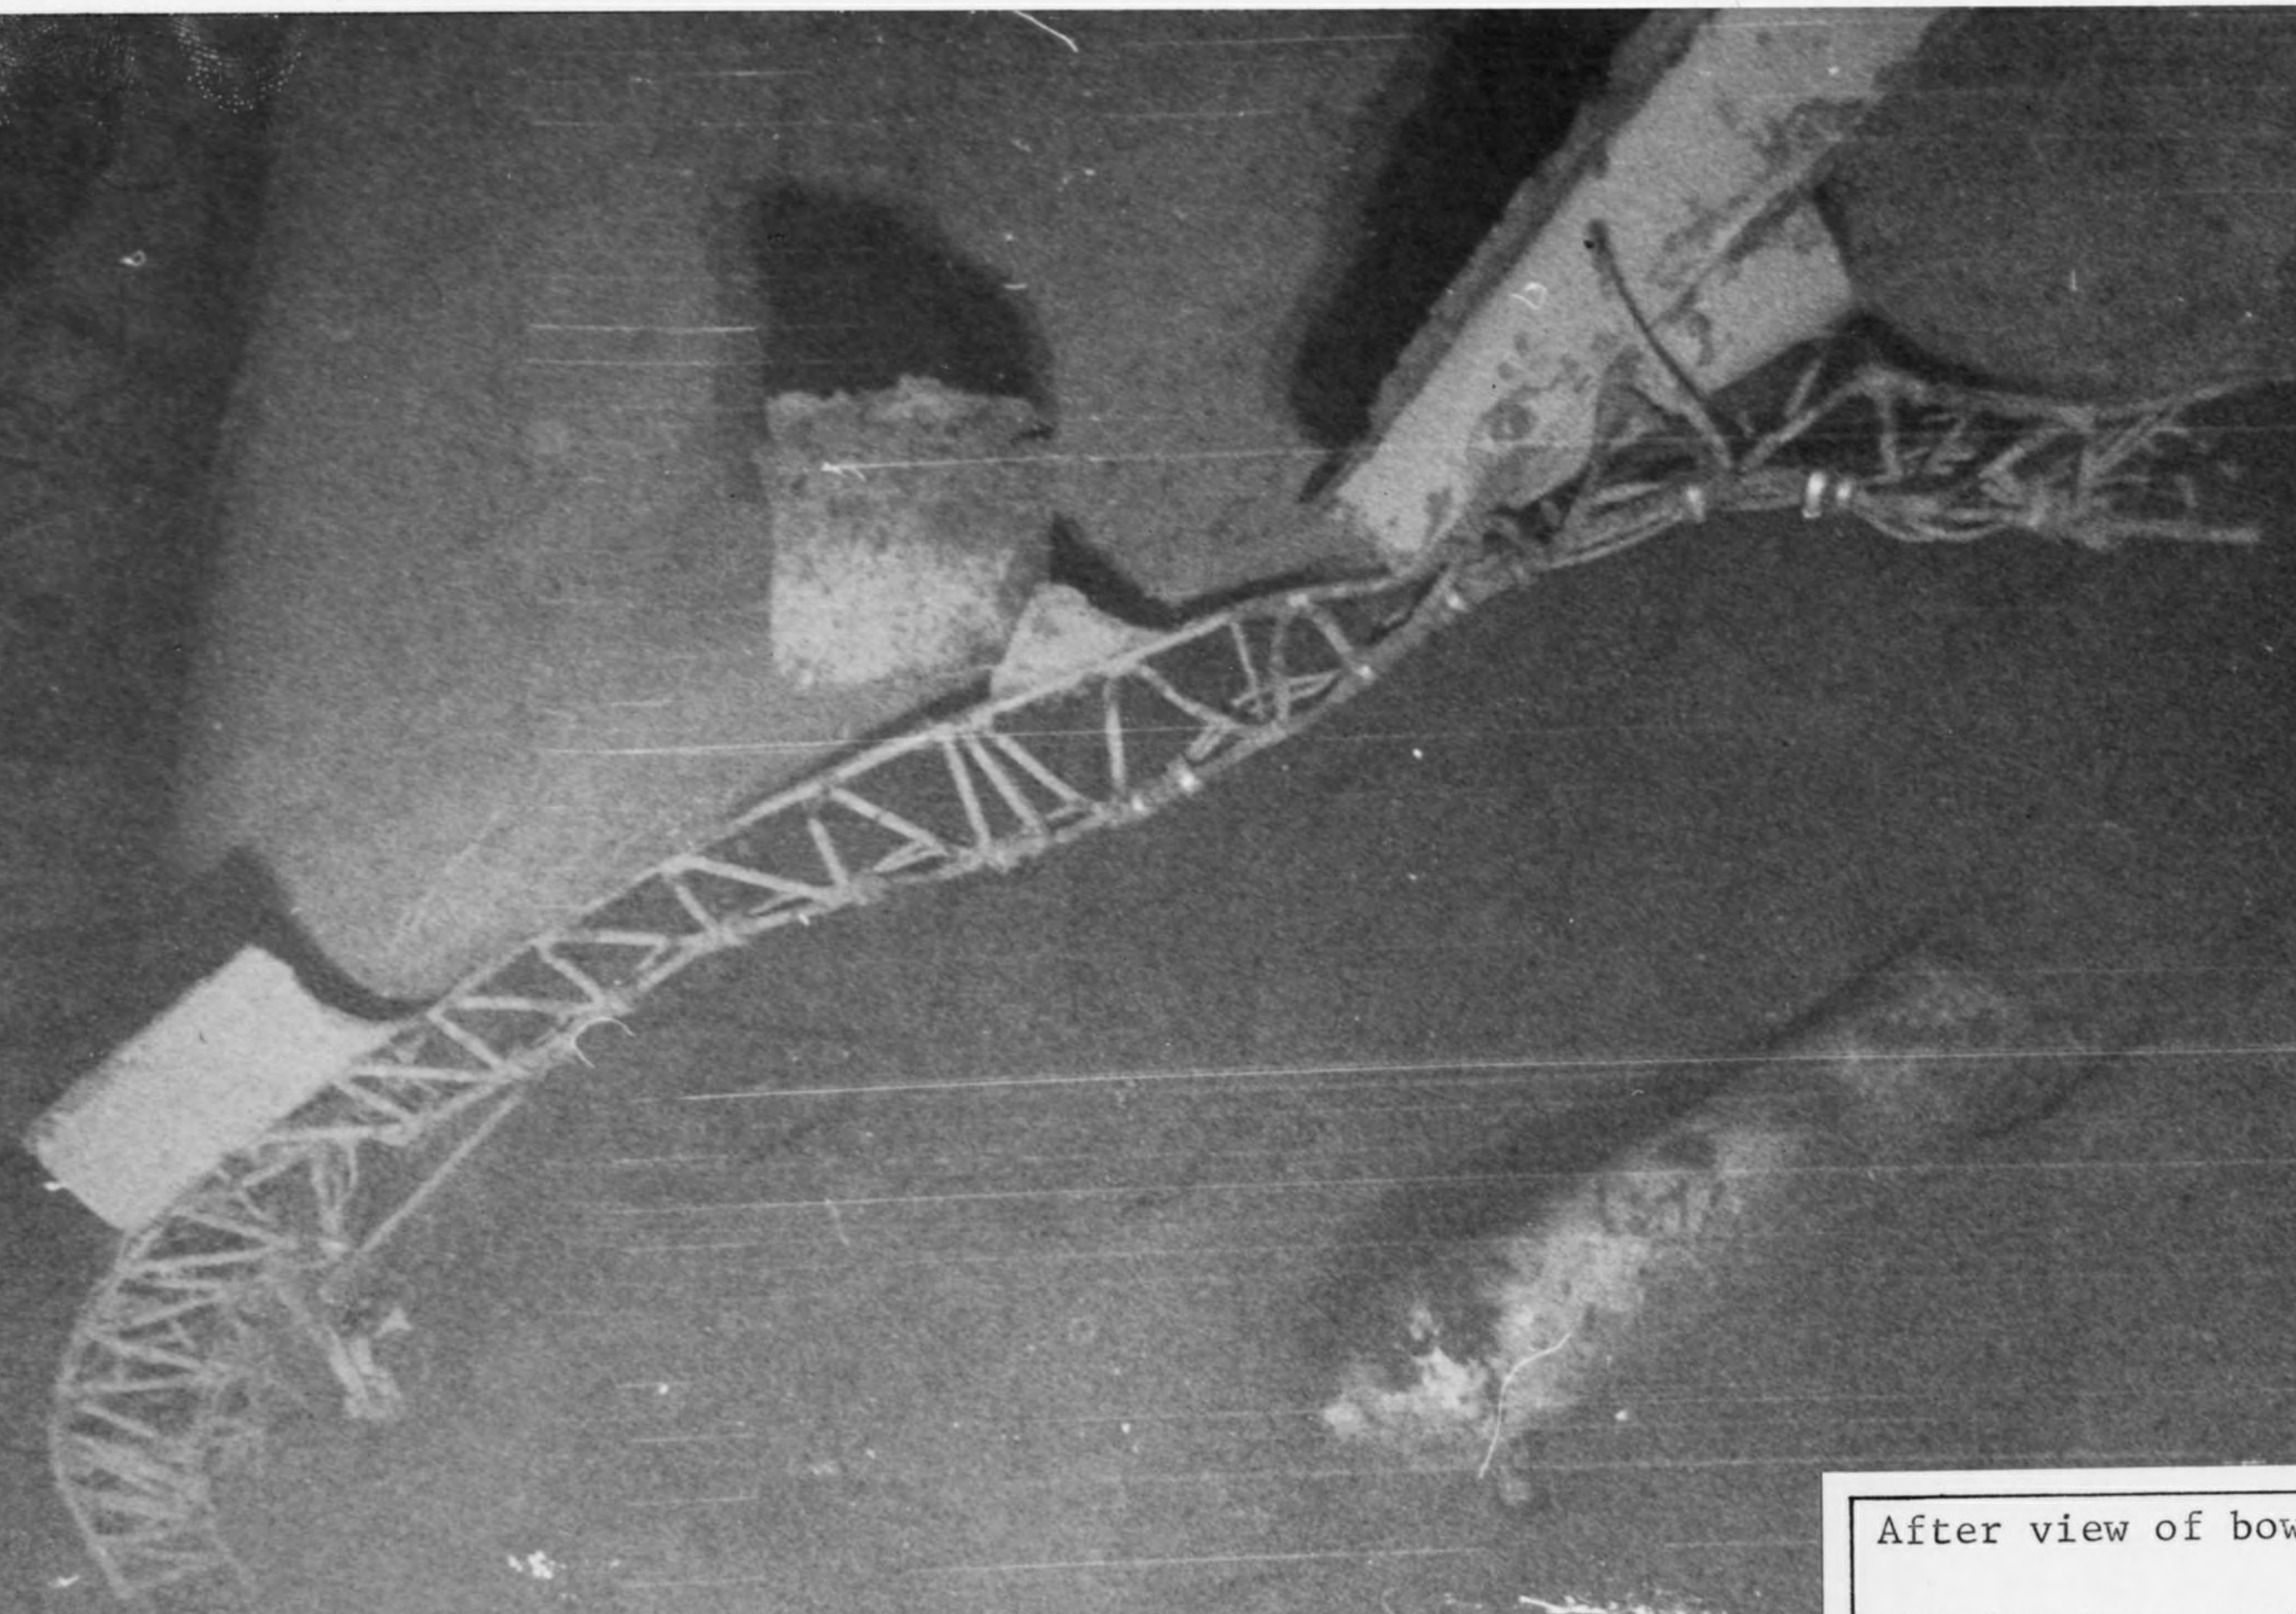
After view of bow section  
showing torn portion (up-  
per left) and an air bottle.  
(Run #0028-S) (NRL/MIZAR)

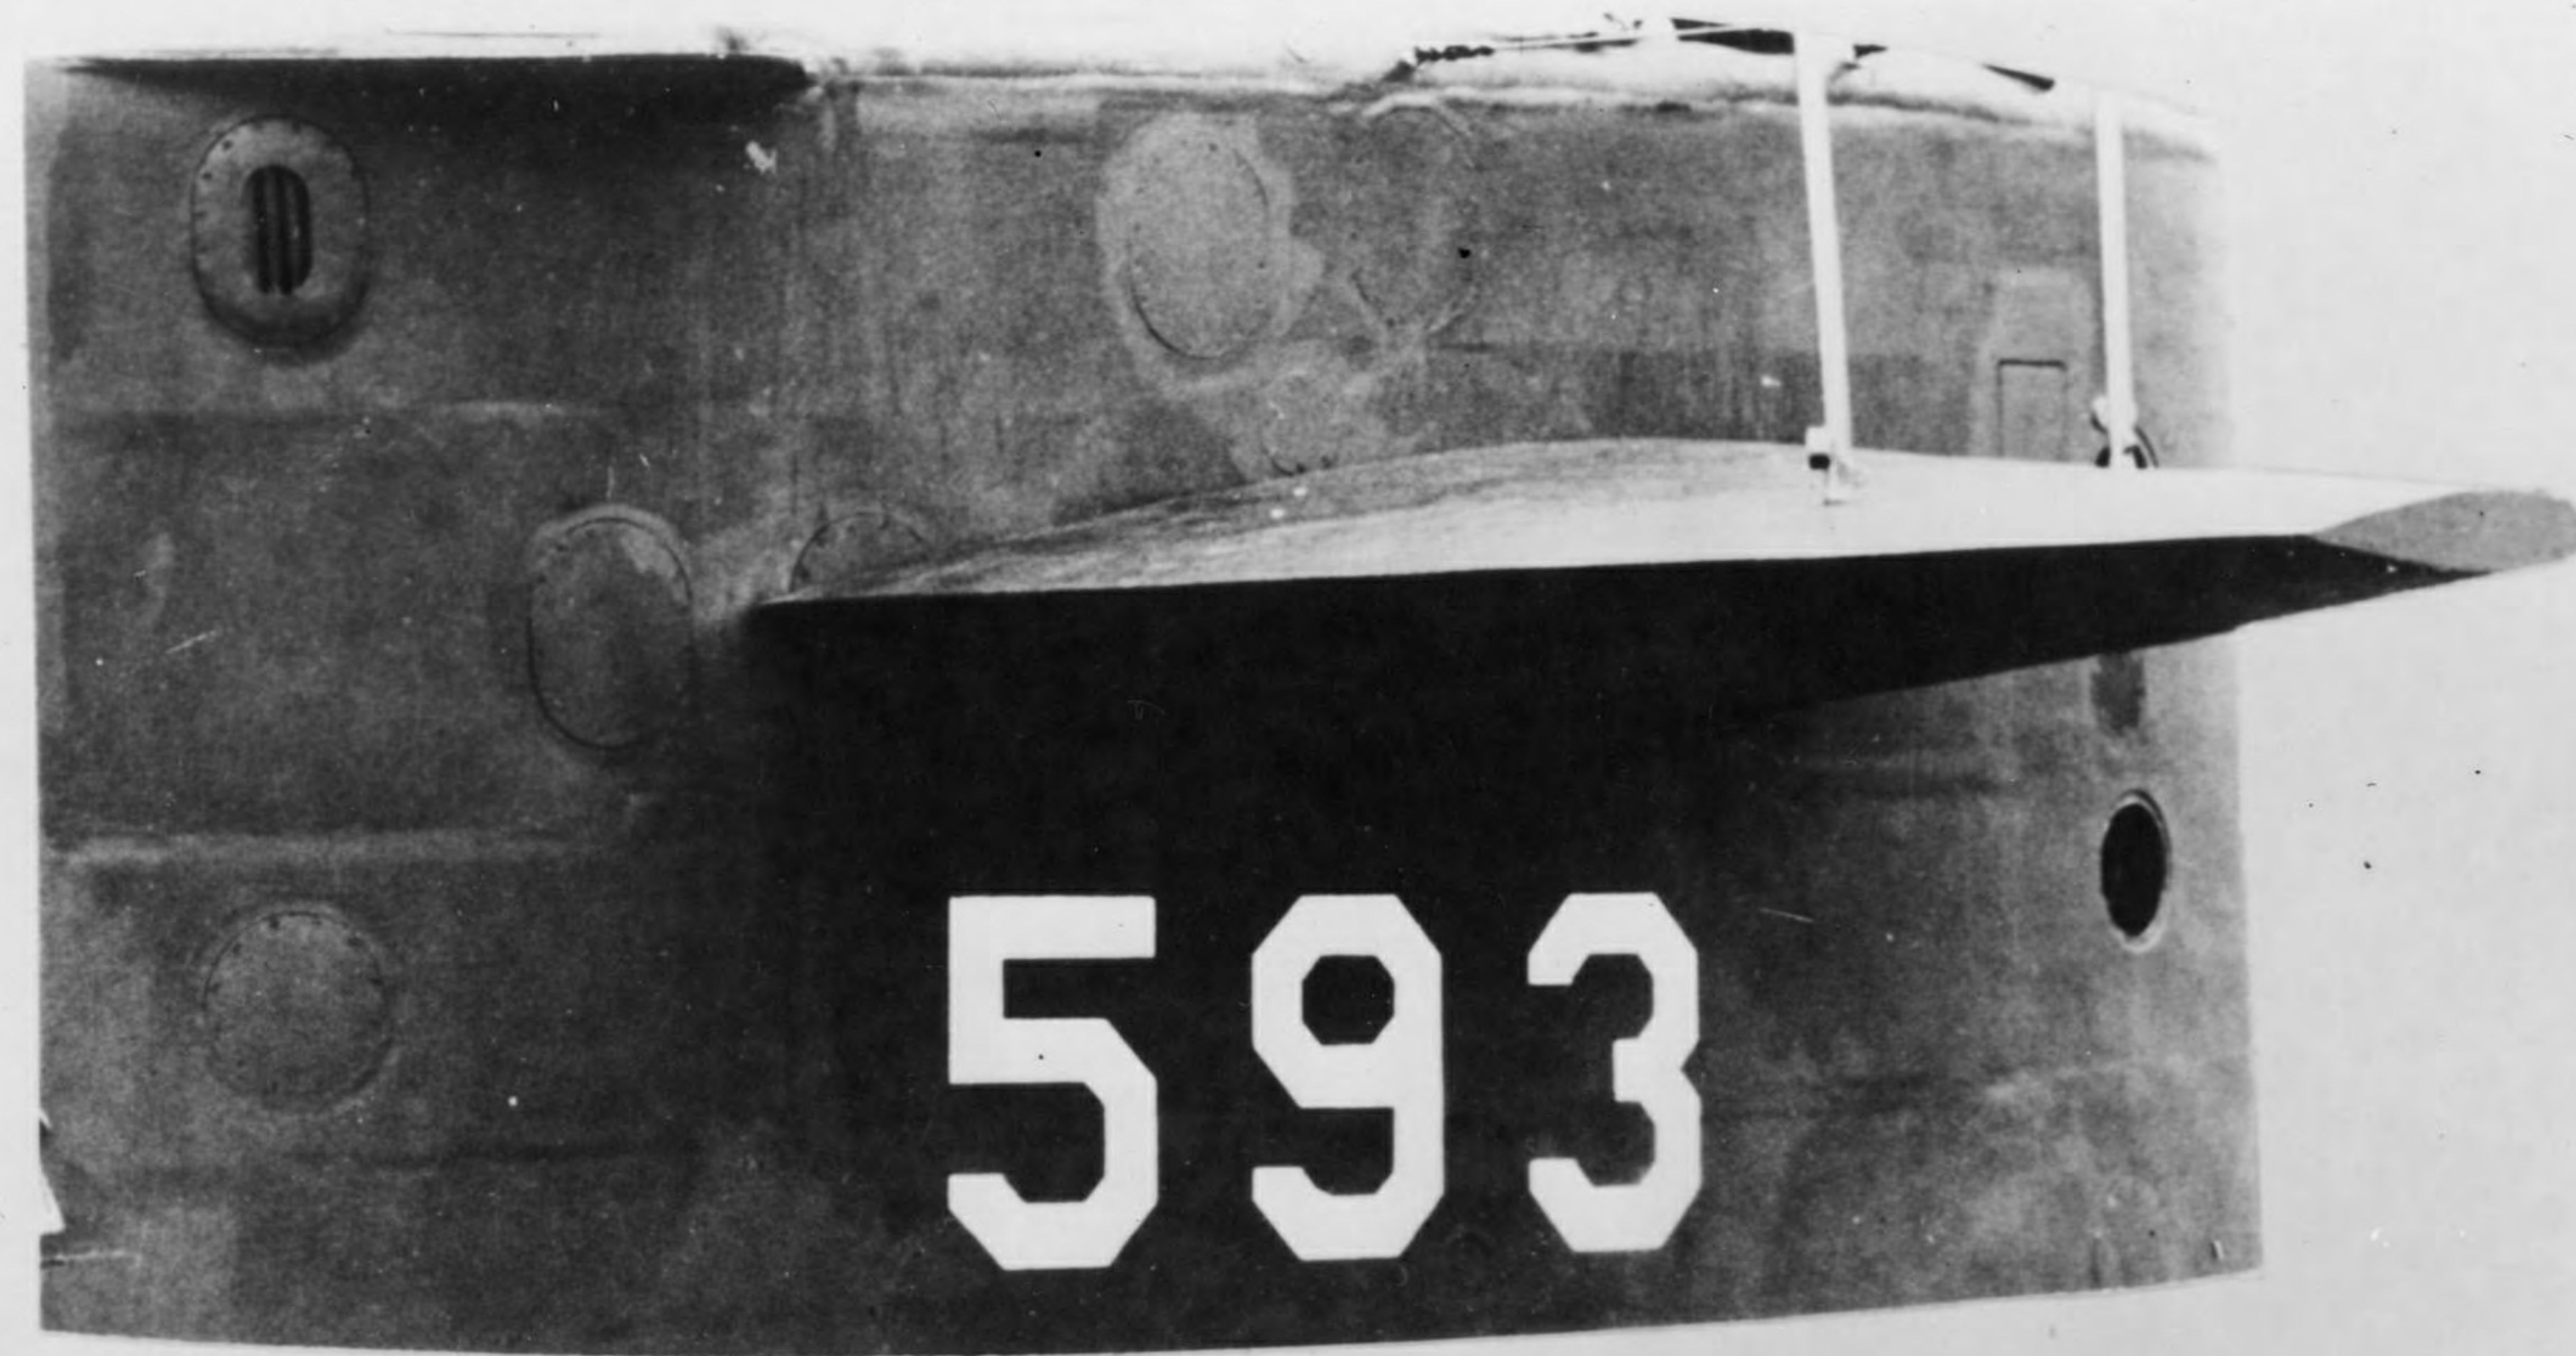
Shipyards photograph.

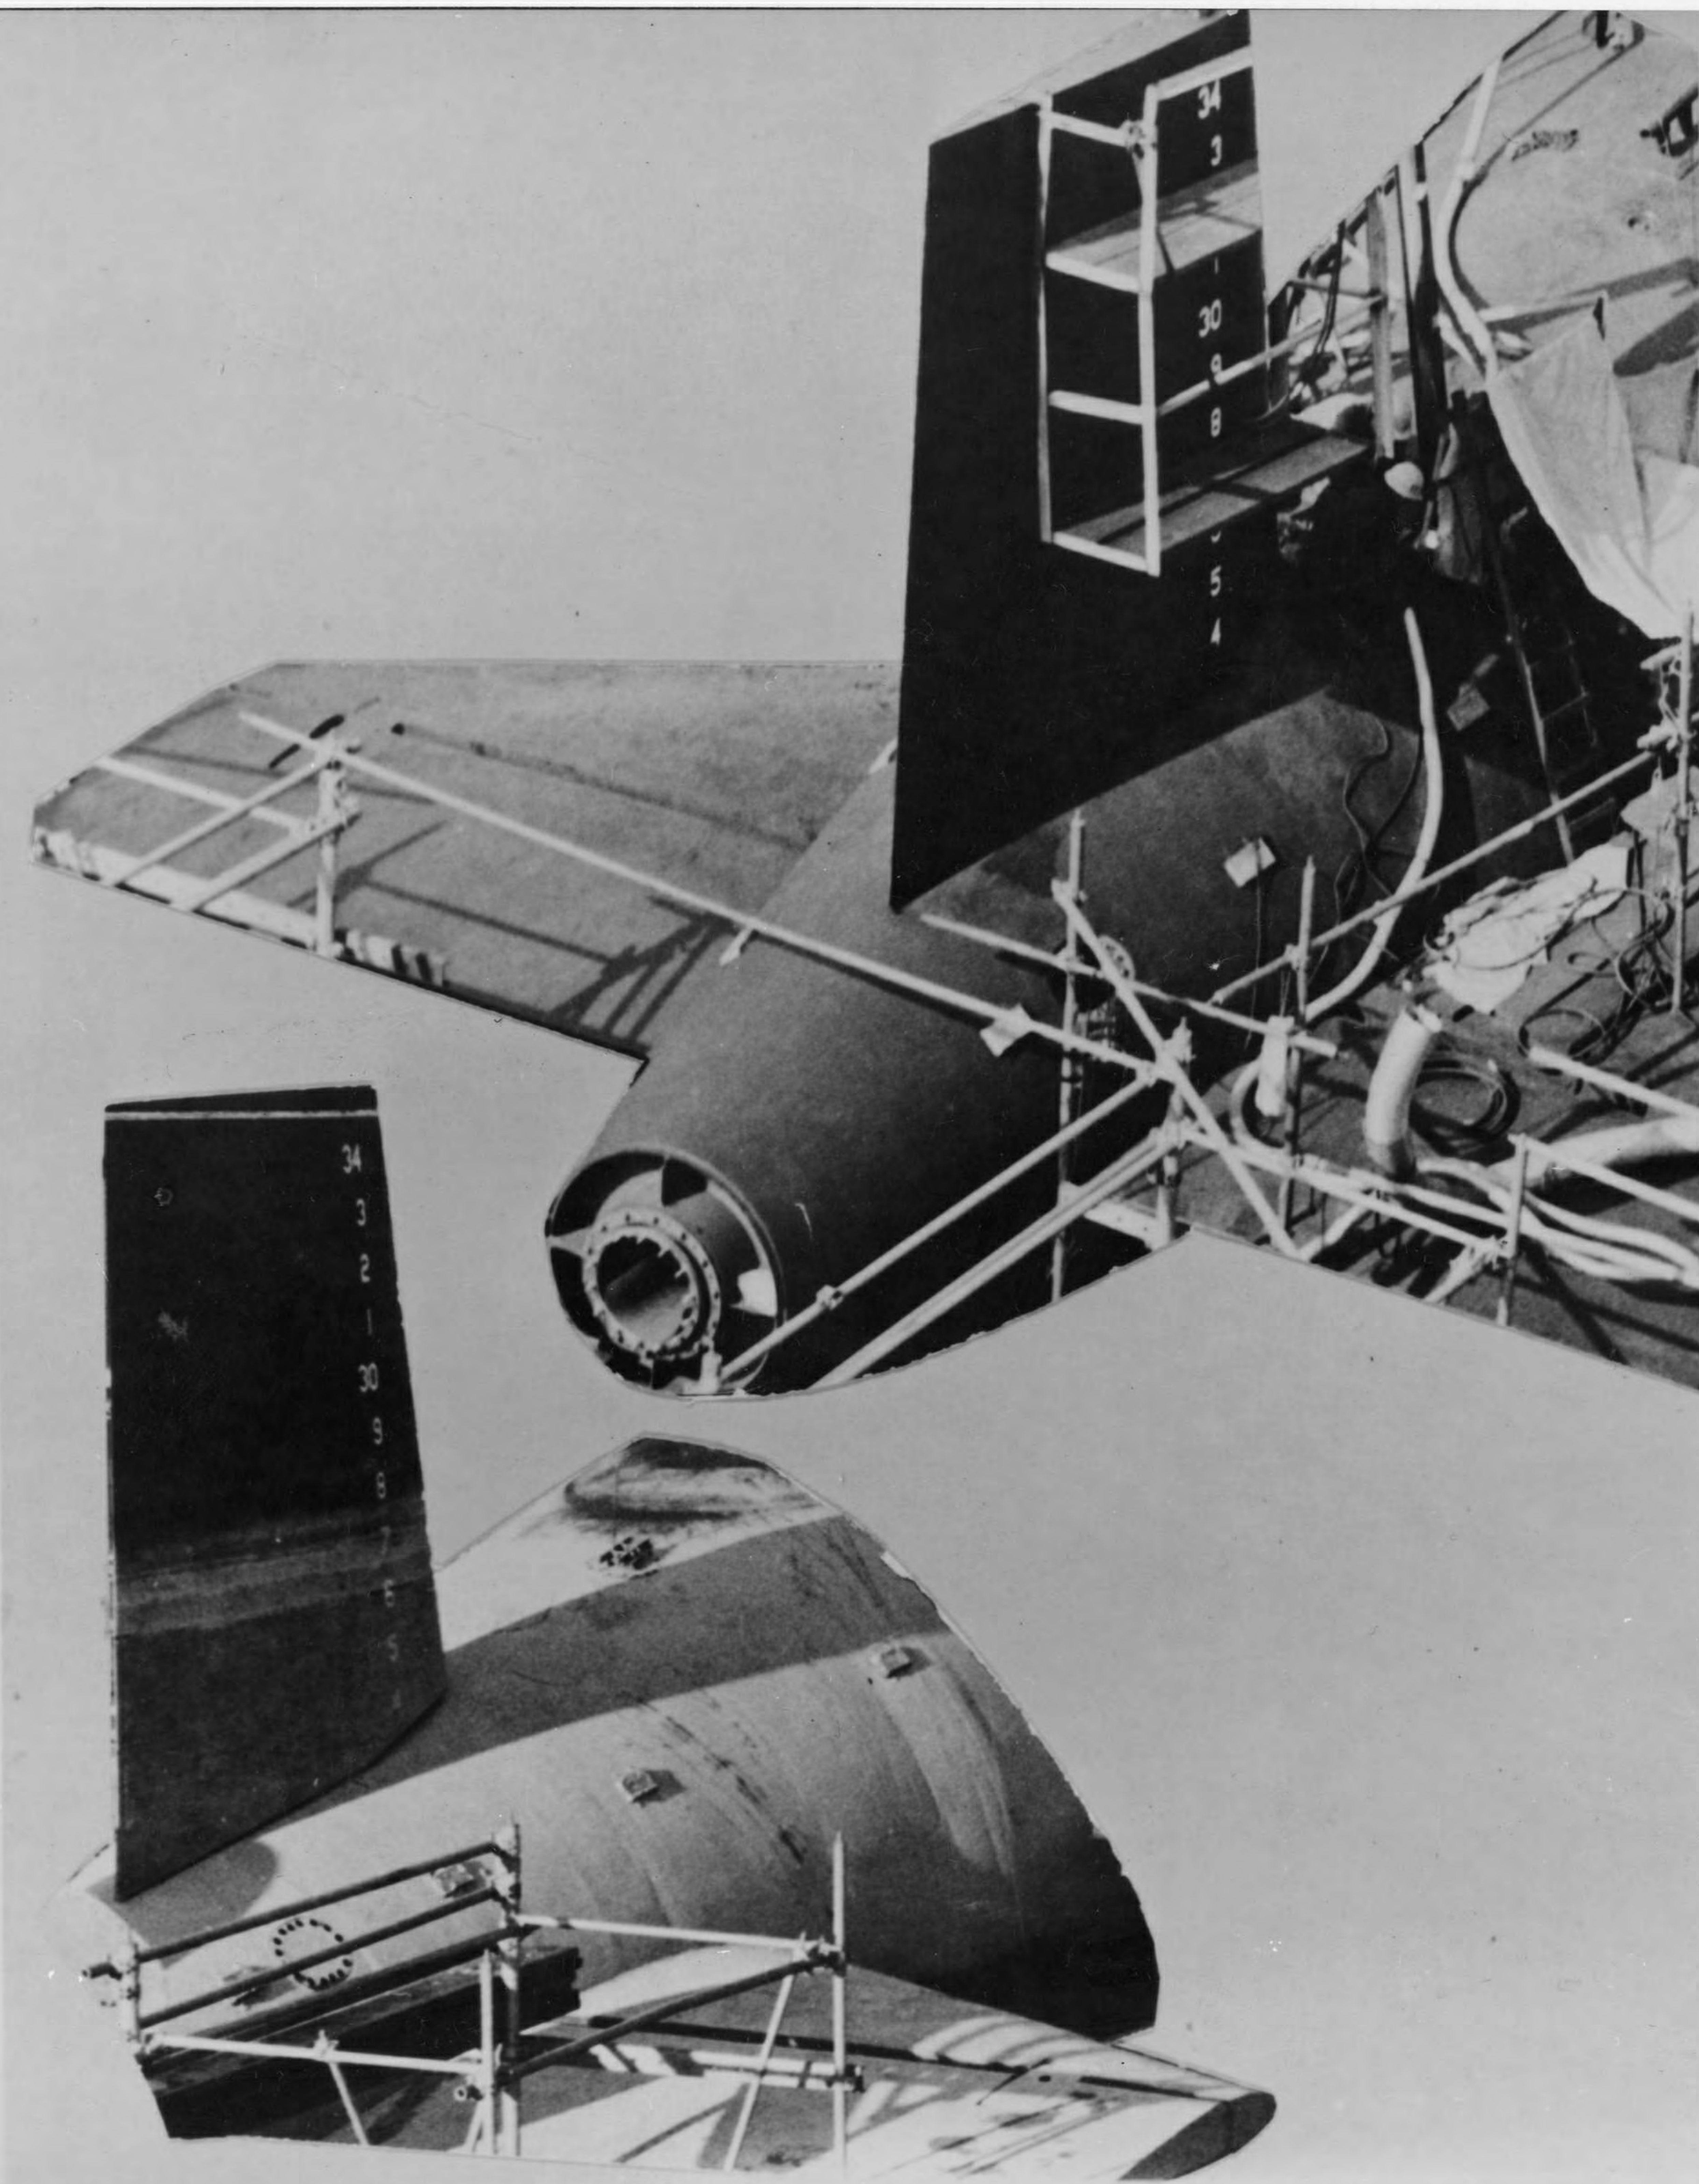
Mosaic of the tail section.  
Topside rudder is at the upper  
left. Pinched section occurs  
at frame 103. (NRL/MIZAR)

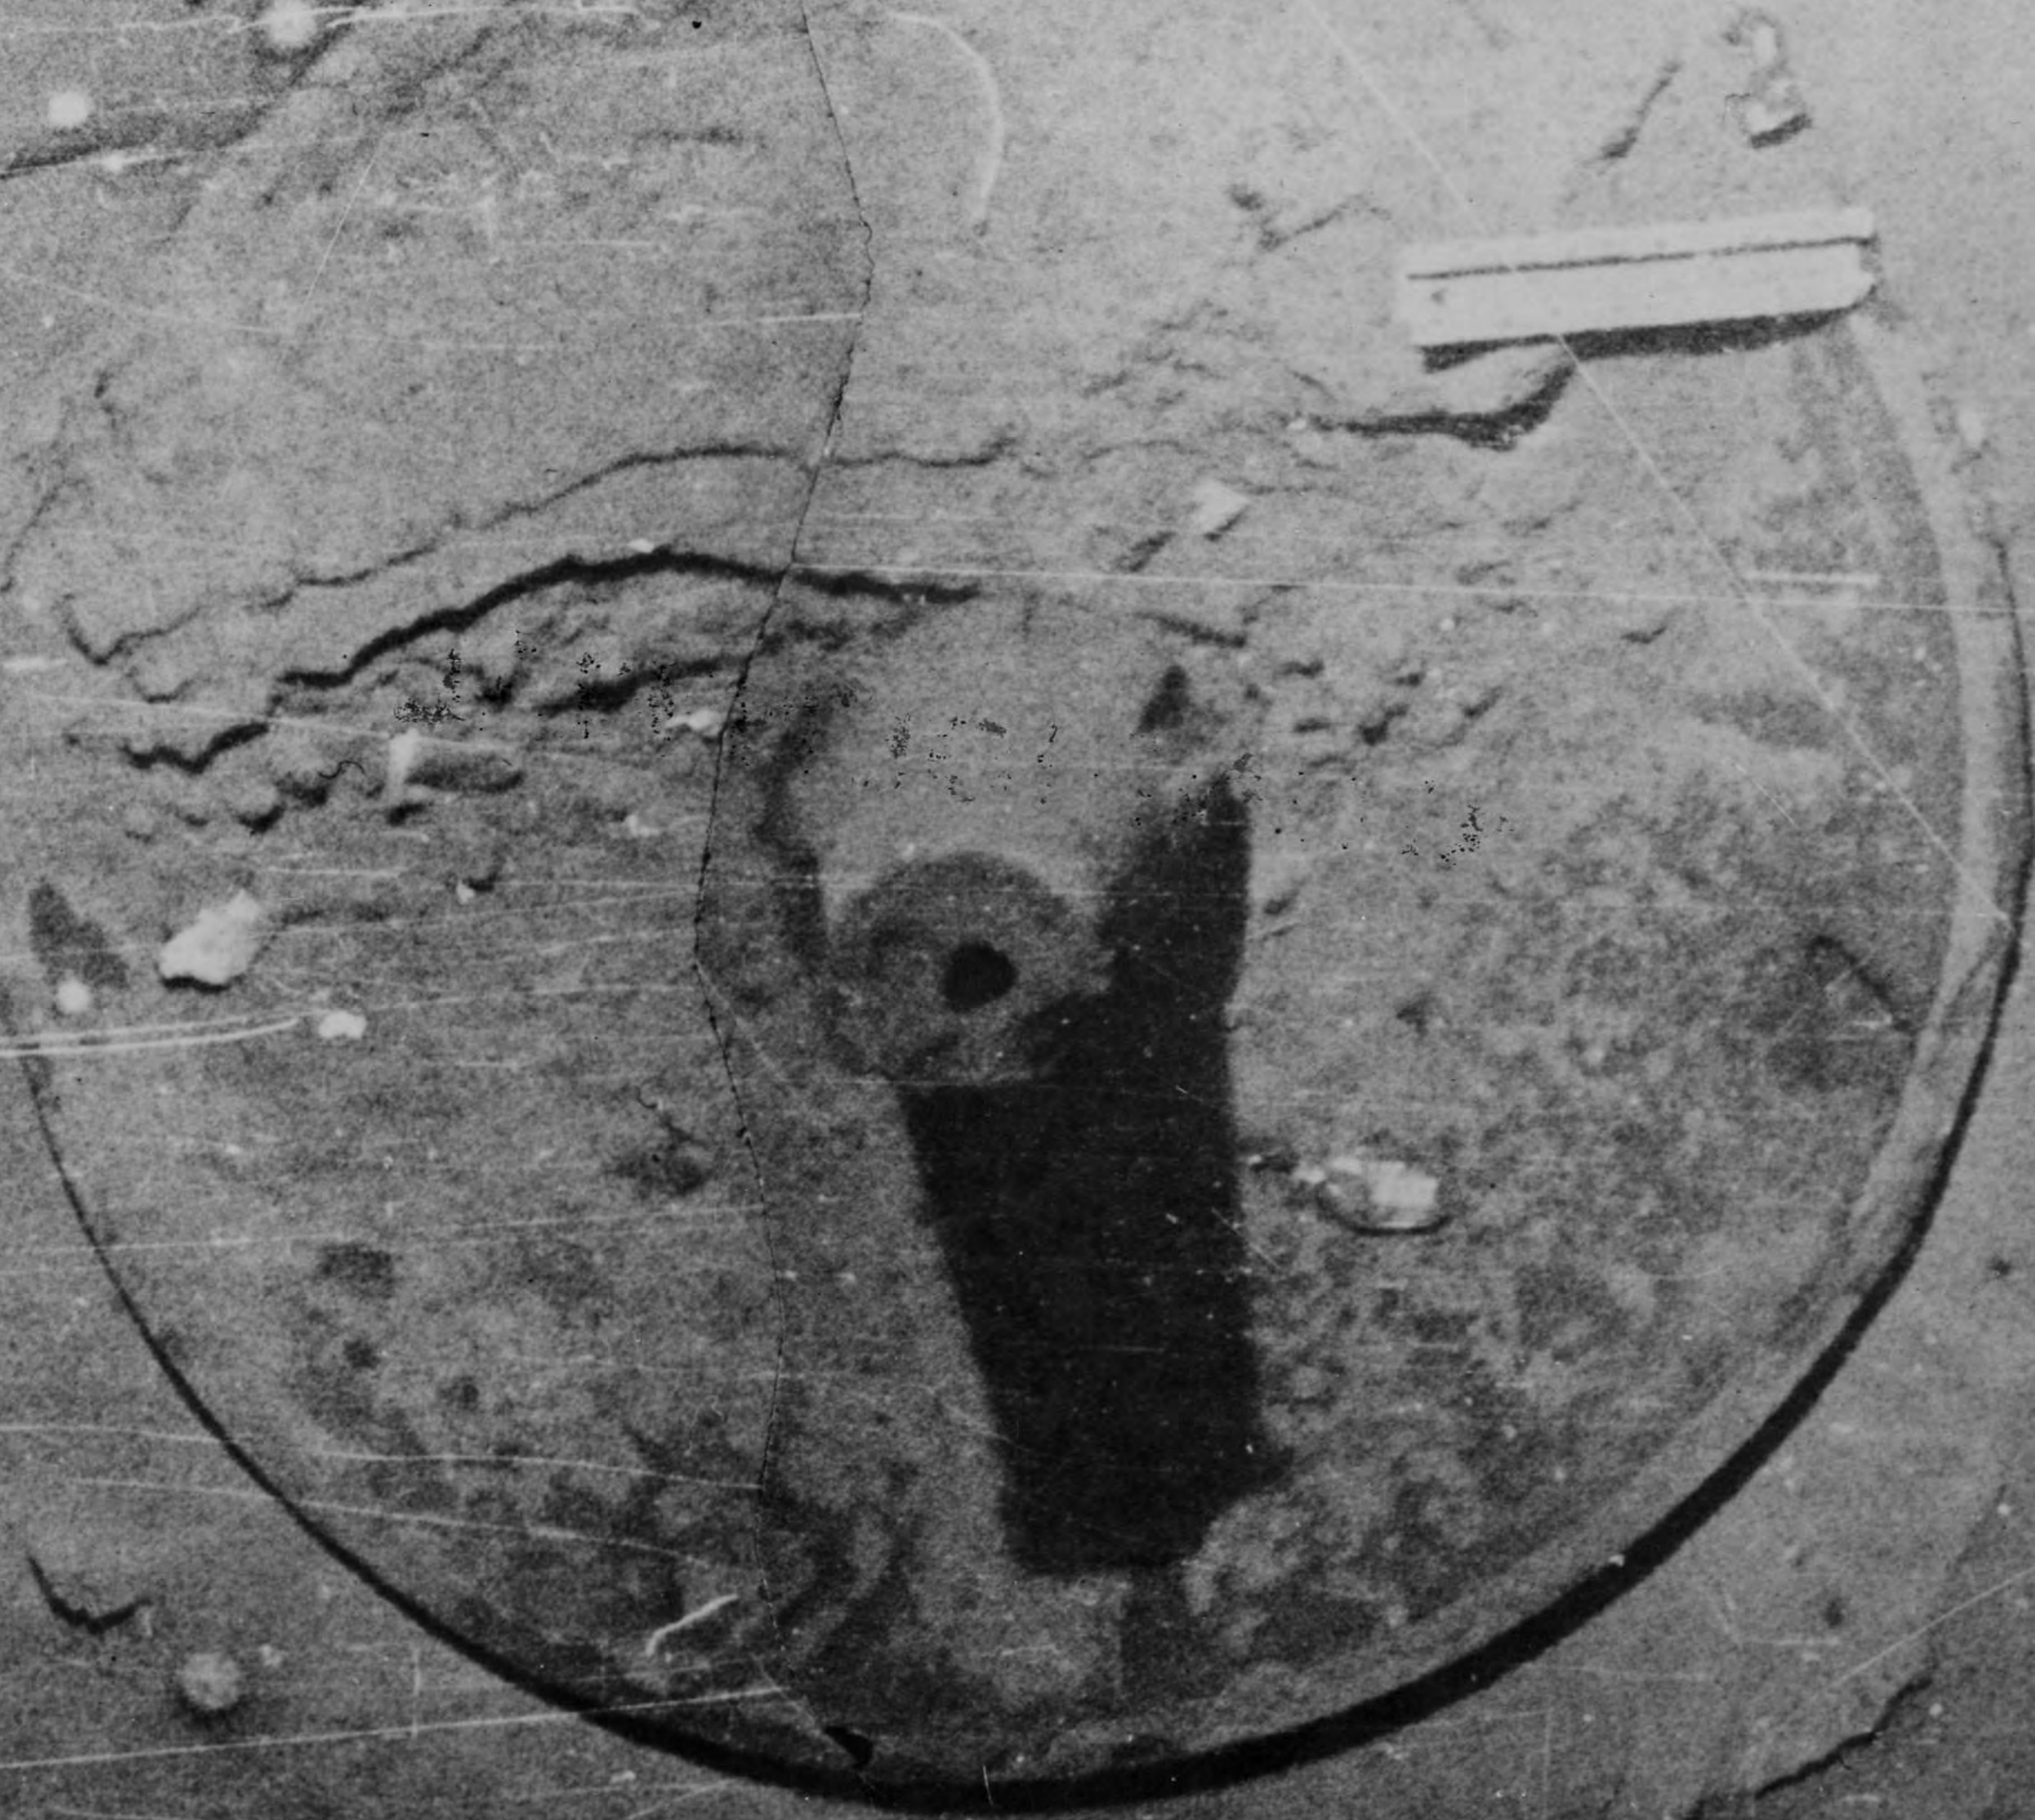
Anchor. (NRL/GILLIS)

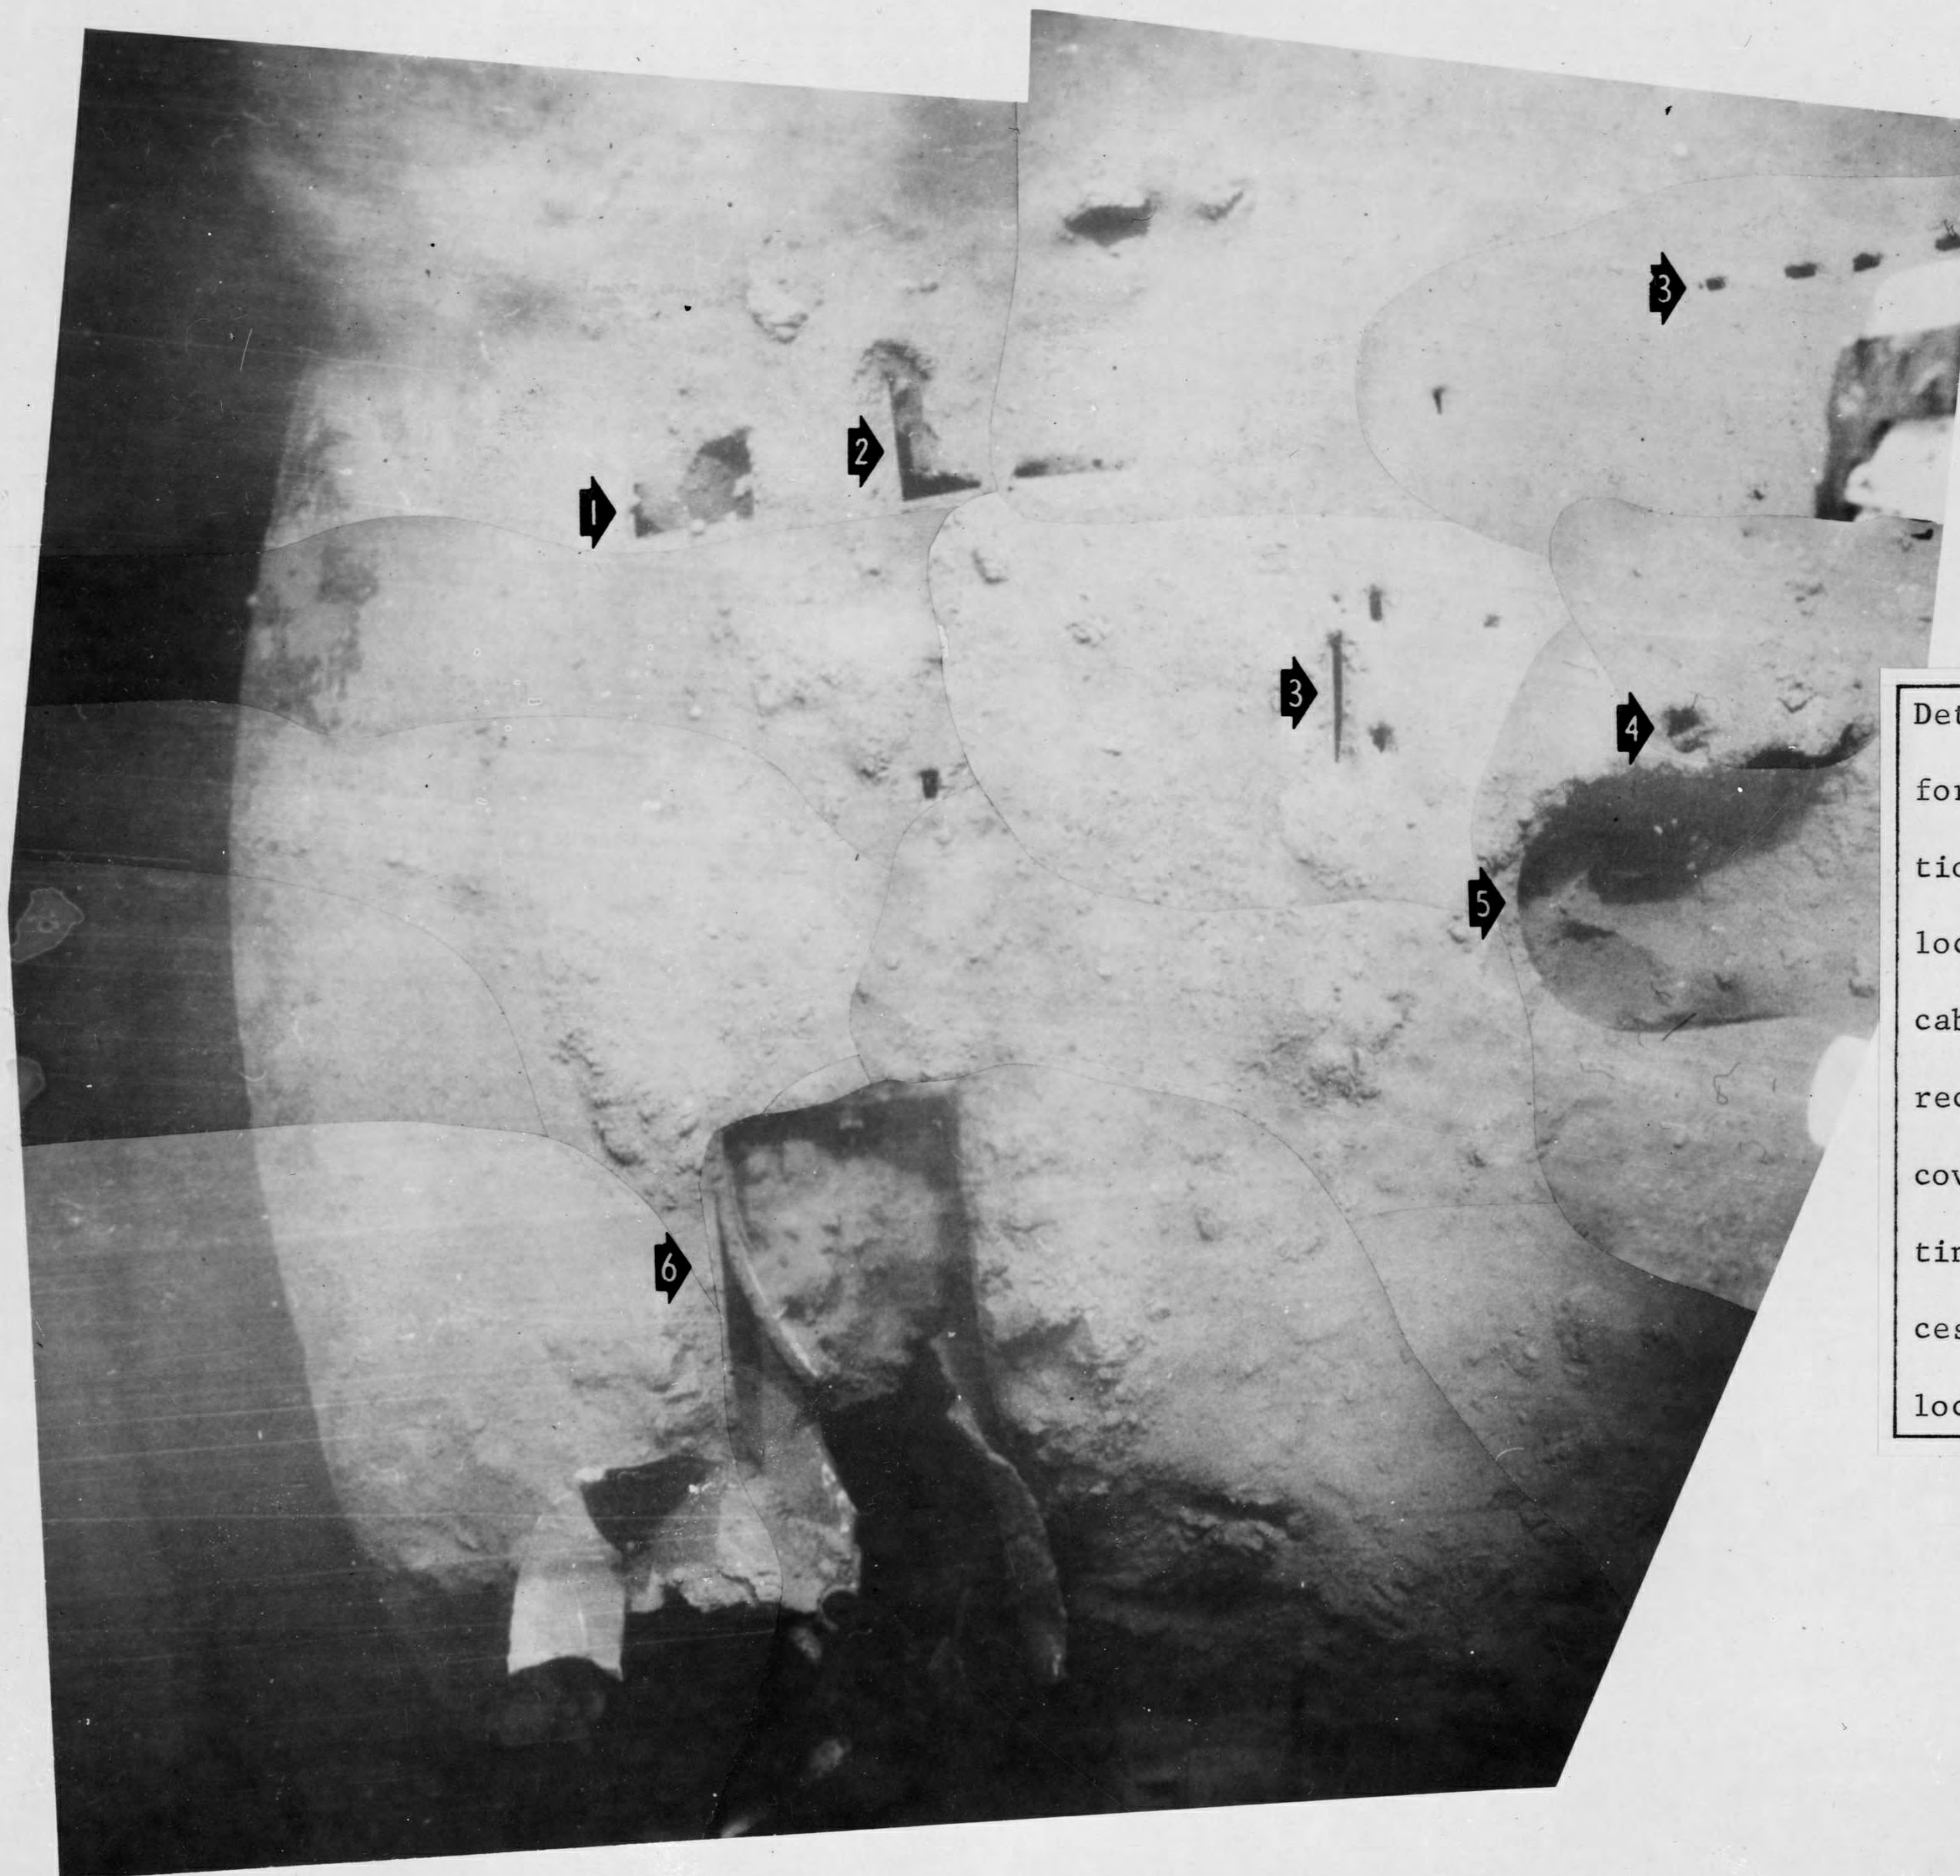
Detail of topside arrangement forward of frame 78. Annotations are as follows: line locker (1), messenger buoy cable reel recess (2), hand recesses for various hatch covers (3), salvage air fitting (4), messenger buoy recess (5), and stern chock location (6). (TRIESTE II)
