USS THRESHER

SSN-593

1963-1964 Search Photography

A collection of selected towed camera and R/V TRIESTE  
photographs taken in 1963 and 1964 during the search  
operations for USS THRESHER.

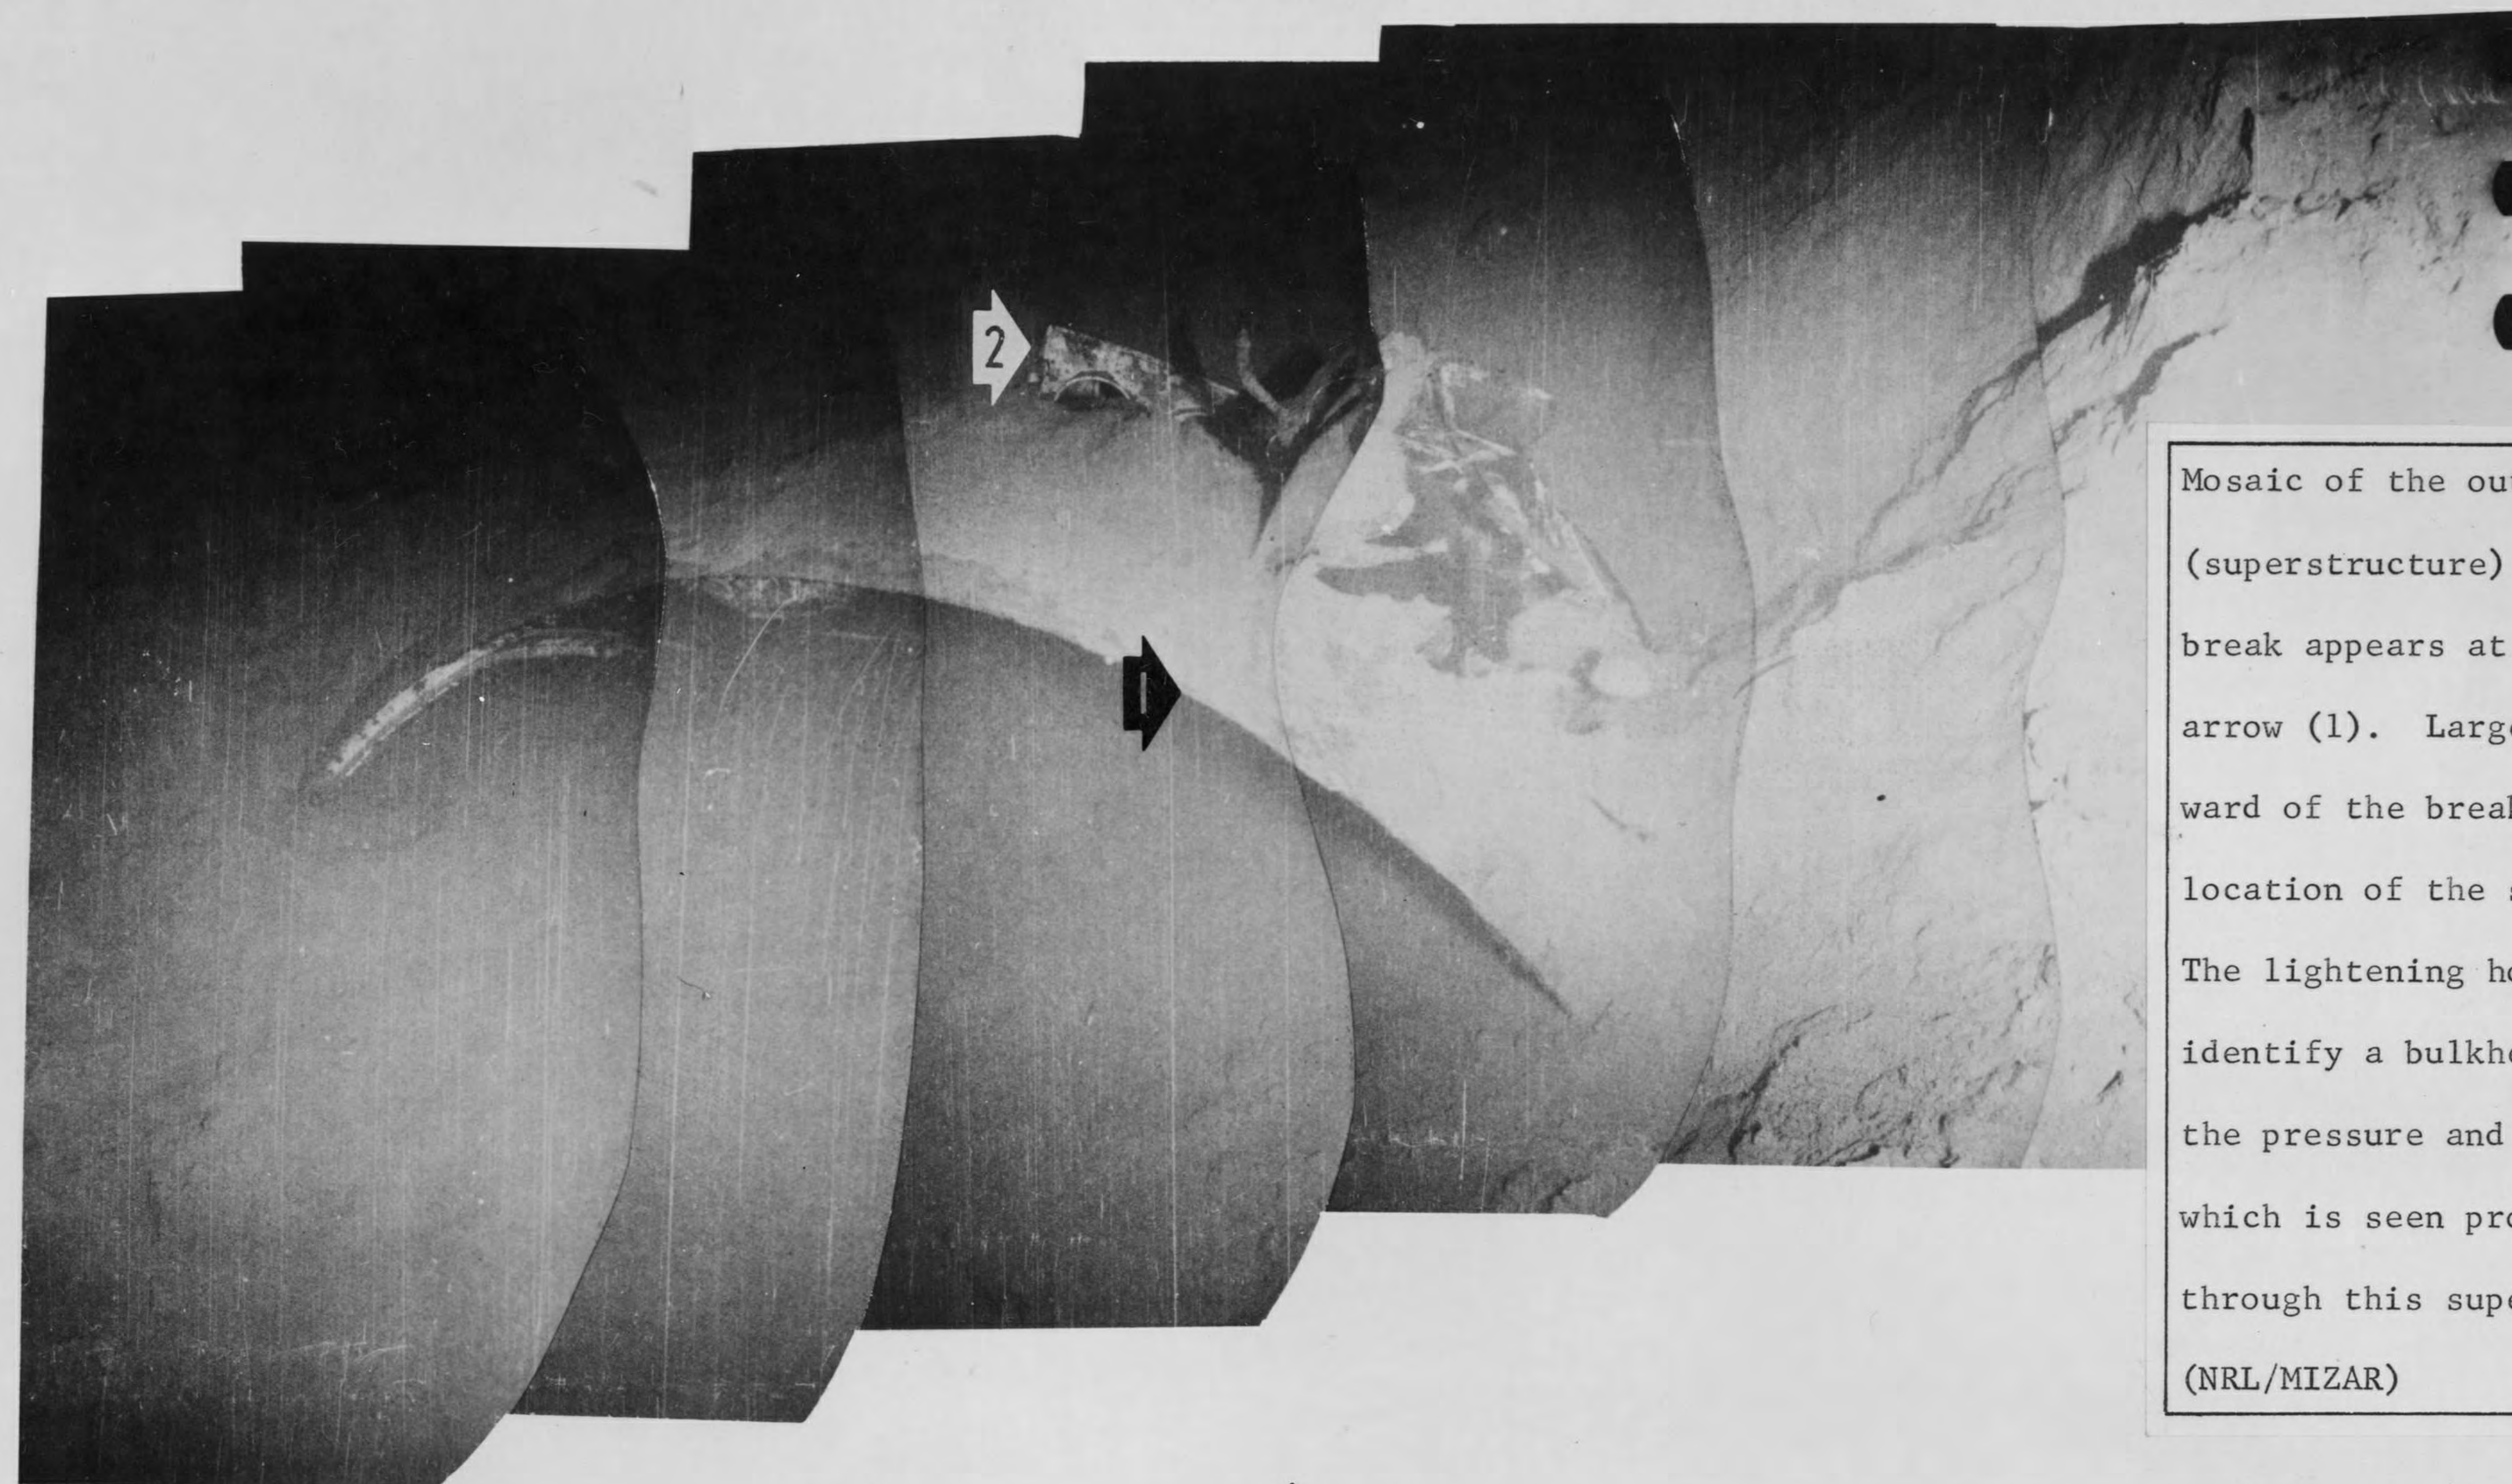
Mosaic of the outer hull  
(superstructure) aft. Clean  
break appears at frame 78,  
arrow (1). Large hole for-  
ward of the break is at the  
location of the stern chock.  
The lightening holes (2)  
identify a bulkhead between  
the pressure and outer hulls  
which is seen protruding  
through this superstructure.  
(NRL/MIZAR)

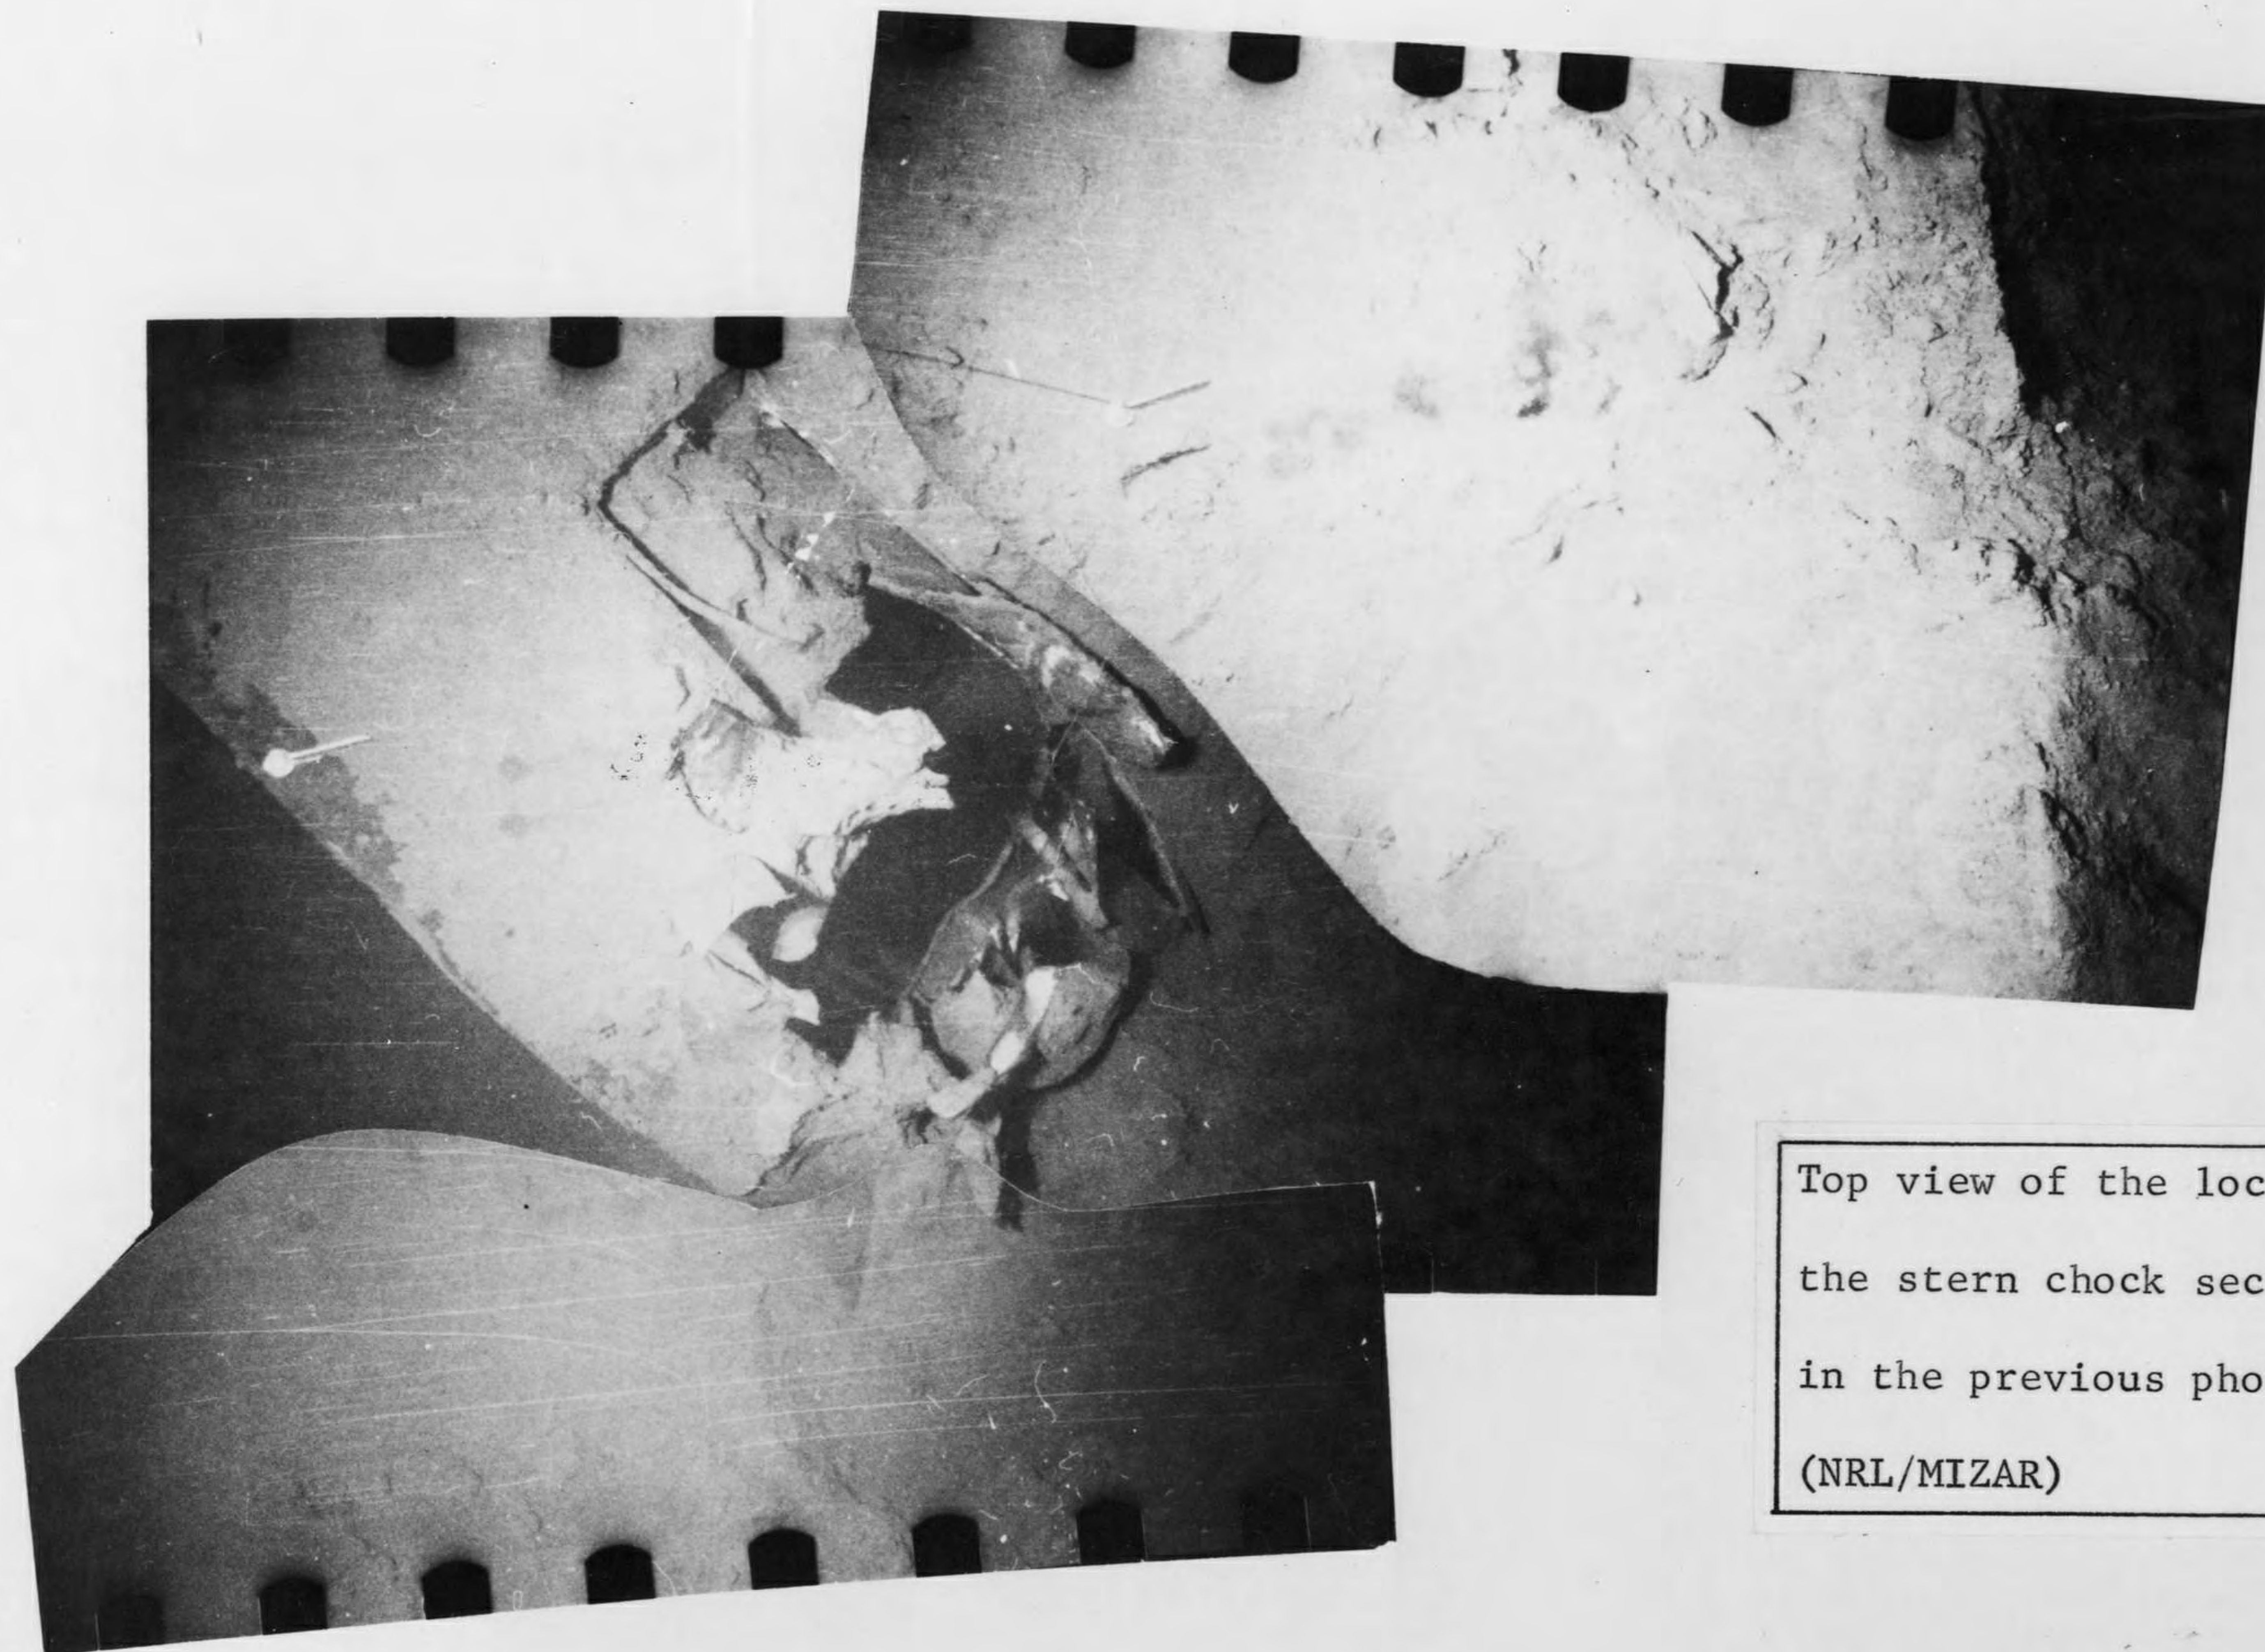
Top view of the location of  
the stern chock section seen  
in the previous photograph.

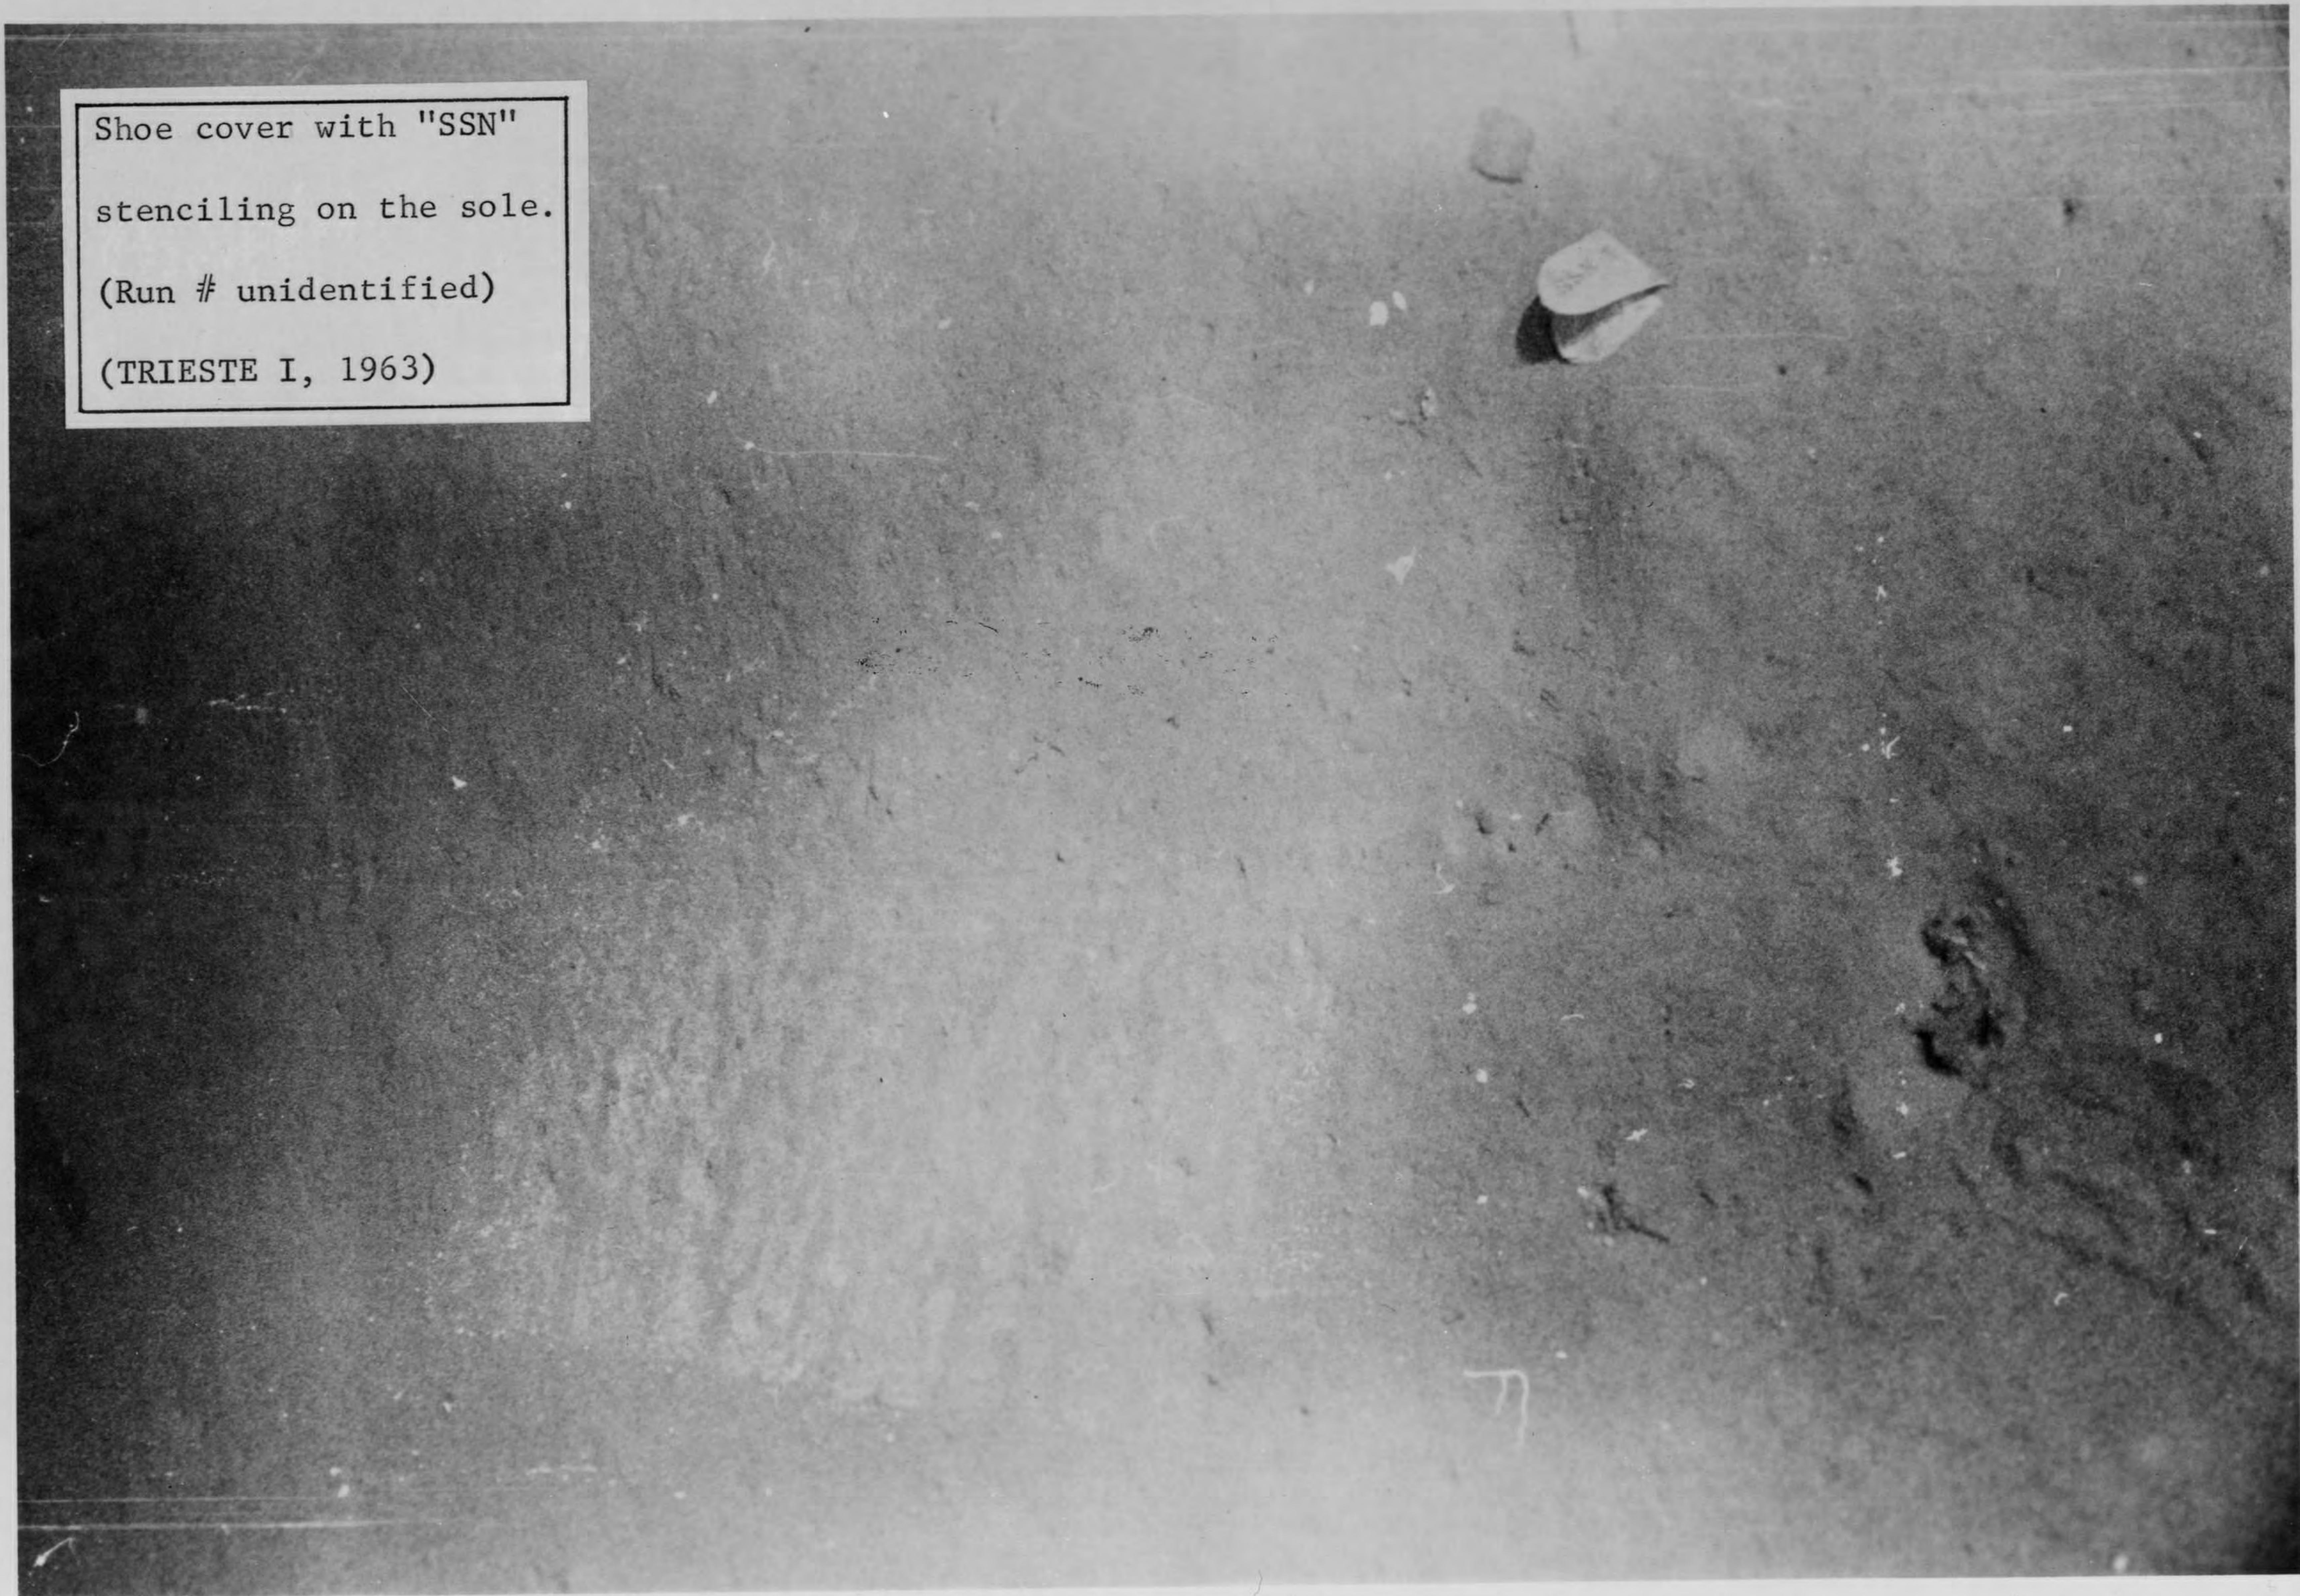
Air bottle. Compass on the camera sled can be seen over the bottle. Compass vane indicates camera motion. (Run #0022-C) (NRL/MIZAR)
