SALVOPS 70

A review of significant salvage operations
conducted by U.S. Navy salvage forces
and other salvage activities during 1970

Department of the Navy
Naval Ship Systems Command
Washington, D.C.

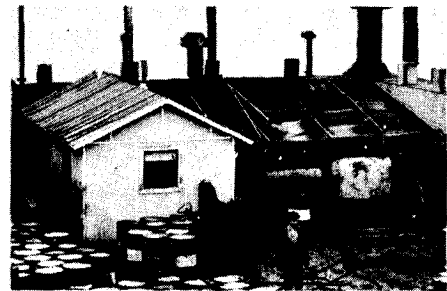
RCN Steam Generator and 30 KW Generator in Shack. Fuel Tank for 30 KW Generator and Secondary Feed Water Tank in Front of Shack.

Two steam power plants were installed to support the pumping system and to heat the Bunker "C". Extensive outfitting was required to transform the barge into an effective tender for extended salvage operations.

During this period, the Royal Canadian Navy installed a second power plant aboard the barge. The Port Hawkesbury Shipyard also delivered four 6-inch cargo hose rigs with open steam traces. Installation of the RCN steam generator and the arrival of these hose rigs enabled the salvage force to develop a multiple-station pumping capability. Repair work was also performed on the first or portable boiler that had been used during the first pumping deployment.

The salvage force had recovered an additional 6,000 barrels by the evening of 8 April when the RCN steam generator failed. Pumping had been completed from tank 9C and was in progress on all three tanks in #7 cargo compartment. Tank 6S had been tapped and rigged for pumping and divers were preparing to check the settling tanks in the after portion of the wreck for possible oil. The problem with the RCN steam generator appeared to be in the feed water modulator valve system.

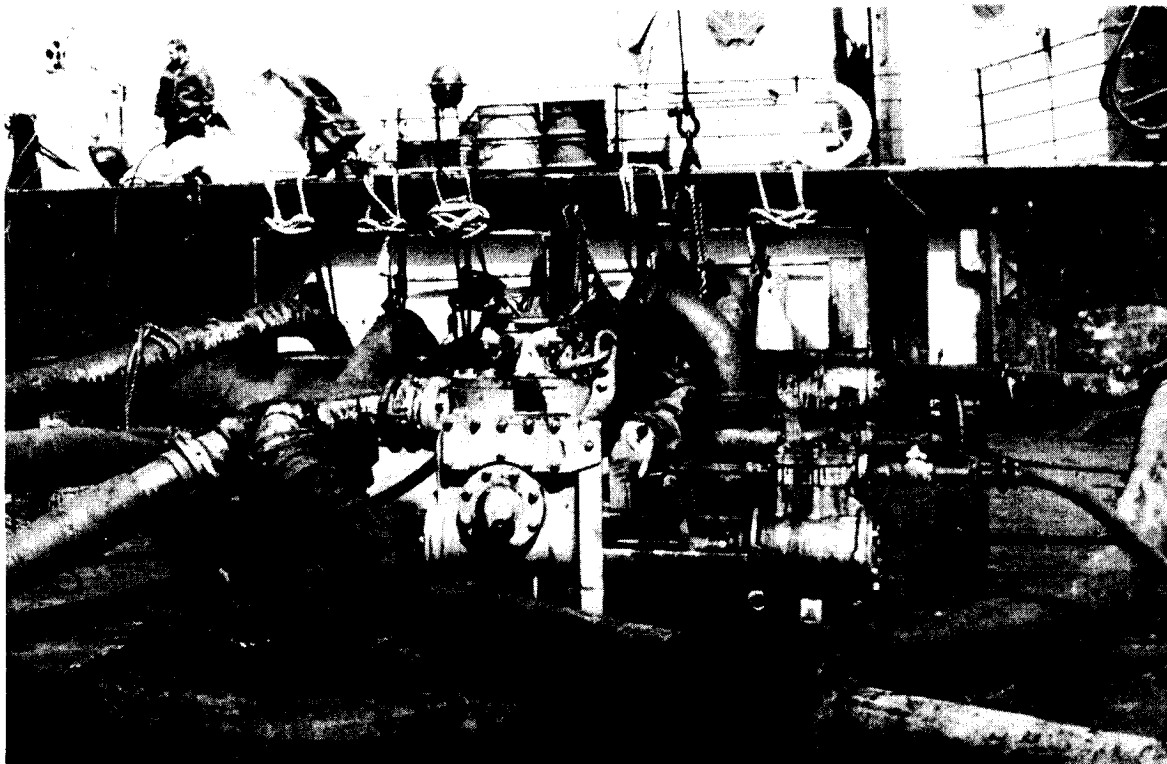
The salvage force used 6-inch steam-driven, reciprocating pumps. They were well suited for the task of pumping the Bunker "C", being reliable, general purpose rigs. Both 6-inch and 8-inch heavy duty discharge hoses were used as suction hoses.

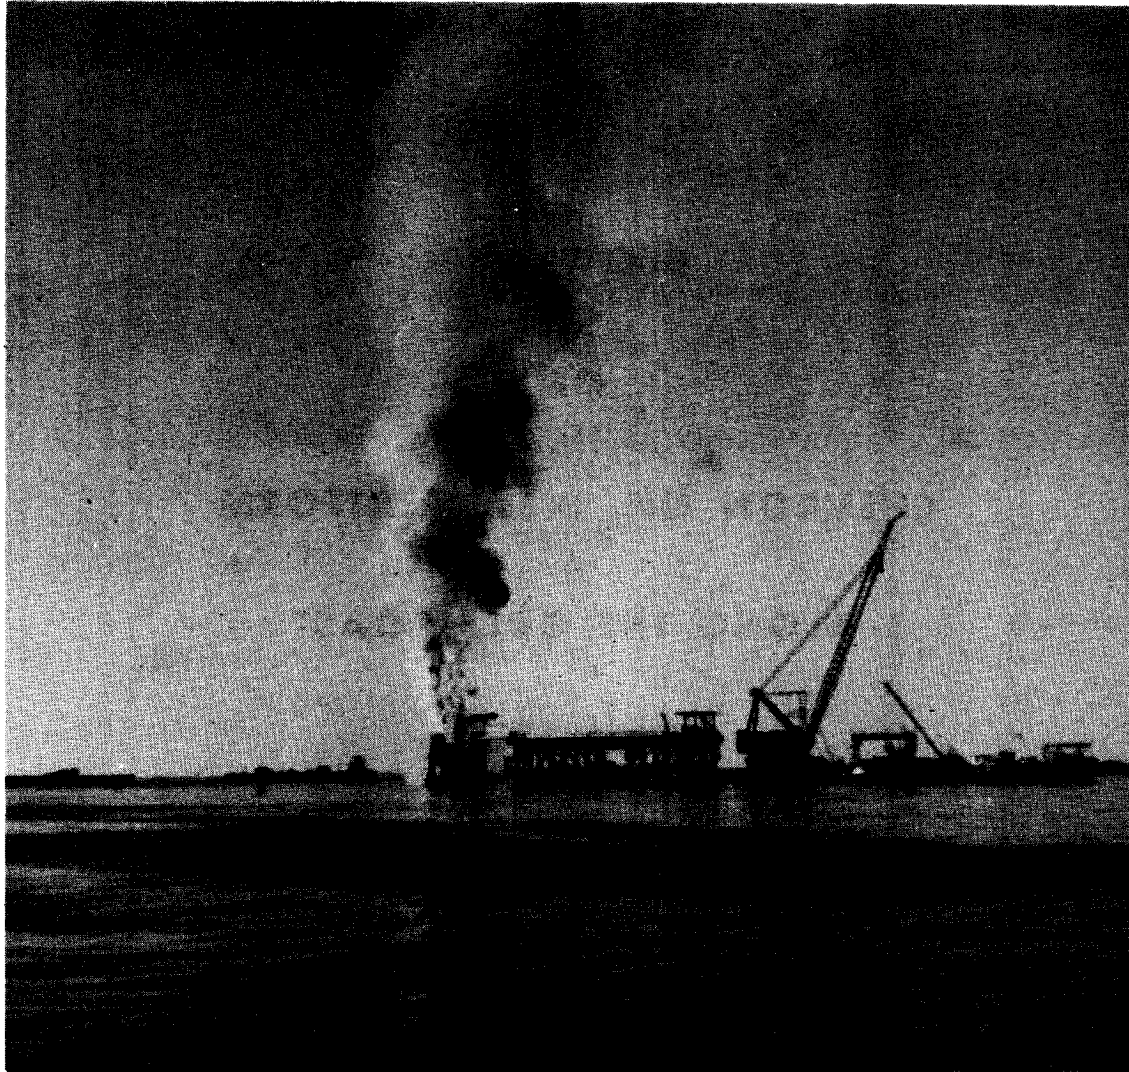
Chevron forces constructed a huge work platform to gain access to the blowout. Barges in the background formed a boom/barge barrier to contain the oil spill from the wild wells.

Chevron tasked the Adair Fire Fighting Company to put out the fire. To gain access to the site, a long work platform, 450 x 50 feet, was constructed adjacent to the burning oil well platform. The giant floating crane, "George S. Brown", provided by the Brown and Root Construction Company, was used in building the work platform.

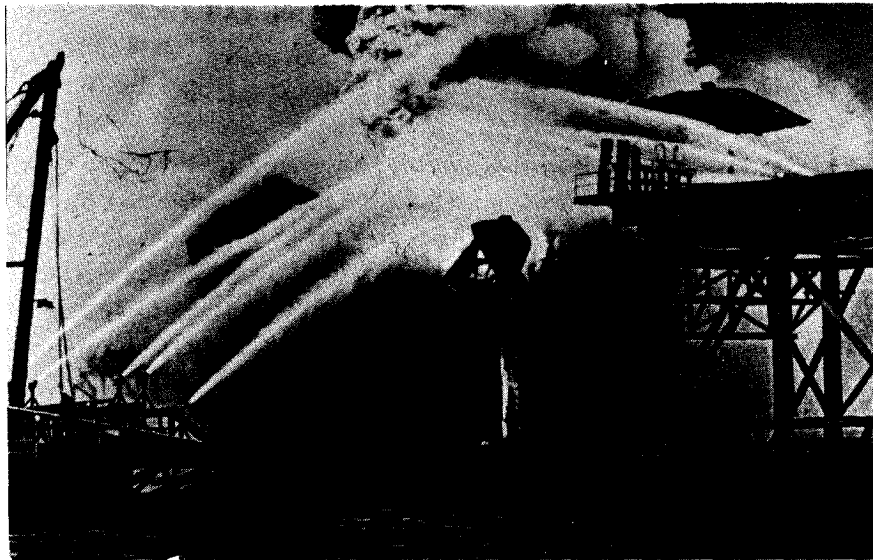
Fire fighters detonated TNT in the heart of the fire and engulfed the site with massive sprays of water from the work platform and a trenching dredge. Their second attempt on 10 March succeeded in putting out the fire.

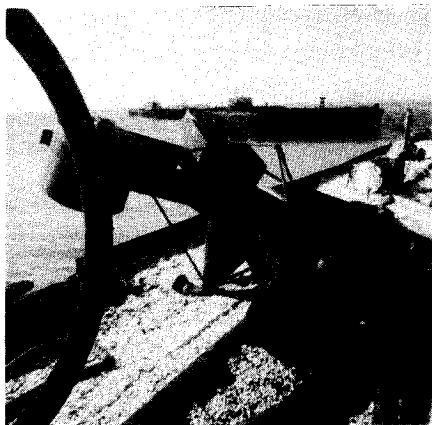
SKIMMER BOAT OPERATIONS

The skimmer is suspended over the side and maintained just below the surface with the four flotation barrels. Oil is pumped up into tanks on the boat through a hose connected near the top of the cone-shaped receptacle at the center of the device. Pumping through a separate connection at the bottom of the receptacle helps to separate the oil from the heavier water.

Chevron outfitted six work boats with skimmer devices and settling tanks. The company also rigged a larger craft, a work barge, for skimming operations, installing settling

tanks and a skimmer of its own design. This skimmer barge was similar in concept to the "Norfolk Skimmer" developed at the Norfolk Naval Shipyard. The skimmers were intended to complement the boom/barge stationary barrier, with priority of operations being given initially to picking up any oil that had escaped the barrier and was threatening the coastline.

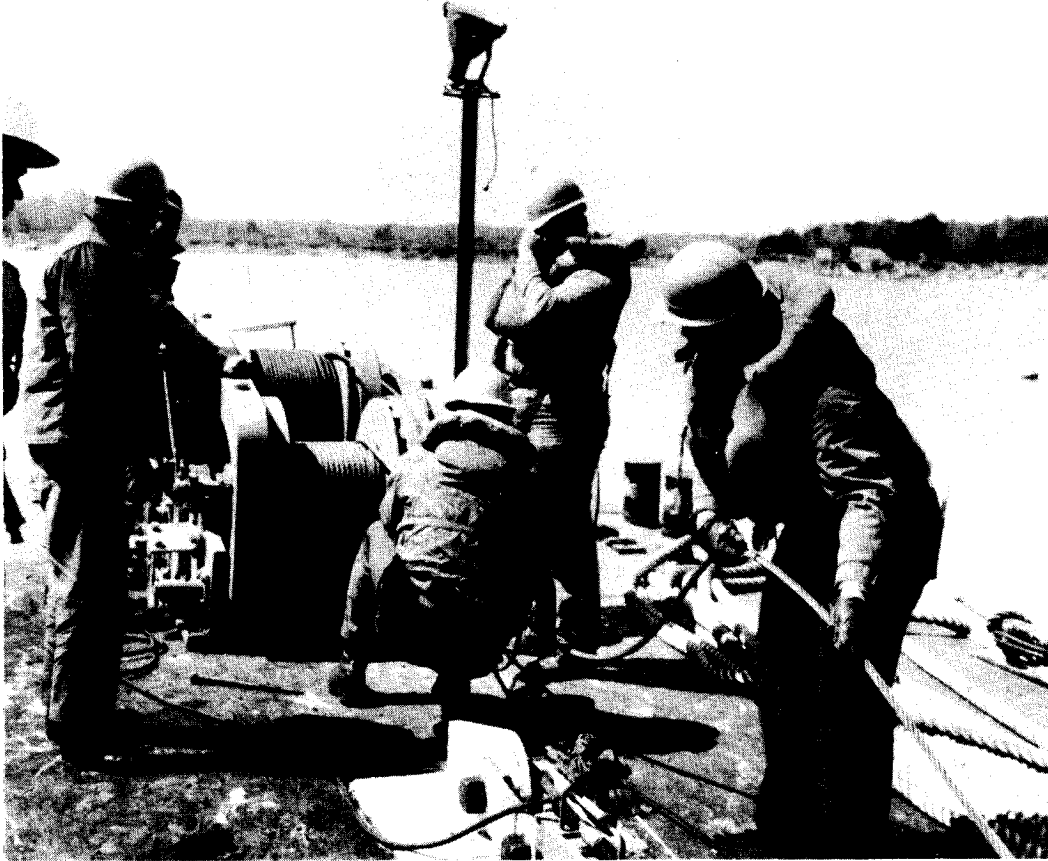
Clyde winches became critical items in planning as local craft were not rigged for heavy lifting. The salvage force obtained two winches and installed them on YD-89.

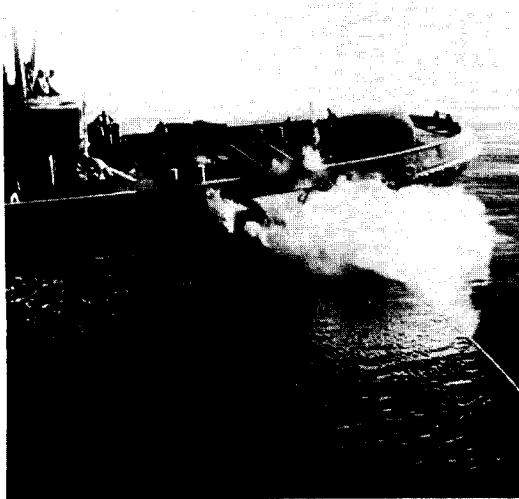
KALMIA DEPLOYING MK-4 SURGE BUOYS AT MOORING SITE

The huge surge buoys were used extensively throughout the mooring operation to help control the lowering of clumps, anchors, and the SQUAW itself.

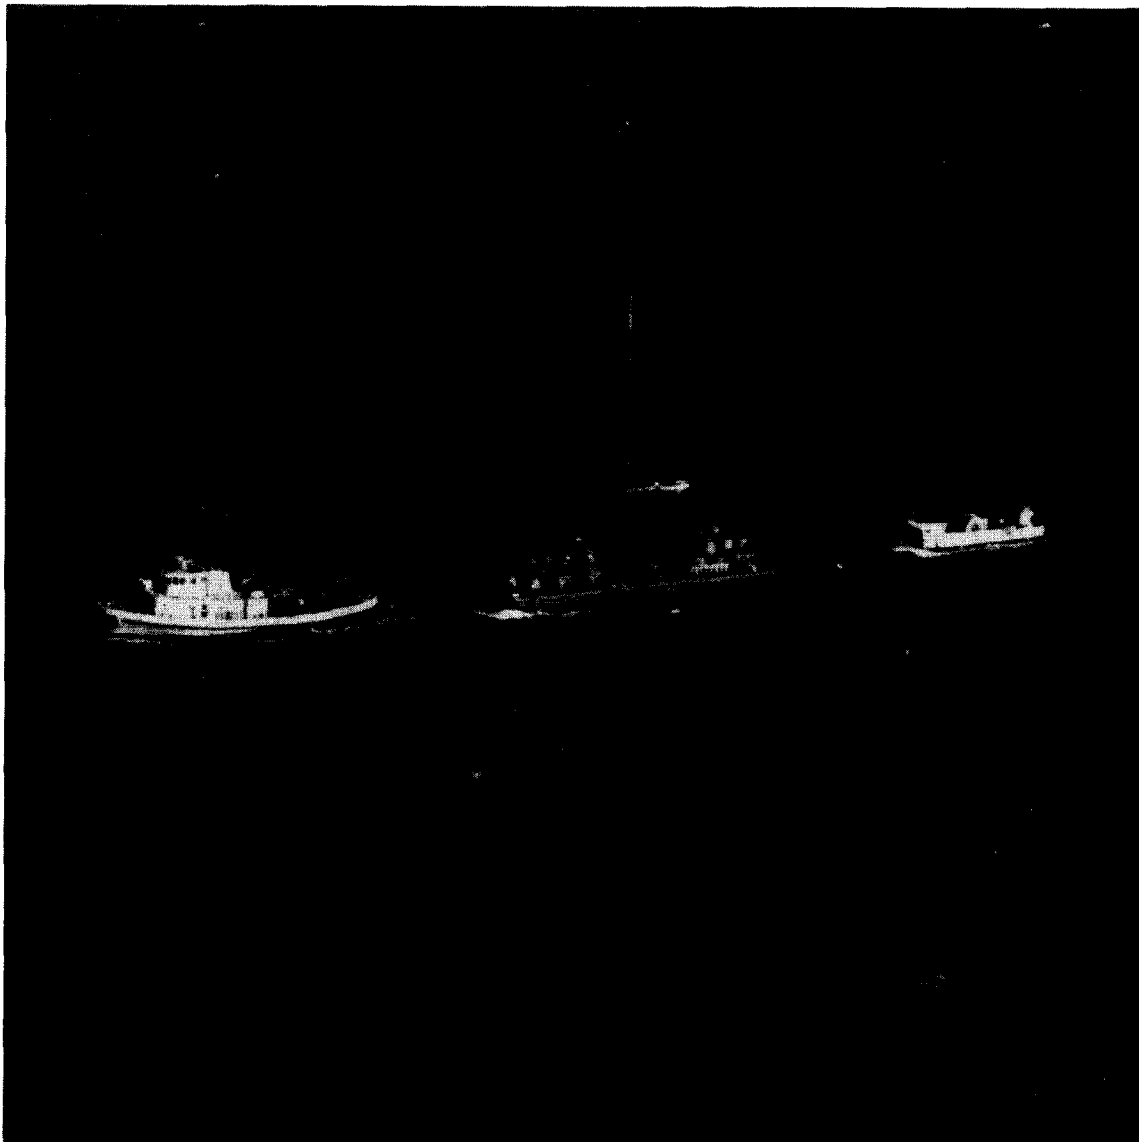
BARGE-TOWER UNDER TOW TO IMPLANTMENT SITE

The barge, YC-1429, was sunk off Block Island to function as a platform for the hydrophone array tower in a Naval Underwater Sound Laboratory project. The task force used deck-loaded salvage pontoons to help control the barge during the implantment operation.

The technique used to sink and implant the barge-tower, i.e., preassembling the system, sinking it in shallow water, and skidding it to the implantment site, is practical and effective. However, details of the method such as pontoon location, which, in this instance was far from ideal, must be refined if the operation is to be accomplished with maximum effectiveness and safety.

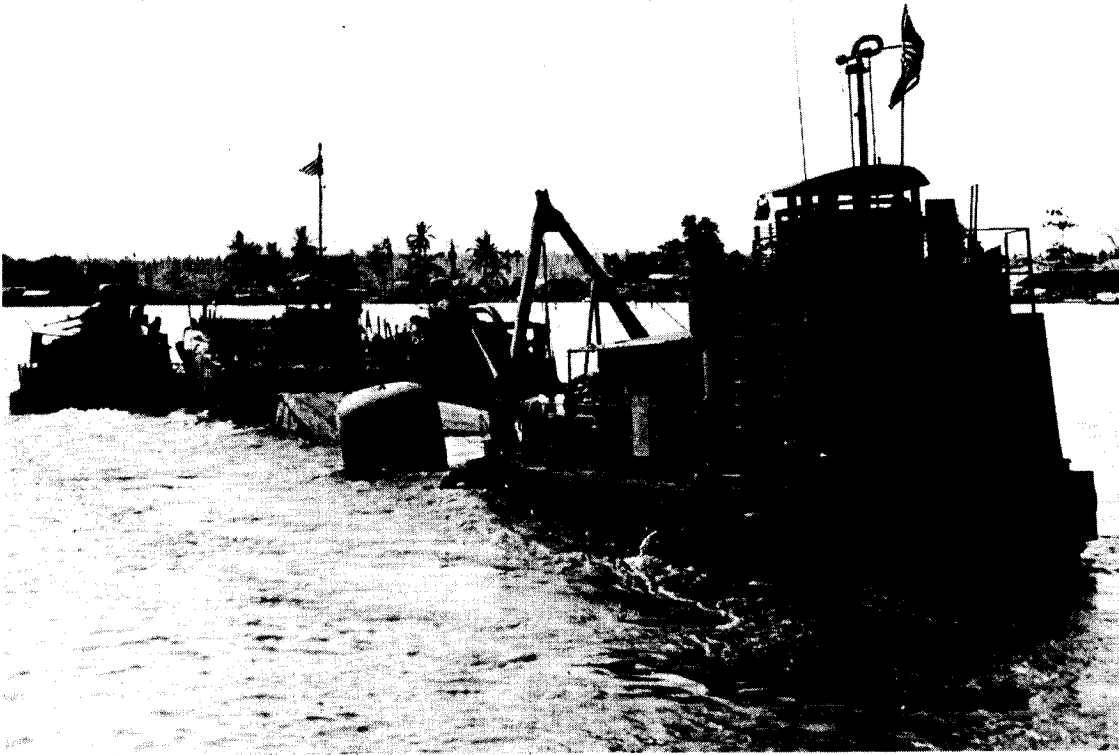
**SALVAGE NEST TOWING SUNKEN TROOP CARRIER
TO REPAIR BASE**

CSB, foreground, and LCM provide the tow while support craft of Vietnamese Navy provide escort protection. Salvor is manning port gun aboard CSB.

In practically every service craft salvage operation, salvors were able to make only temporary hull repairs. Due to the extensiveness of hull damage and the material condition of power plants, salvaged service craft had to be held in a lifting bridle and towed for several miles to a repair base. Many techniques included a salvage nest with salvage lift craft forward and aft or one on each side to keep the salvaged craft from going under. Salvors frequently employed lift balloons as a technique to restore lost buoyancy. The balloon helped keep the damaged craft afloat and relieve the severe stresses on lift equipment, particularly during salvage nest towing operations.
