Photo 1: U.S.S. HORNET during morning attack. Note smoke on flight deck from the two bomb hits aft. Note "suicide" dive bomber about to crash into leading edge of stack.

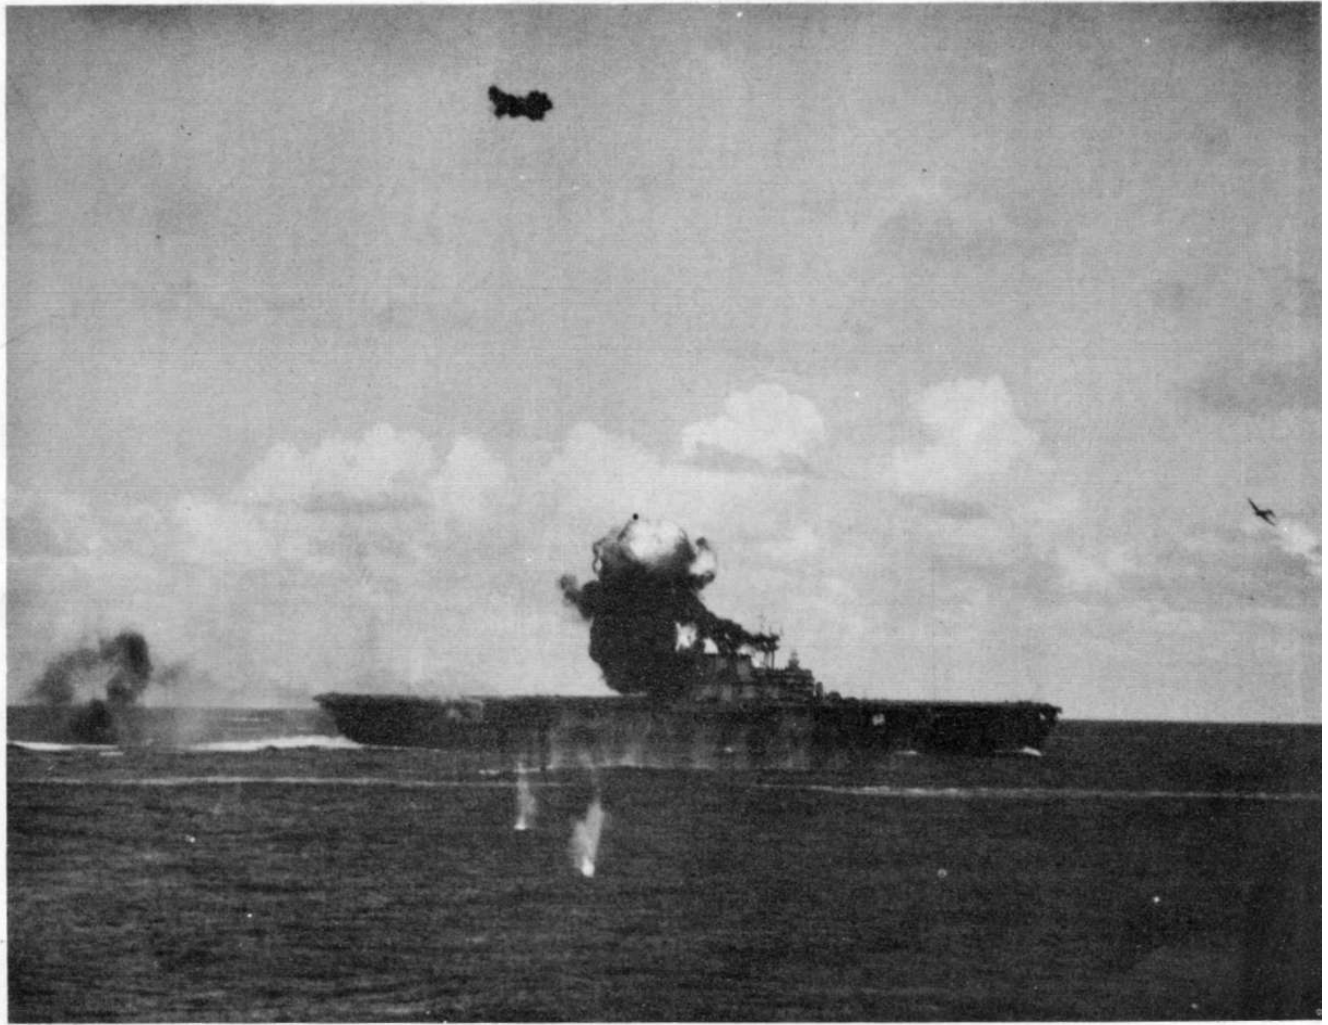
Photo 2: U.S.S. HORNET during morning attack. "Suicide" dive bomber, in photo No. 1, has just crashed into the leading edge of the stack. Note smoke coming from hangar deck due to bomb hits aft.

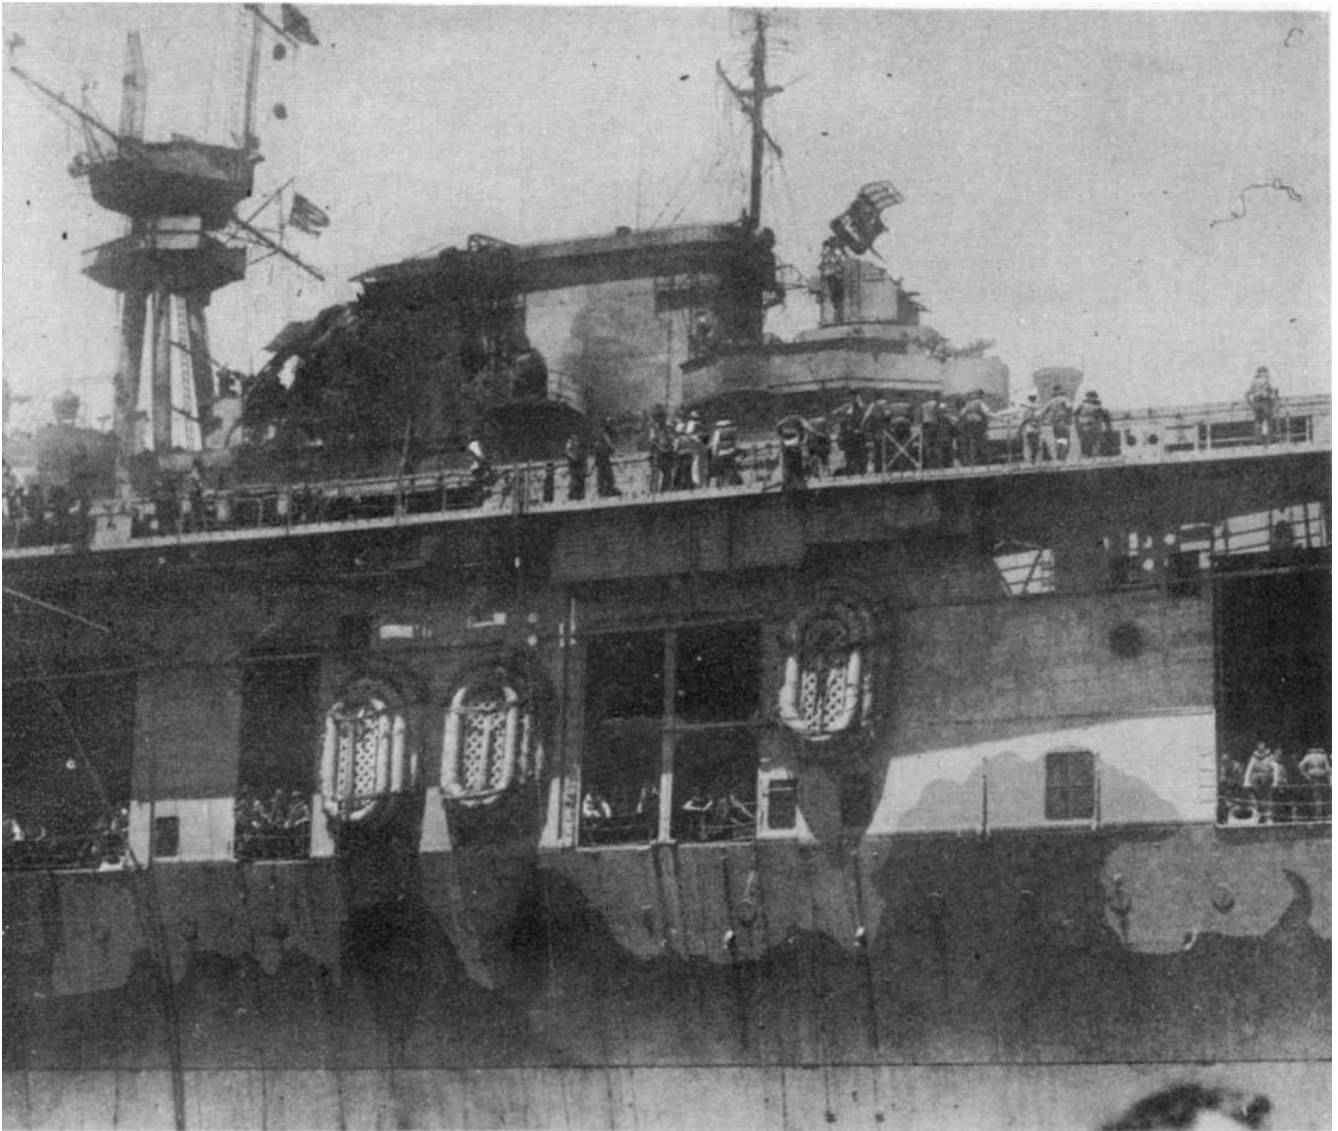
Photo 3: Port side view of damage to the stack as a result of enemy dive bomber crash

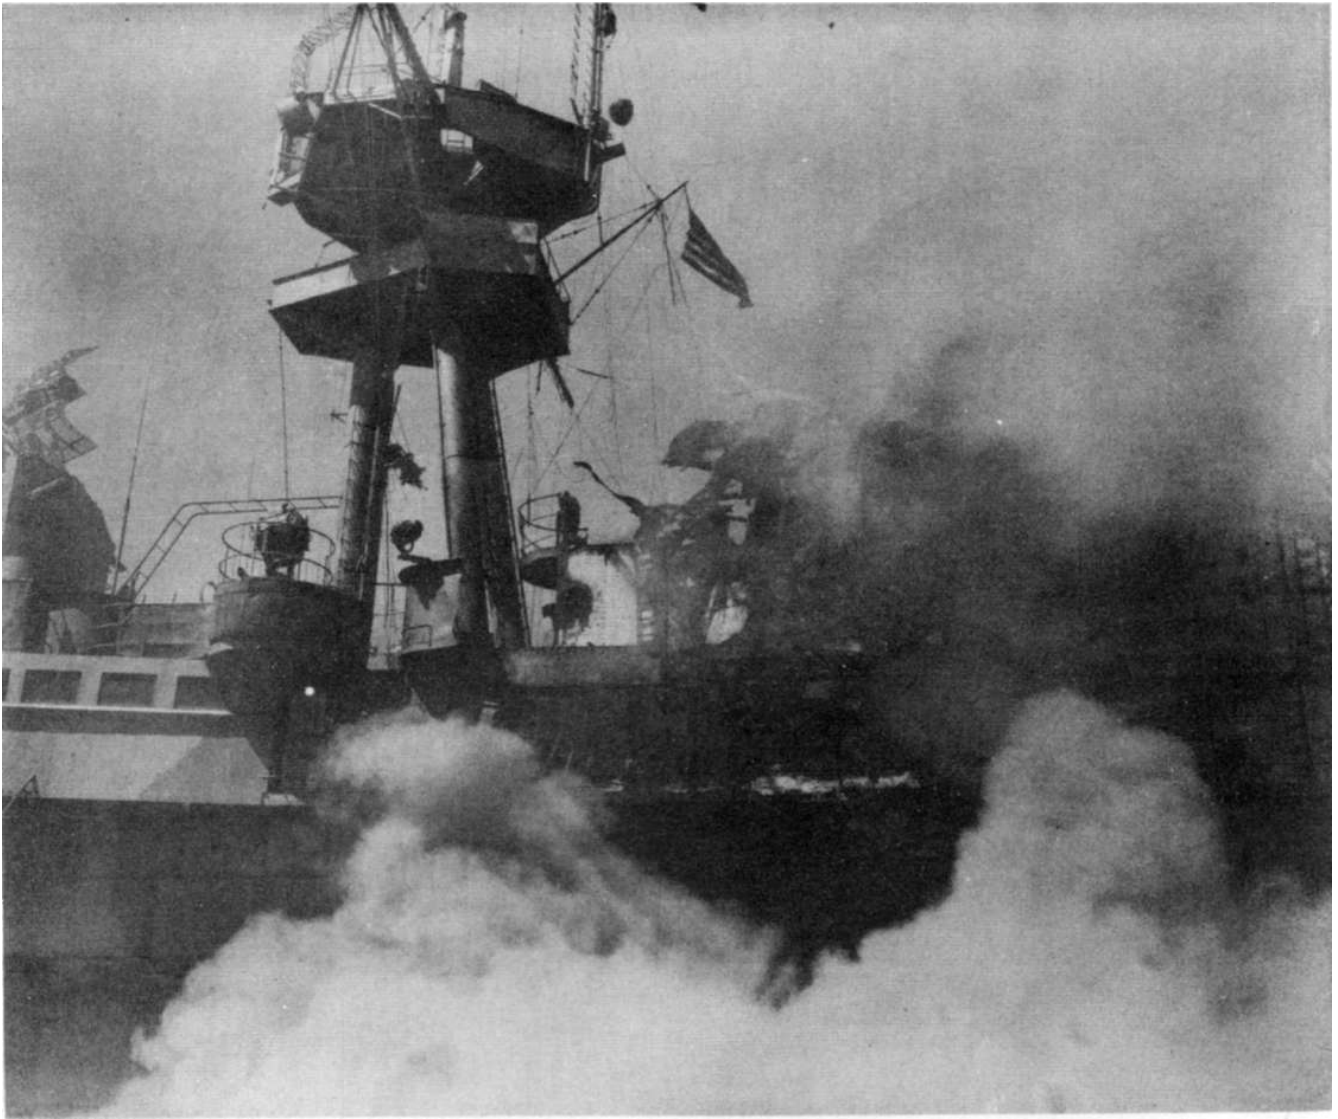
Photo 4: Close-up view, port side, of damage to stack immediately after crash of enemy dive bomber. Note damage to stack walkway. Note destruction of signal bridge forward of stack.

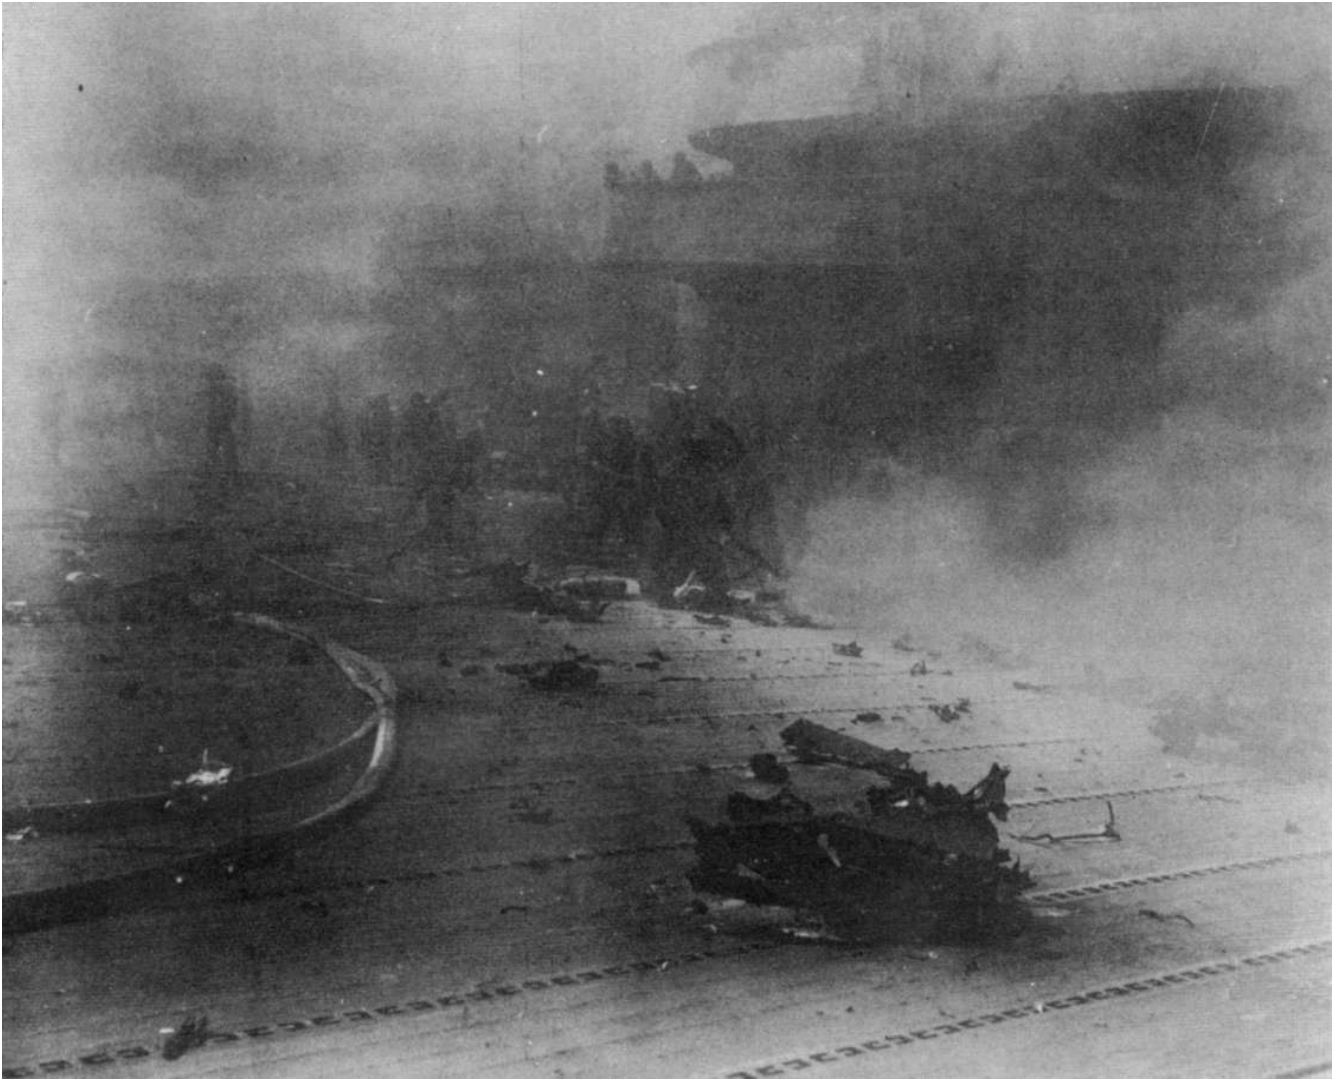
Photo 5: Close-up view of flight deck in way of stack showing wreckage of enemy dive bomber.

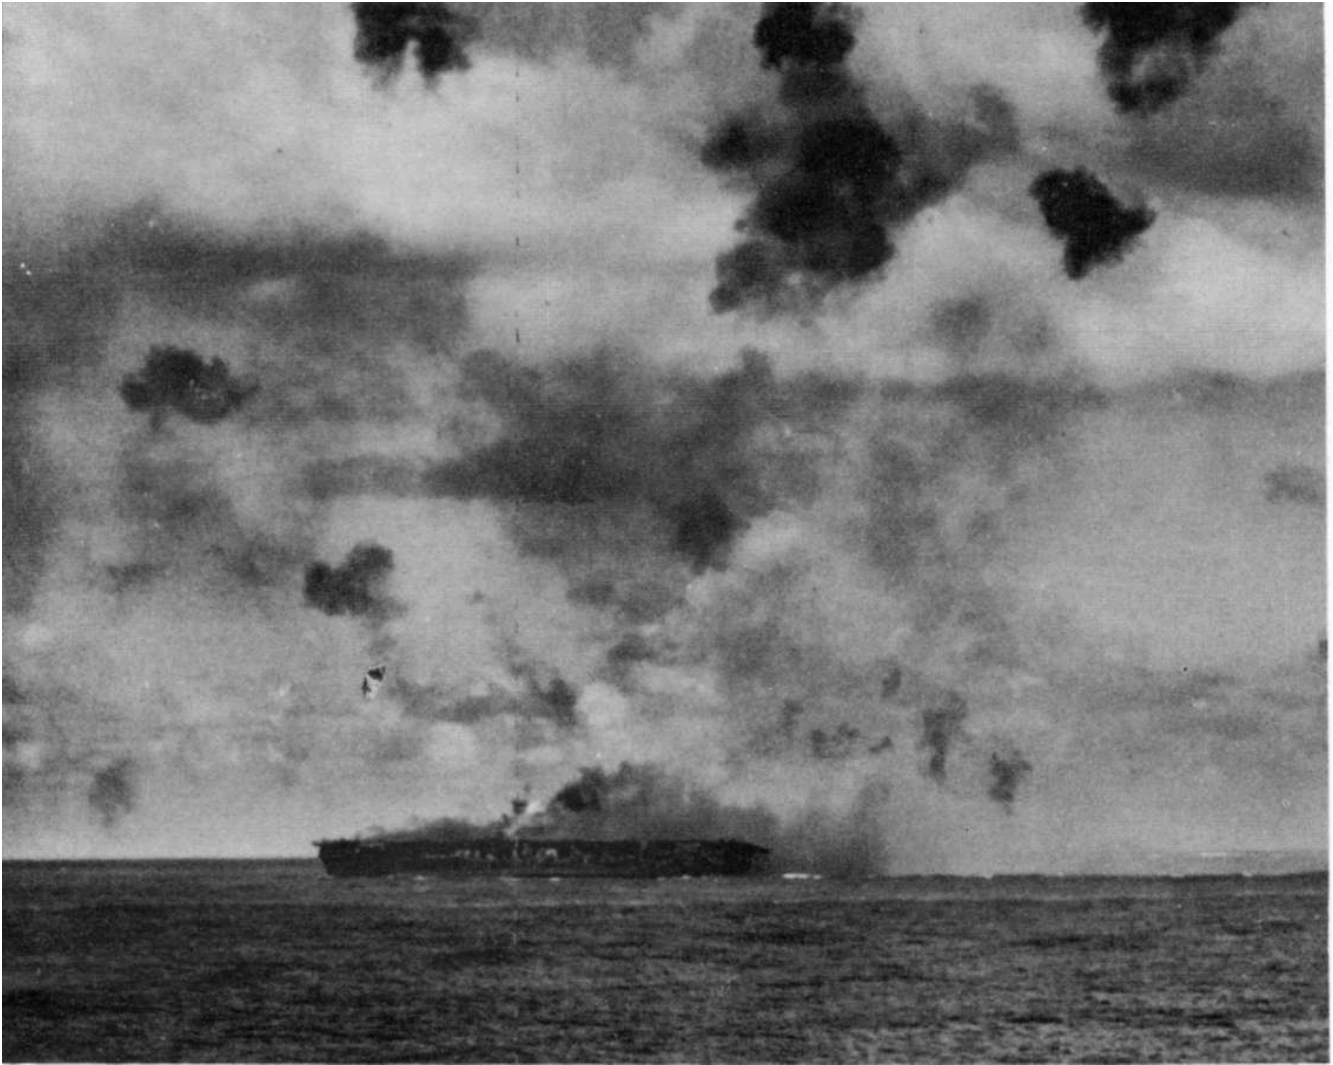
Photo 6: U.S.S. HORNET during latter part of morning attack just after an enemy dive bomber has rounded bow and crashed into port side gallery deck just forward of No.1 elevator. Note heavy smoke amidships from crash of first enemy dive bomber. Note starboard list as a result of the two torpedo hits.

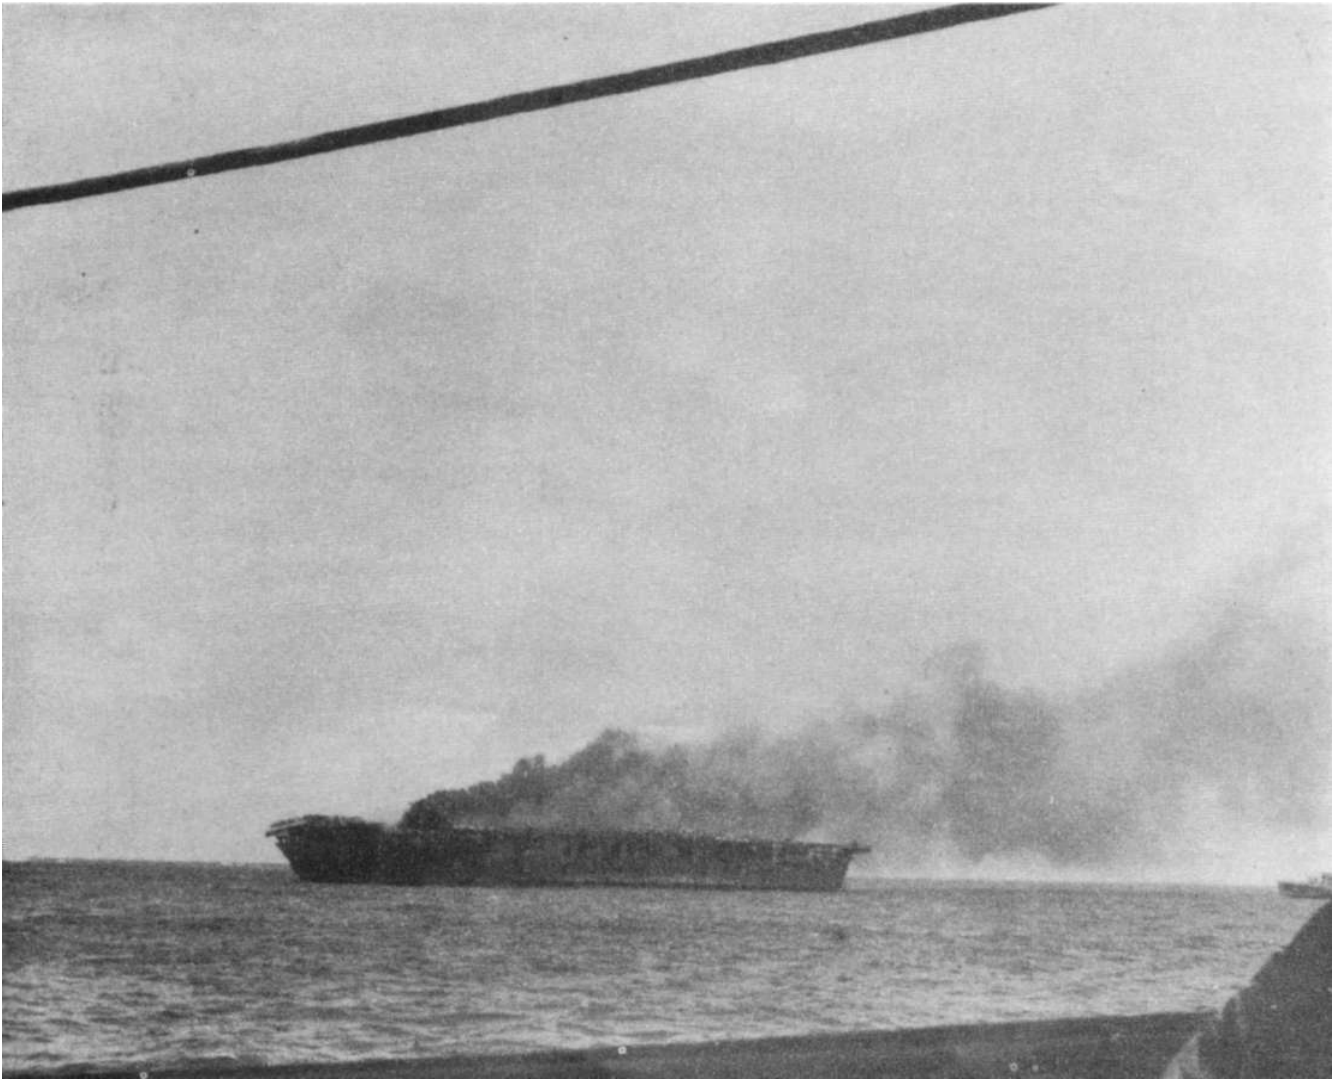
Photo 7: U.S.S. HORNET dead in the water after morning attack. Note smoke forward from crash of second enemy dive bomber. List is about 7° to starboard.

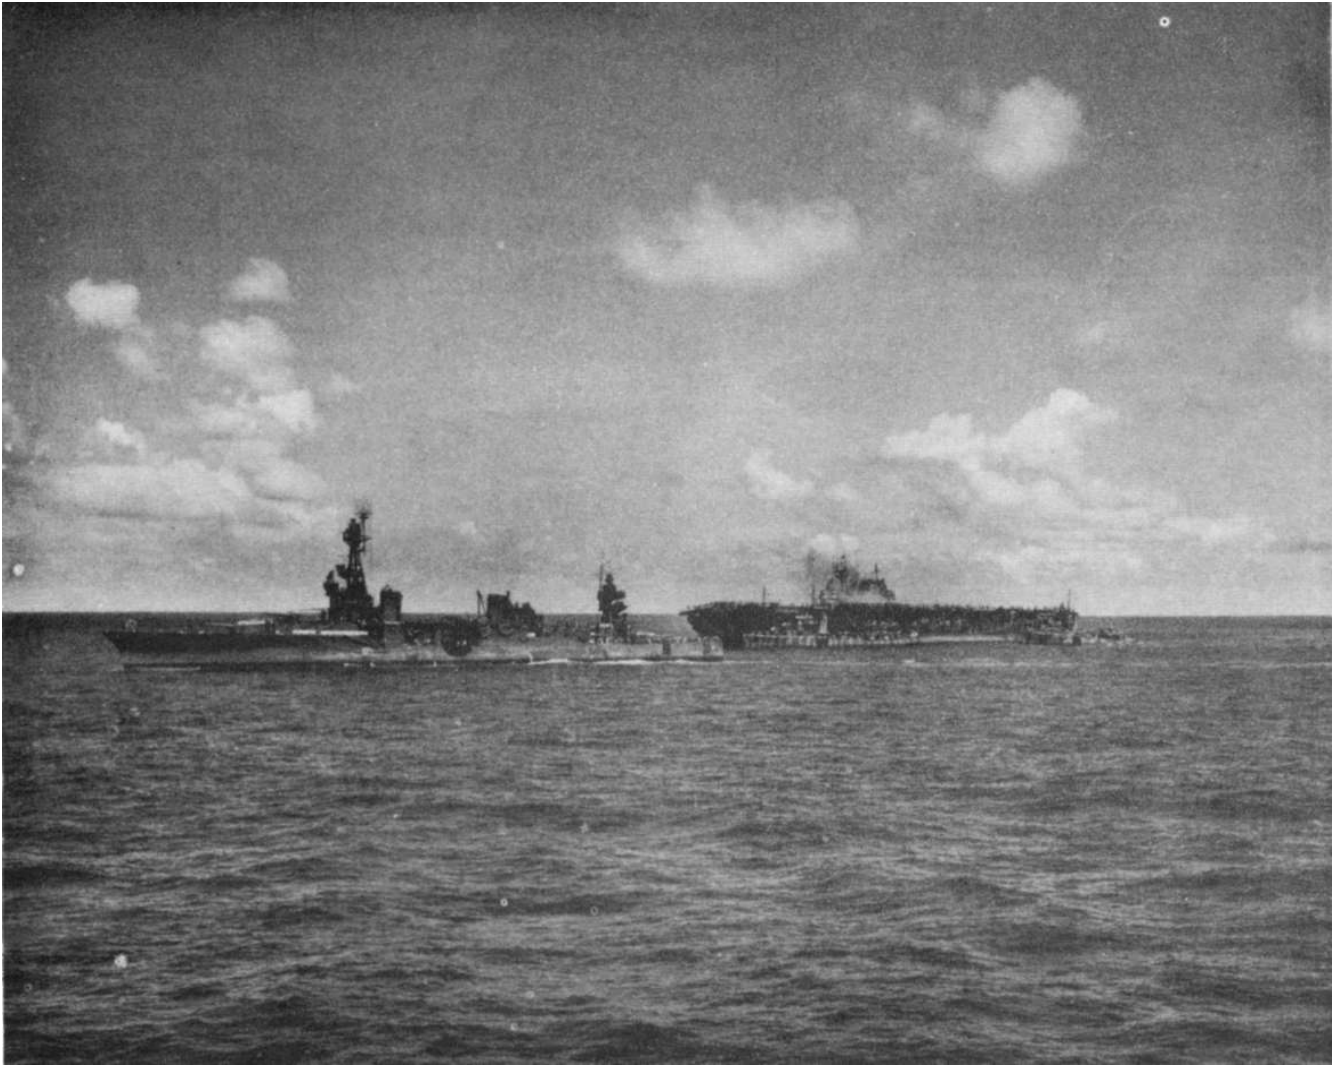
Photo 8: U.S.S. RUSSELL, U.S.S. MUSTIN along port side and U.S.S. MORRIS along starboard side (only top of mast visible) assisting U.S.S. HORNET in fighting fires after the morning attack. U.S.S. NORTHAMPTON standing by to commence towing operations.

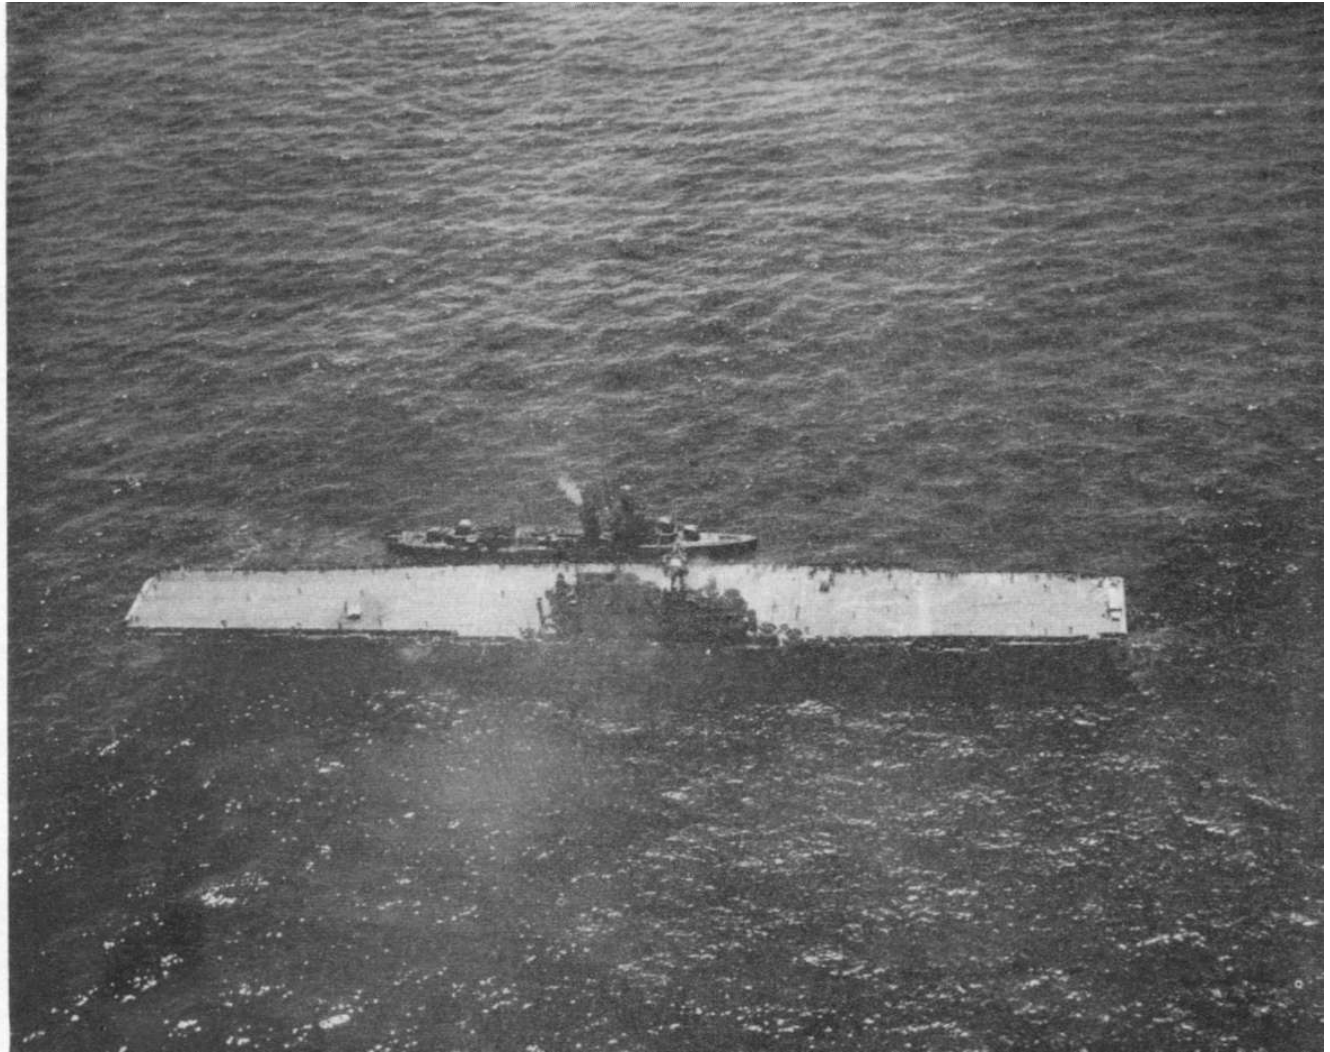
Photo 9: Aerial view of U.S.S. HORNET during lull between morning and afternoon attacks. Note hole in flight deck aft and damage to leading edge of stack. Note bucket brigades still fighting fires on flight deck near the stack.

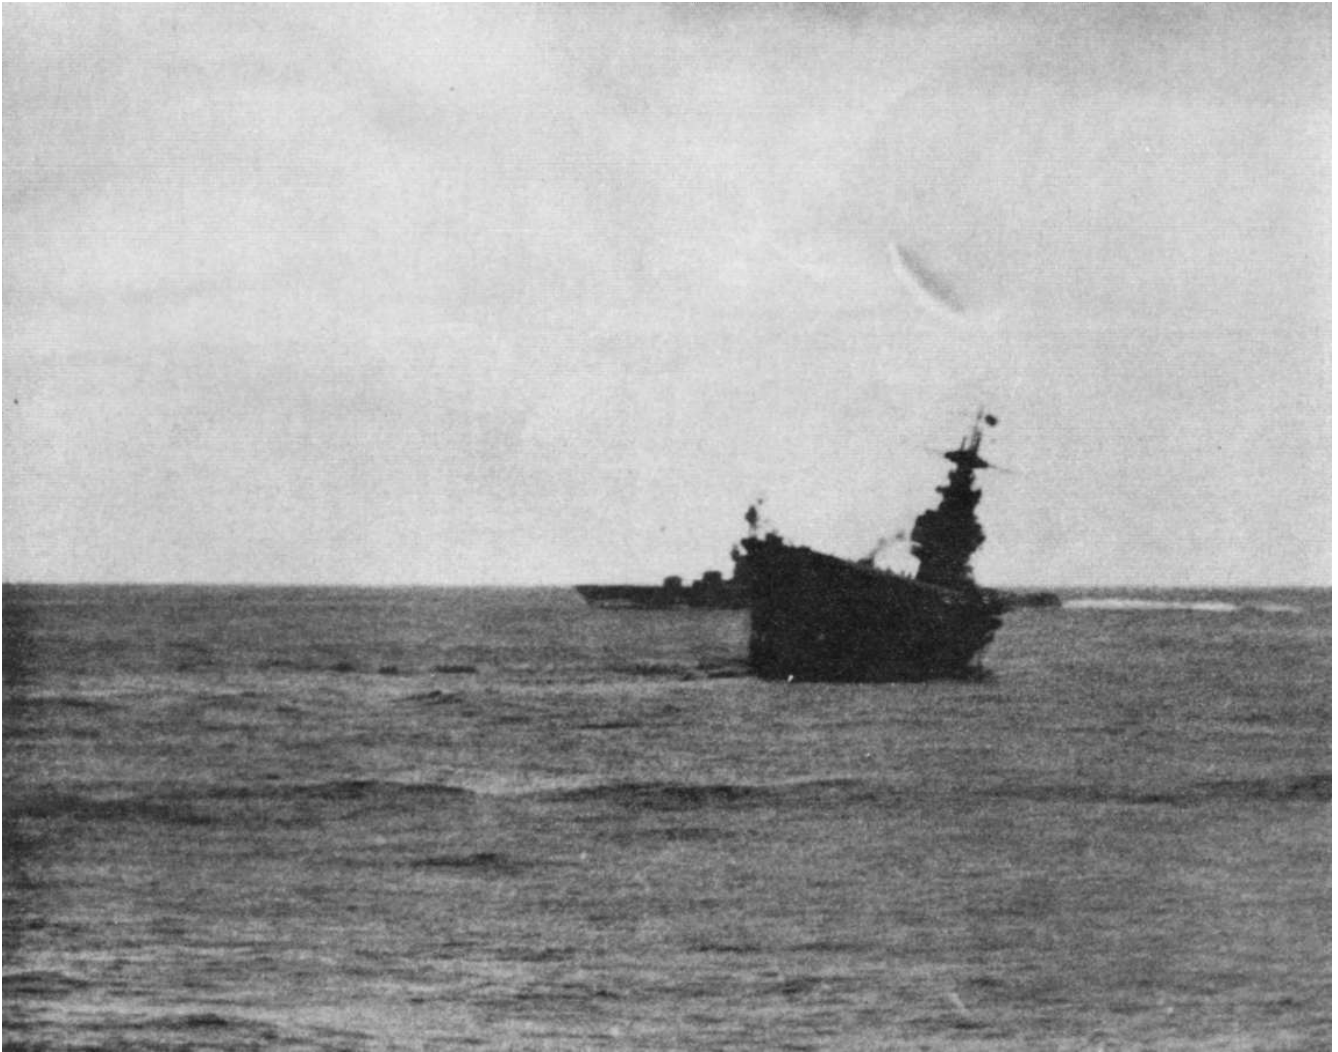
Photo 10: Stern view of U.S.S. HORNET during abandoning some time before last attack.

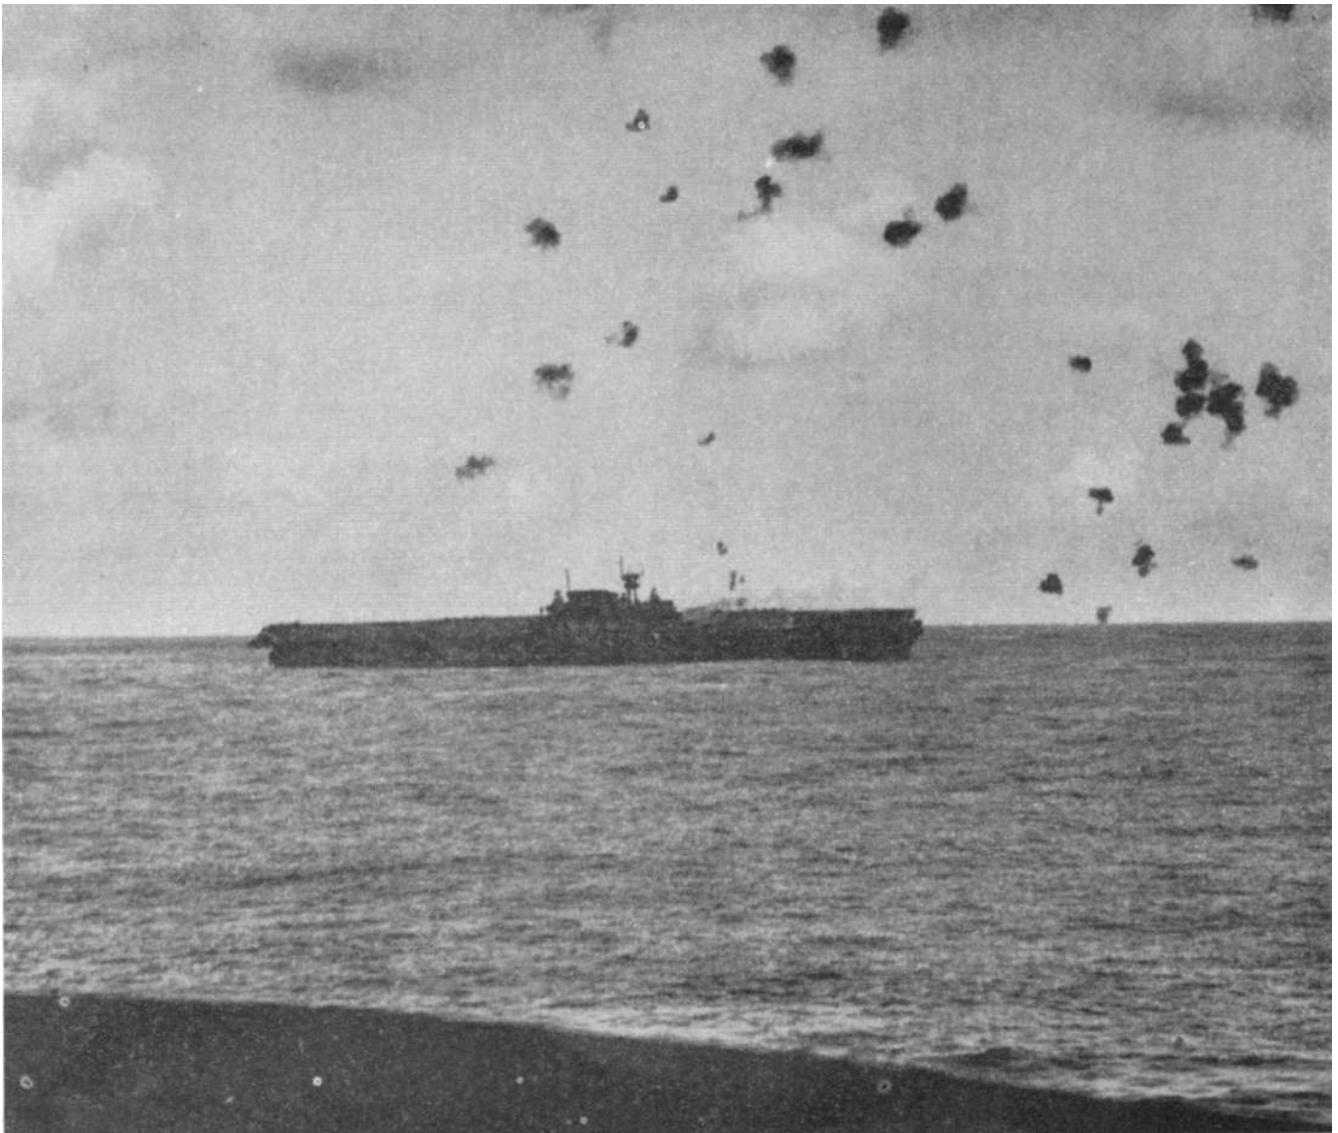
Photo 11: Starboard side view of U.S.S. HORNET after abandoning and during last attack. Note smoke from bomb hit amidships. Note trim by stern.

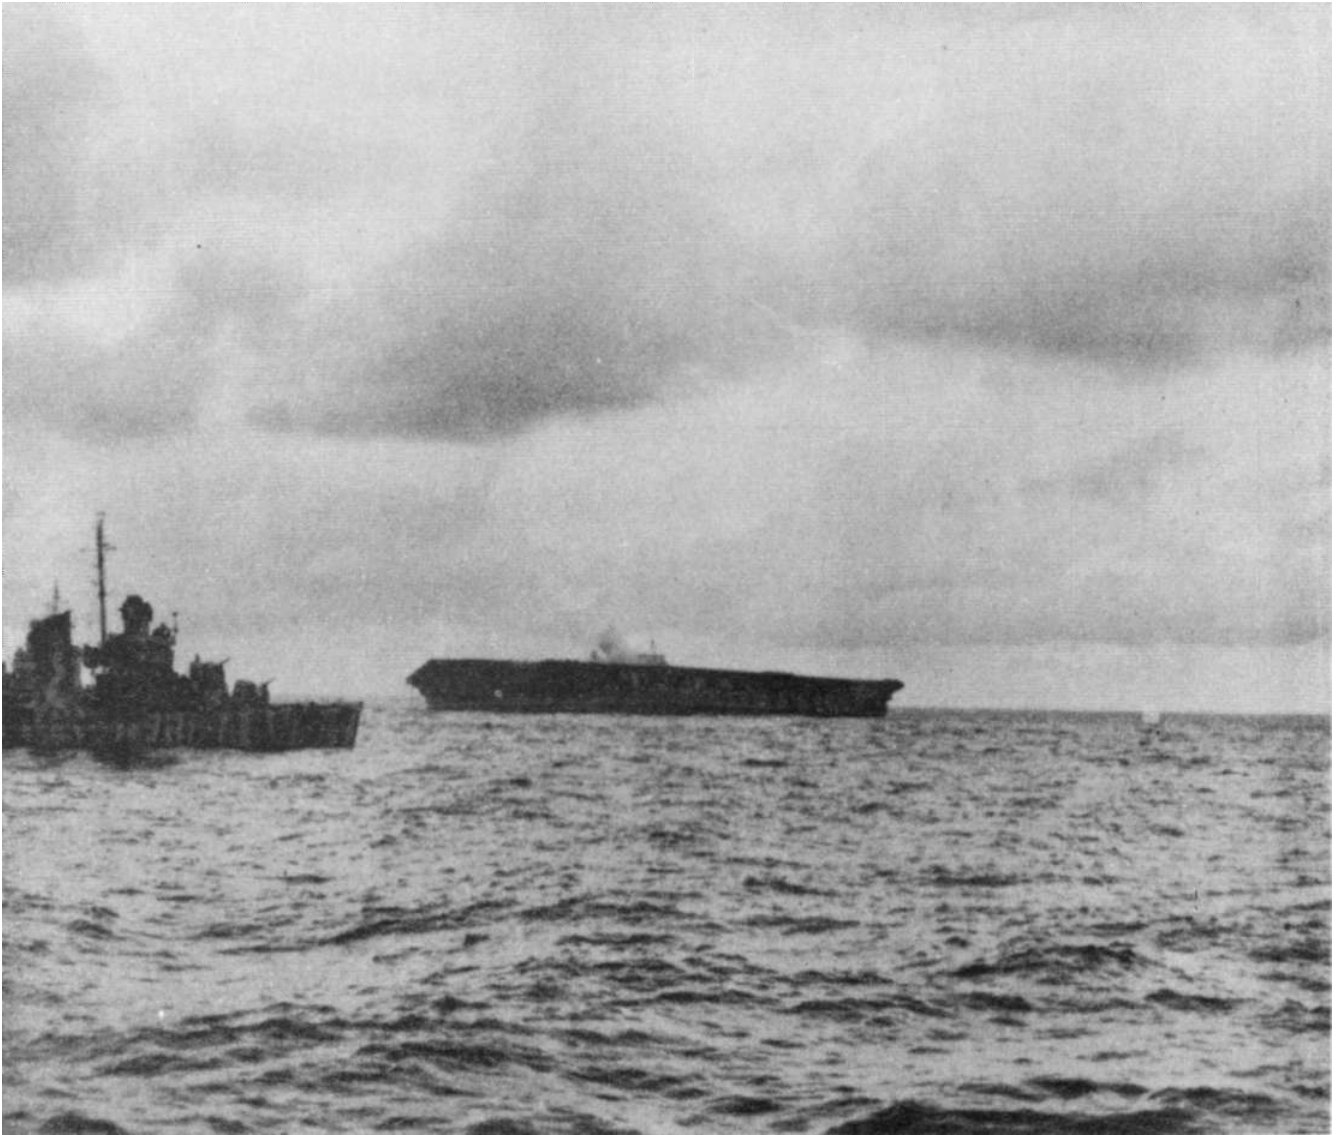
Photo 12: Port side view of U.S.S. HORNET after last attack. Smoke is from fire amidships due to last bomb hit.
