Analysis of photo NS02xx01

by David Buell

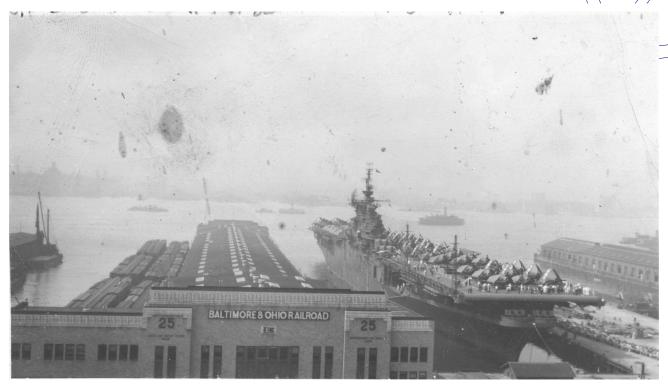
I think that this Mystery Photo #1 Carrier is definitely USS Lake Champlain CV 39. She was in the Atlantic at this time and is the most probable Carrier to fit this ID.

CV 39	Lake Champlain	Had "bloomers" on the 5" barrels, level gun tub top edges, shields on the 40mm, cross bars on her two forward radio masts, SP radar, the fuel line on starboard side matches other CV 39 photos.
CV 40	Tarawa	In the Atlantic, but never had shields on the 40mm mounts from commissioning. Had SX radar on foremast. Ship in photo does not. <i>Tarawa</i> did have bloomers at times.
CV 45	Valley Forge	In the Atlantic, but never had shields on the 40mm mounts from commissioning. Had SX radar on foremast from commissioning. Ship in photo does not. CV 45 did however have bloomers at times.
CV 47	Philippine Sea	In the Atlantic, but never had shields on the 40mm mounts from commissioning. Had no radar on mainmast in the forward position at this time.

I believe that the number on the bow is probably a "39" however blurry. It does seem to have the shape.

Therefore, using these points as processes of elimination, I strongly feel that the Mystery Photo #1 is USS Lake Champlain, CV 39.
