A VISUAL GUIDE TO THE U.S. FLEET SUBMARINES
PART ONE: GATO CLASS
(WITH A TAMBOR/GAR CLASS POSTSCRIPT)
1941-1945

DAVID L. JOHNSTON

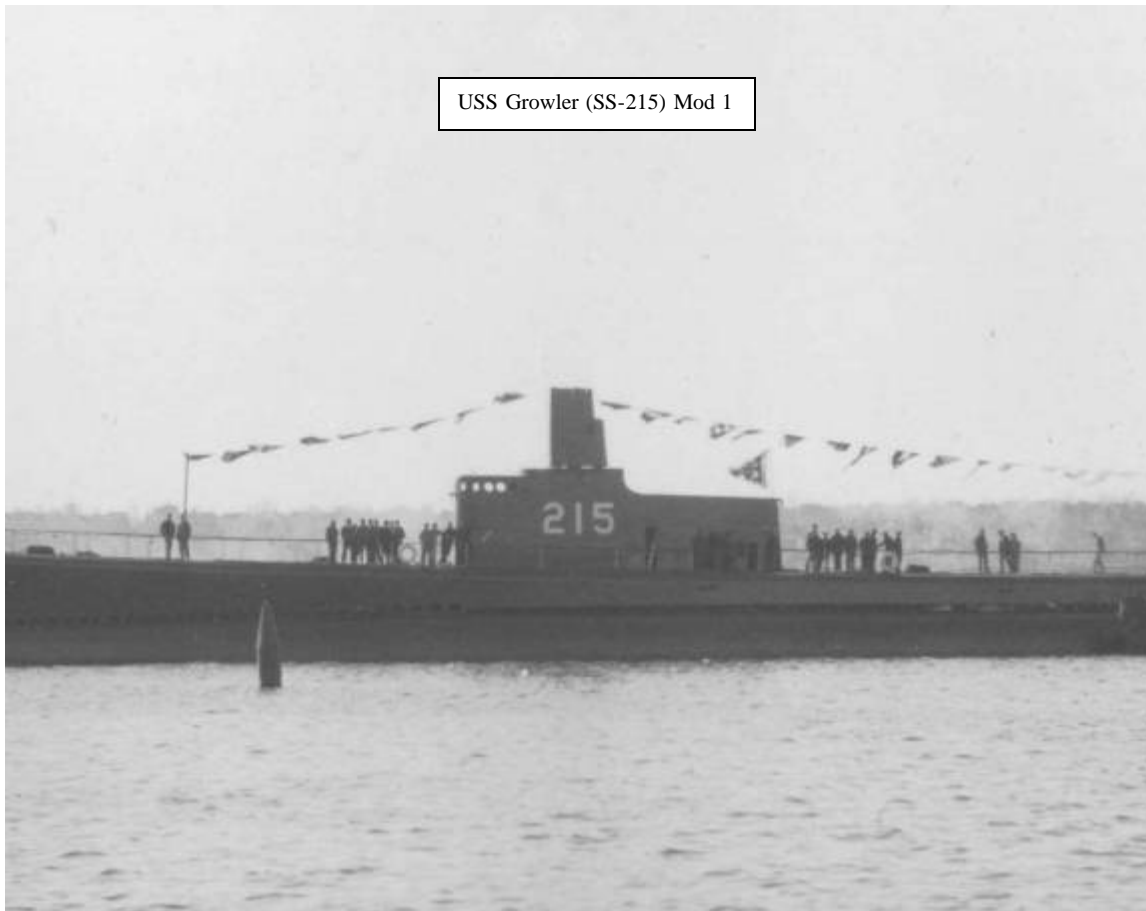
USS Growler (SS-215) Mod 1

This photo of *Growler*, taken on her launch day of 22 November 1941, shows the Mod 1 EB design. At the forward upper end are a series of circular windows that let into a sheltered area for the bridge crew during surface transits, a much-appreciated feature during rough weather. It also housed an auxiliary steering station for the helmsman. Directly abaft, and raised slightly higher (just above the number 2) is the open-air bridge which was protected from strong

ocean breezes along its forward edge by a wind venturi. The vertical stepped rectangle above the 15 is the shears that house the periscopes. The rest of the fairwater curves gracefully downward for a short distance directly aft of the shears, then heads aft in a level fashion for quite a distance then straight down to the main deck. The fairwater aft of the shears actually covered two decks. The lower one housed the large main air induction valve, which allowed the prodigious amounts of air that was used by the diesels to be sucked into the engine rooms. Just aft of the number 5 is a rectangular cutout that allowed access to this lower fairwater deck. On the aft end of the conning tower was a watertight door that opened into this void area between the conning tower and the main induction valve. In a battle surface action, the deck gun crew would exit the interior of the boat through this watertight door; walk through this cutout in the fairwater and onto the main deck. They would then head aft to the normal position of the 3-inch/50 cal deck gun (not yet mounted when this photo was taken). The upper deck started just above this cutout, with the fairwater providing roughly a chest high safety rail. This area was known as the cigarette deck, as it was the area that crewmen could go to catch a smoke while the boat was surfaced. Mounted here but often obscured by the fairwater rail was a .50 caliber water-cooled machine gun, the only anti-aircraft gun in the original design.

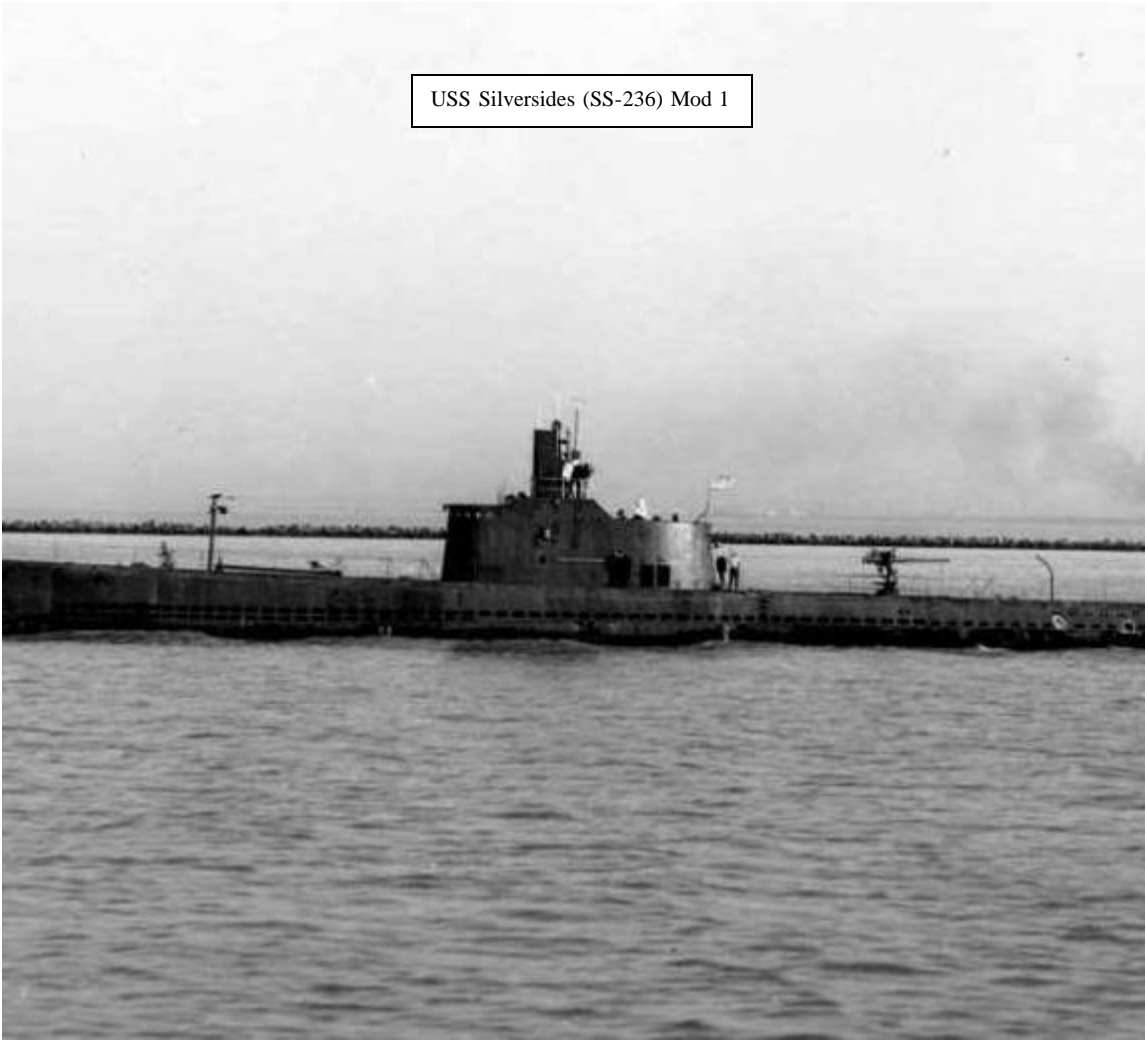
USS Silversides (SS-236) Mod 1

This photo shows *Silversides* on 2 February 1942 and is indicative of the Mod 1 Government design. The main visual difference is in how the lookout platform around the shears is extended aft, providing an extra perch. The cigarette deck fairwater rail angles downward from the shears at about a 45-degree angle, as opposed to curving down on the EB design. One of the first changes made to the boats during the war was the addition of the SD series air search radar. The antennae mast was added to the shears and extended upward from the step perch just aft of the periscopes.

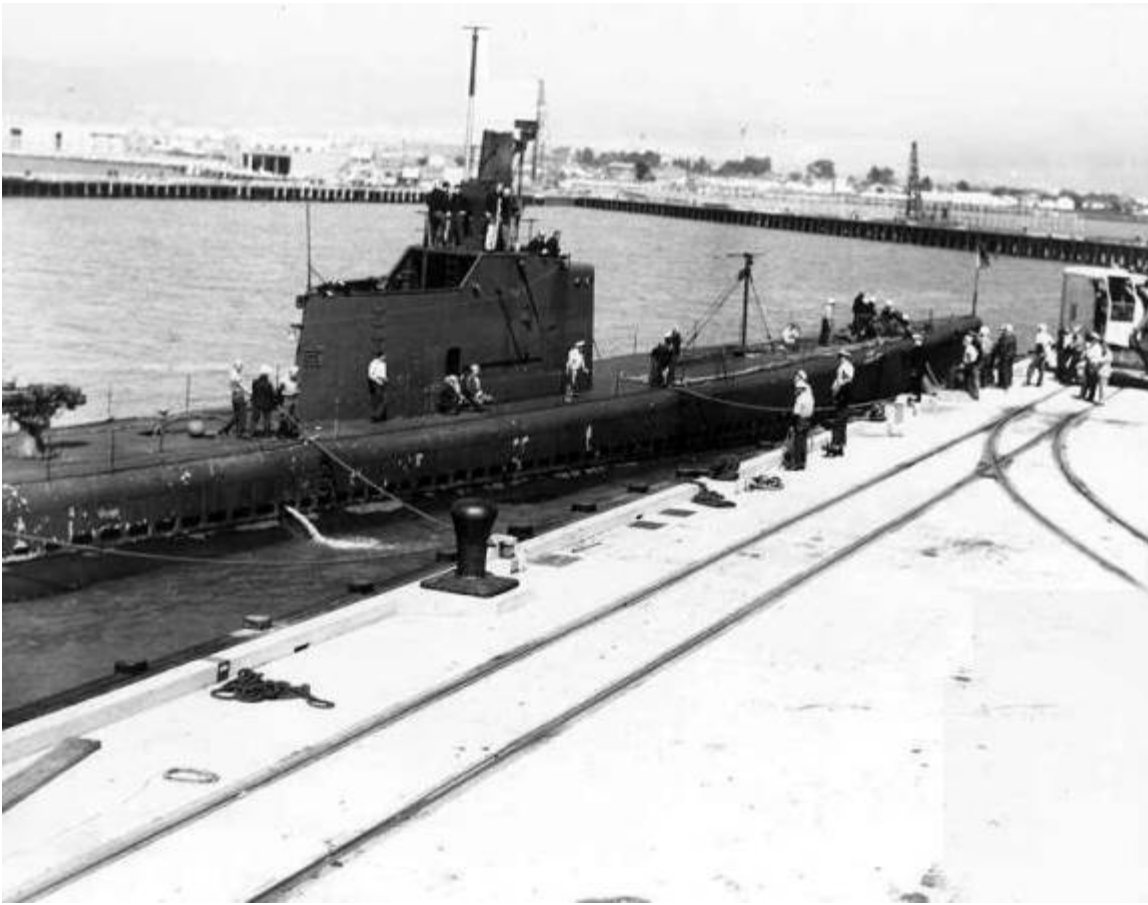
USS Wahoo (SS-238) Mod 1

This photo of the famous *Wahoo* on 1 August 1942 shows the radar arrangement. The T-shaped antenna for the SD is shown on its mast aft of the periscopes. In the late spring of '42 the SJ series surface search radar began to be installed on the boats and its normal position was on a mast forward of the shears, extending down through the bridge and into the conning tower. Angle brackets fixed the mast to the forward edge of the shears. An SJ set on a Mod 1 boat was actually pretty rare, as most of the boats received the Mod 2 prior to getting their first SJ.

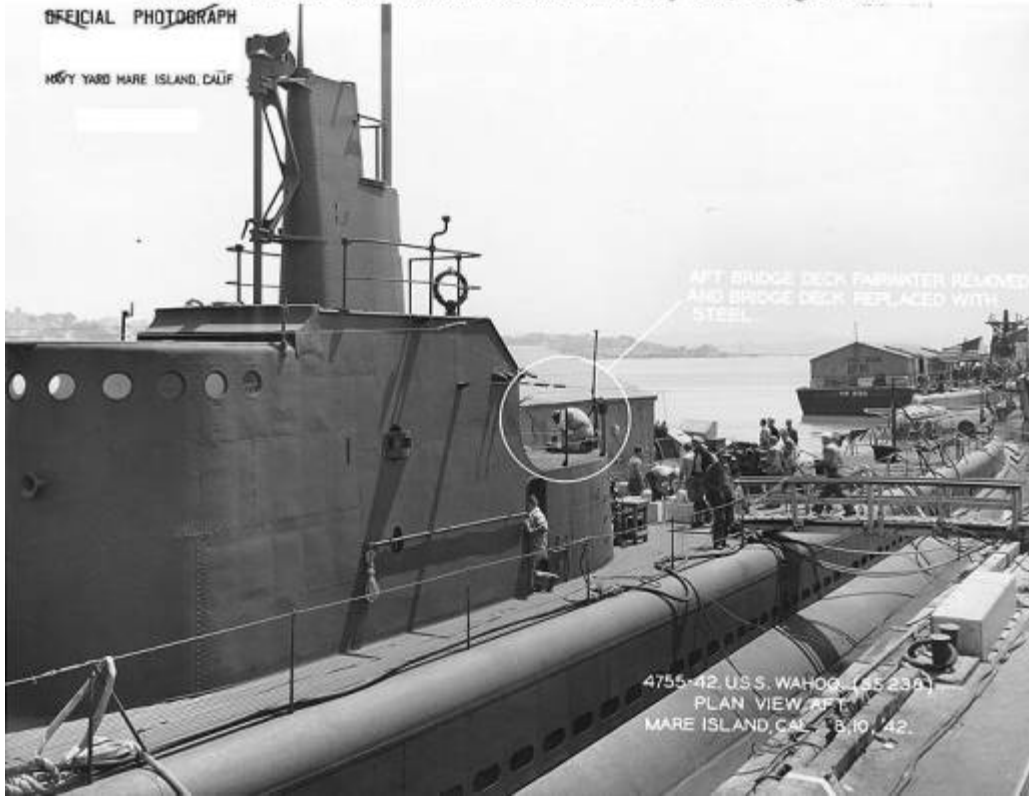
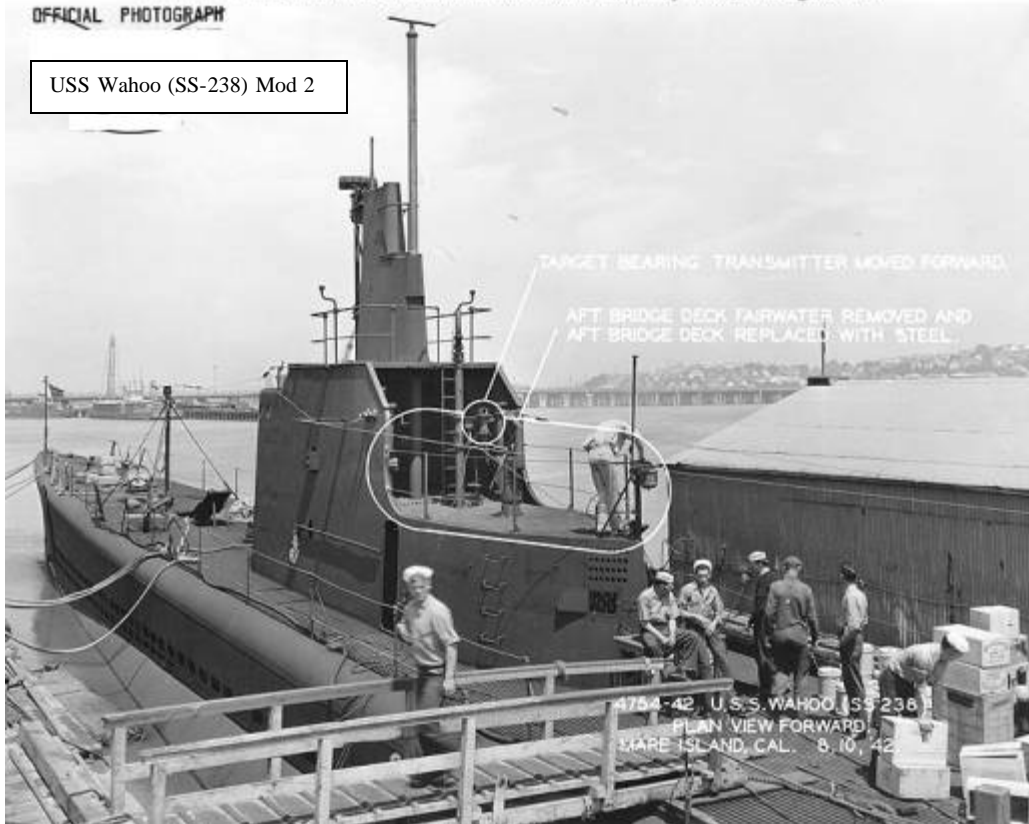
USS Wahoo (SS-238) Mod 2

These two photos show *Wahoo* at Mare Island on 10 August 1942. These are excellent shots of the early Mod 2 configuration. The periscope shears retained the plating and the SJ mast mounts are clearly visible. The cut down started right where the down angled part of the fairwater ended. On the EB boats this part would have been curved.

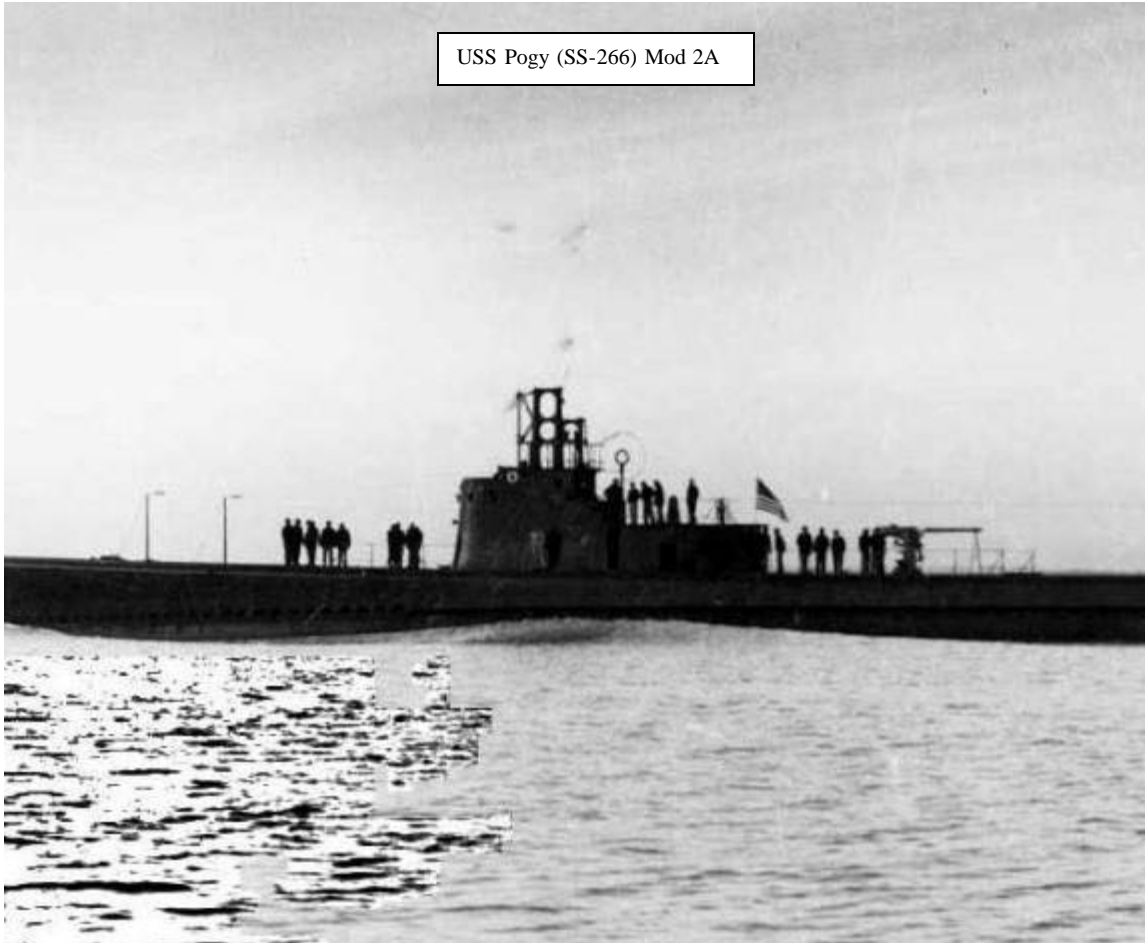
USS Pogy (SS-266) Mod 2A

As 1942 wore on, a further attempt was made to lessen the silhouette. It was the simple expedient of removing the plating around the periscope shears, giving them a skeletal look. The General Board authorized this change on 26 September 1942. The photo below shows *Pogy* on builder's trials on Lake Michigan in the fall of 1942 with the shears unplated. *Pogy* is an interesting boat in that she went through four major fairwater modifications during her lifetime. She was launched by Manitowoc Shipbuilding (a follow-on yard that built boats to EB plans) on 23 June 1942 with a Mod 1 fairwater. During her fitting out phase she was converted to a Mod 2A and ran sea trials in this configuration. Prior to commissioning, she was converted to a Mod 3 and in 1944 she received a Mod 4 (see below).

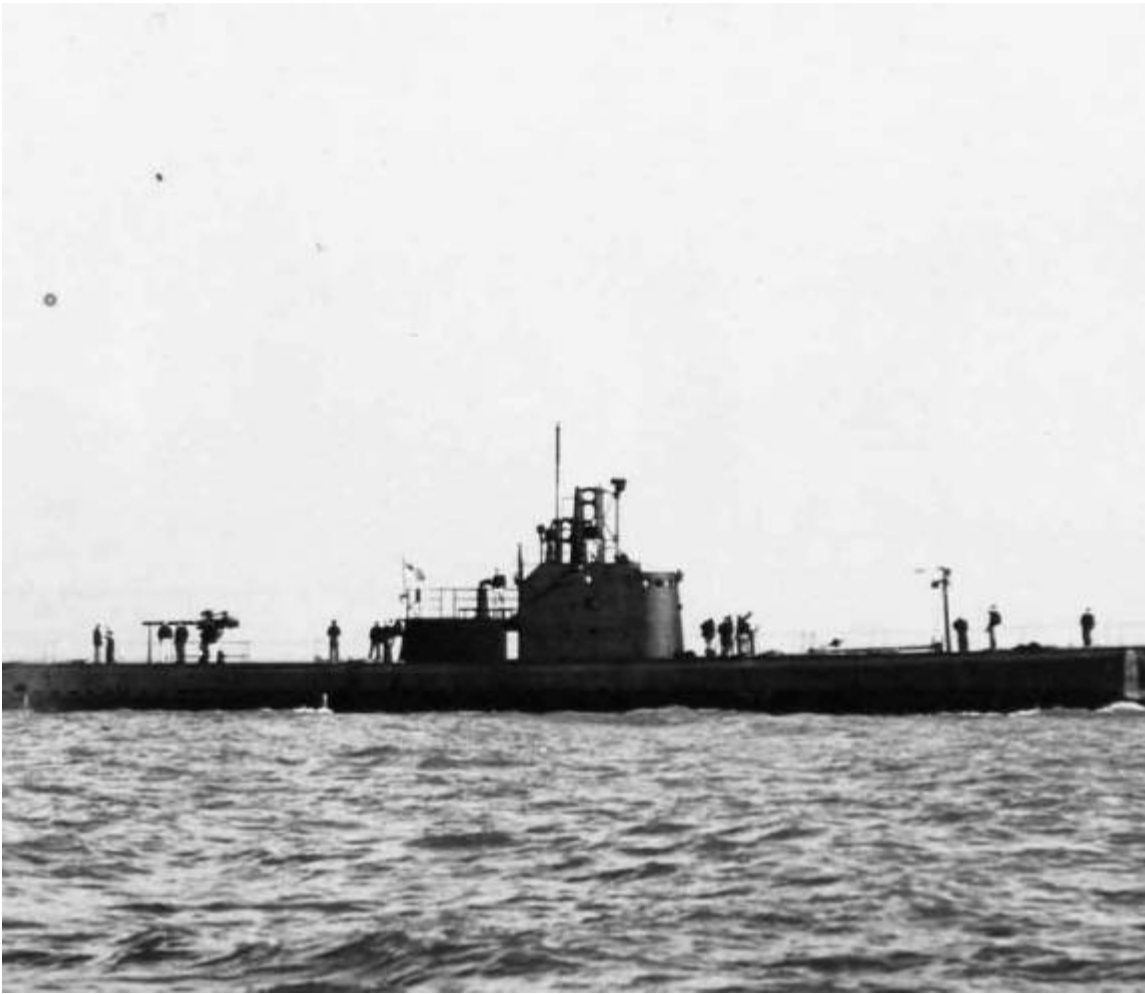
USS Tunny (SS-282) Mod 2A with thick

This following 6 November 1942 photo of a Mod 2A *Tunny* shows a variation given to some of the *Gatos*. The plating on the shears provided a smooth hydrodynamic flow around the periscopes, but it also added a level of structural stiffening. Once the plating was removed reports came in of vibration of the scopes at certain speeds and sea states. An attempt was made to beef up the shears to eliminate this vibration, although it doesn't appear to have been applied to all of the *Gatos*, as some of them finished the war without this change. For reference purposes, I refer to this as the "thick scope" with the other as the "thin scope" This photo also shows one of the earliest mounts for a 20 mm AA gun on the cigarette deck, replacing the .50 cal. It had a heavy enclosed base mount that proved to be a bit cumbersome. It was eventually replaced by lighter, open mount. In both this and the *Pogy* photo the radar installations forward and aft of the periscope shears can be clearly seen.

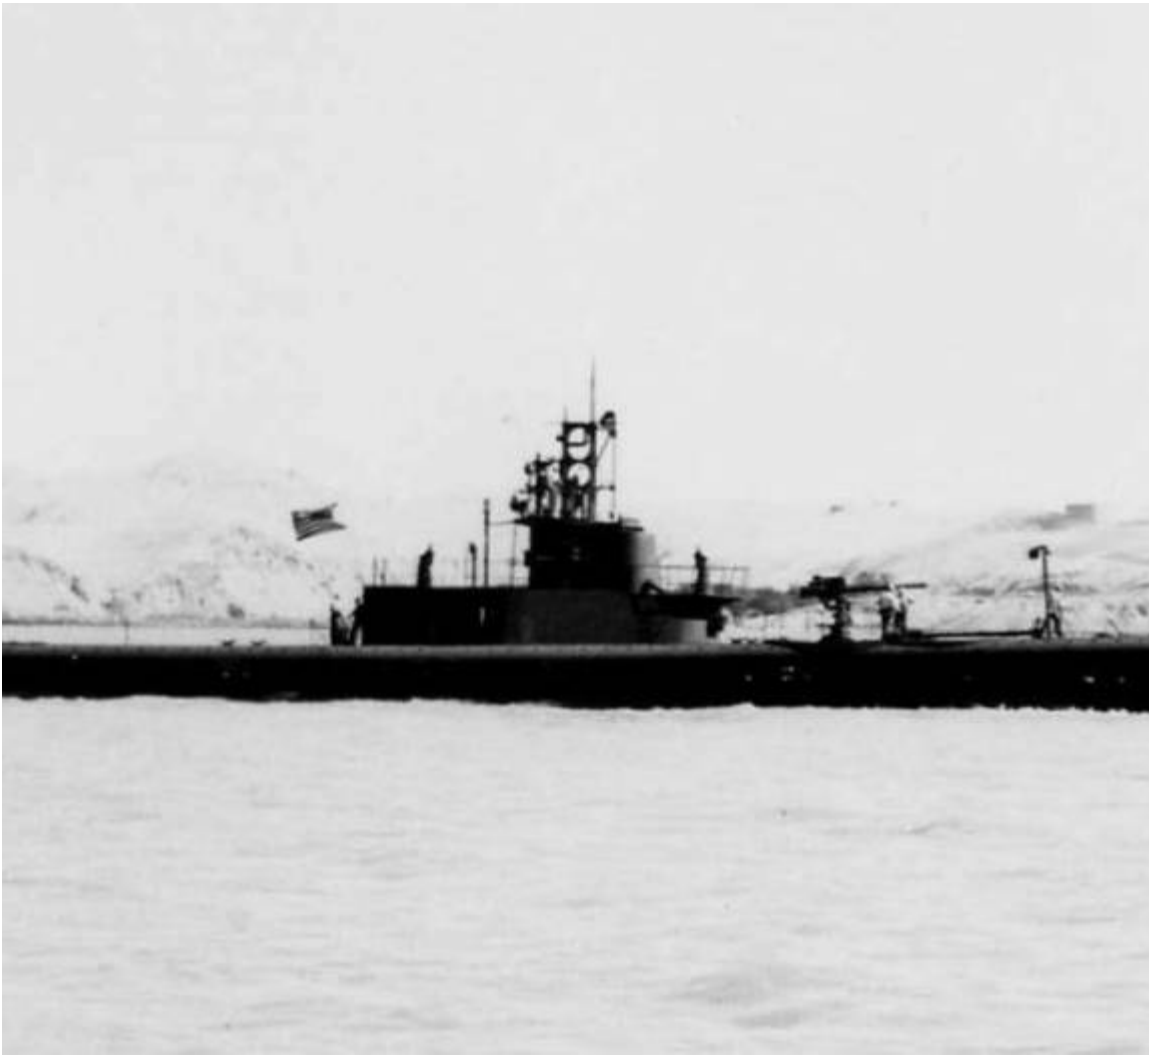
USS Gato (SS-212) Mod 3

This view of the lead boat *Gato* on 6 August 1943 shows an early Mod 3 configuration. At this point in her service, *Gato* still had the thin scopes and the earlier solid base for the 20 mm guns. Corresponding with the Mod 3 changes, the deck gun was moved to the forward position. This provided some tactical advantages as you could fire at the target while approaching, as opposed to swinging broadside or moving away to bring the gun to bear. At the time that this shift was made, large numbers of the more powerful 4-inch/50 caliber gun became available and these were quickly fitted onto the boats. These guns came mostly from decommissioned S-boats and their popularity amongst the boat crews did lead to some short-term shortages, as evidenced by the fact that *Gato* is still carrying the 3-inch/50 caliber gun in this photo. It was actually pretty rare to see this gun in the forward spot.

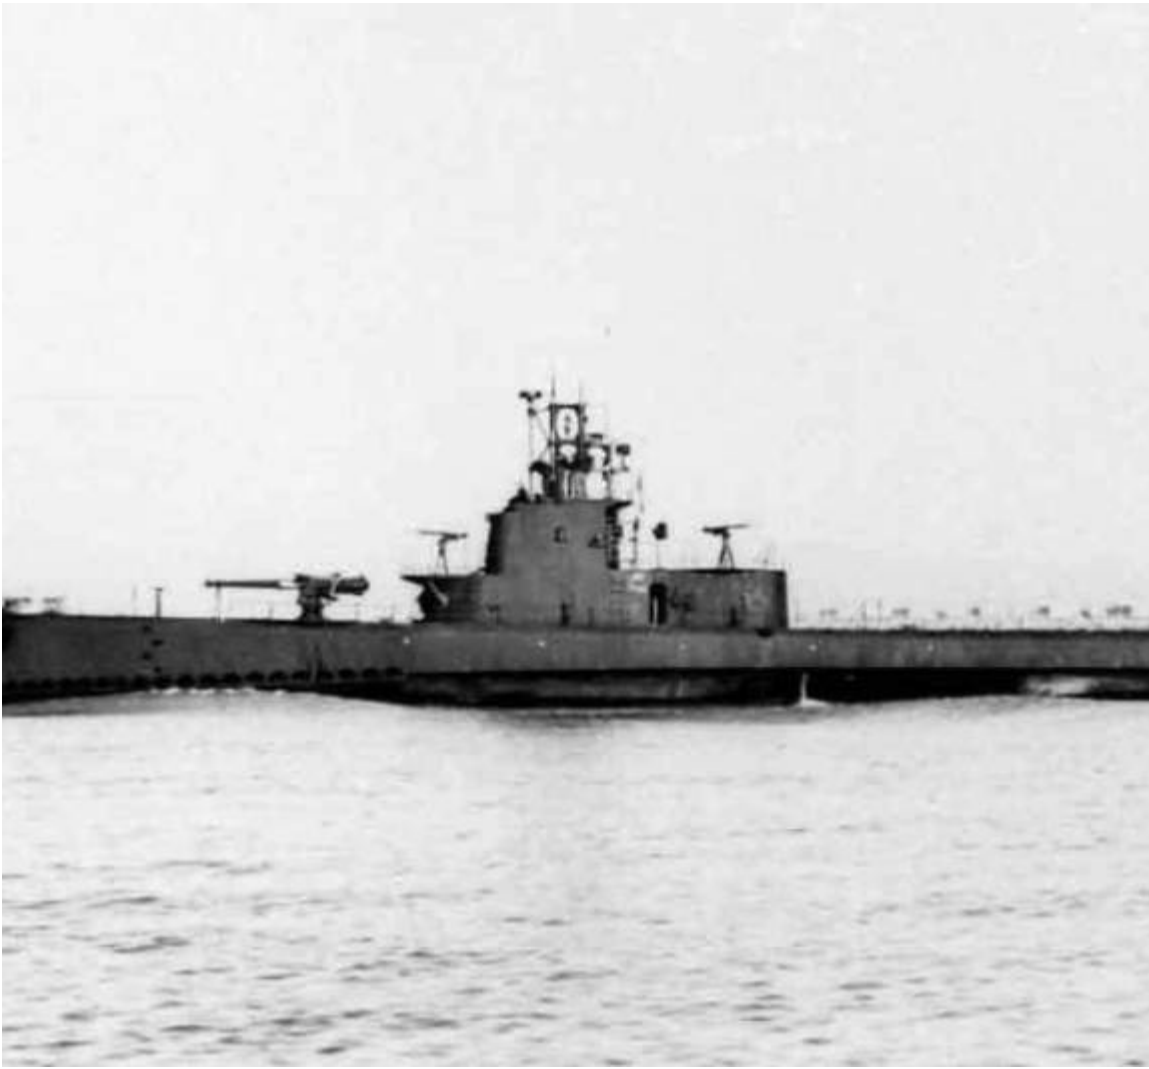
USS Jack (SS-259) Mod 3

This 17 December 1943 shot of *Jack* illustrates the classic Mod 3. With the ammo magazine located under the galley and crews mess aft of the control room, the long passing chain needed to get ammo up to the gun in the forward spot resulted in lower than desired firing rates. To alleviate this, watertight ready service ammo lockers were placed in the fairwater under the forward gun platform and these are visible in both of these photos. *Jack* also sports the newer, lighter 20 mm gun mounts. Note also how the fairwater has been cut away directly under the SD radar mast, leaving a short extension for an aft lookout platform and giving the visual impression of a shortened bridge.

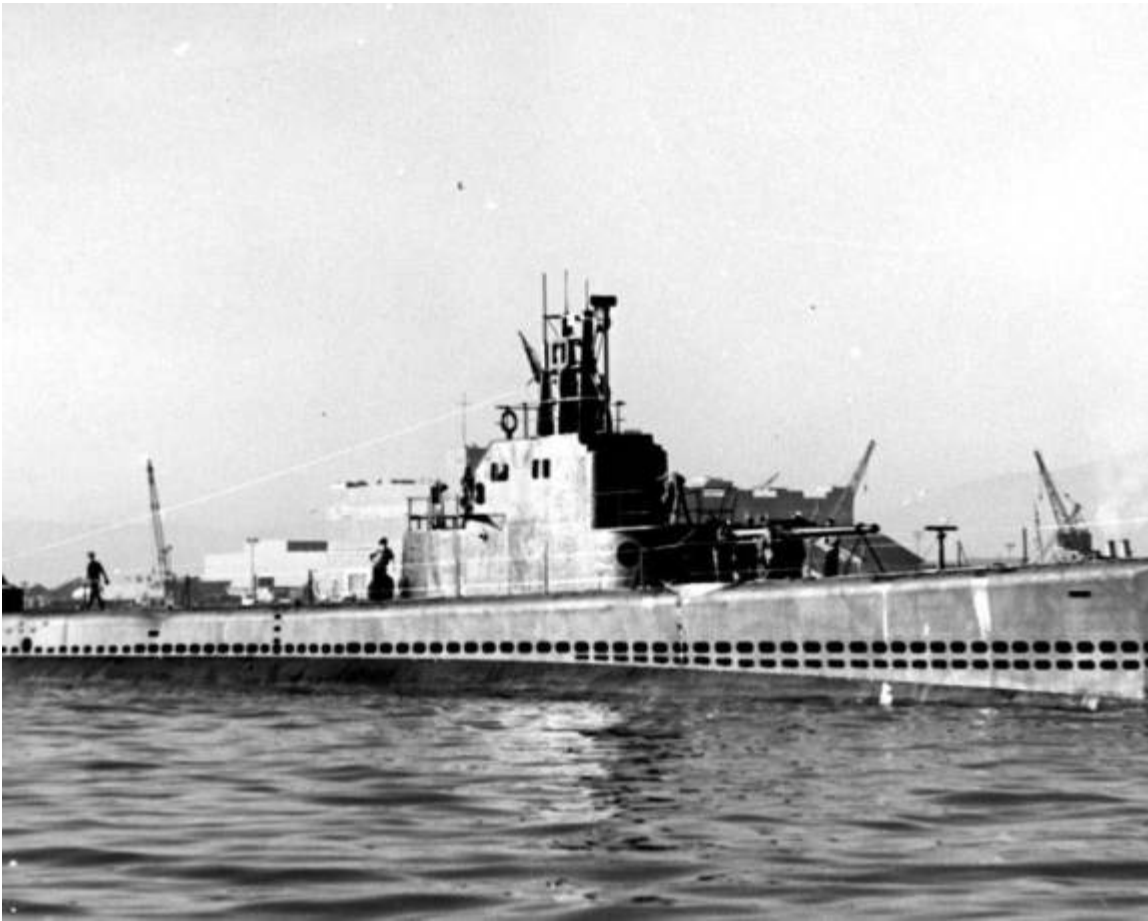
USS Herring (SS-233) Mod 3 Long Bridge

A variation on the Mod 3 is what I call the Mod 3 Long Bridge. Whereas the Mod 3 had the aft part of the bridge fairwater cut away under the SD radar mast, at least five boats (*Grouper*, *Herring*, *Scamp*, *Scorpion*, and *Snook*) did not have this done, resulting in this variation.

Four of the five boats were built at Portsmouth and there is some anecdotal evidence to suggest that this was a Mod 3 that was done while the boat was still under construction. The extended portion may have been cut away once the boat arrived in theater.

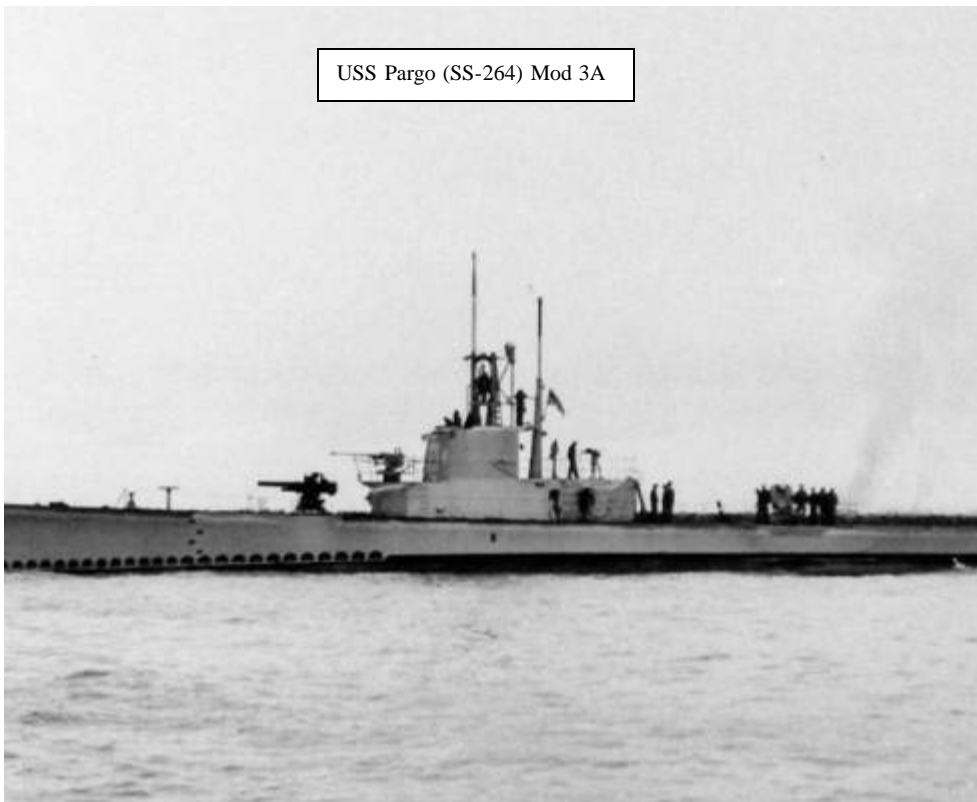
The crowding of the conning tower led to other changes. The SD radar mast was moved aft and out of the conning tower altogether, with a new mast for it installed on the cigarette deck. This allowed the SJ radar mast to be moved to a more optimal position aft of the shears, getting it out of the way on the bridge. This created the Mod 3A, with this mod first appearing in late 1944. The 28 May 1945 photo of *Pargo* below shows one of the many variations of gun armament with the new and much more powerful 5-inch/25 caliber gun in the forward position (unusual, the 5 incher usually was sited aft), a 40 mm single mount on the forward gun deck, and a 20 mm on the cigarette deck.

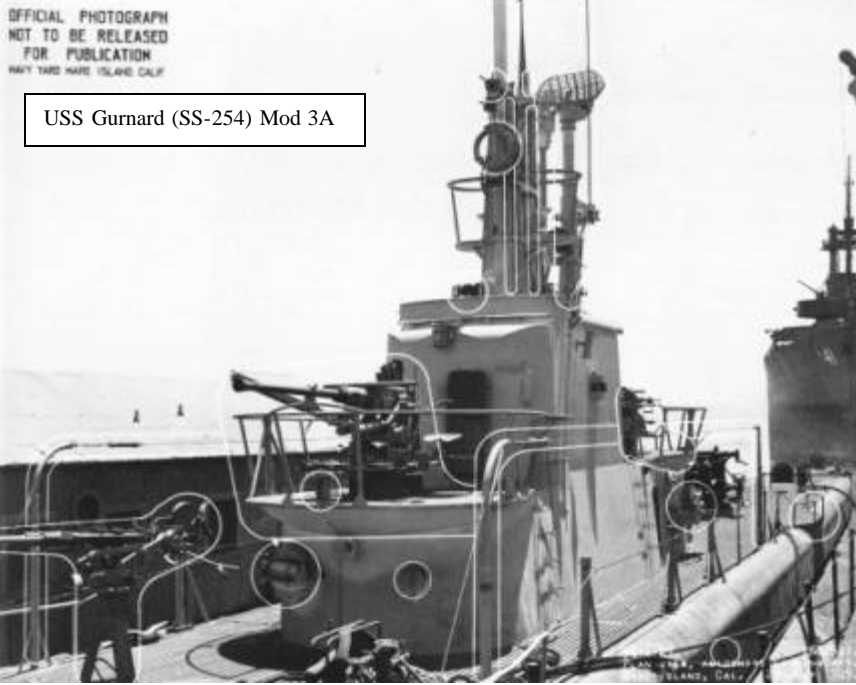
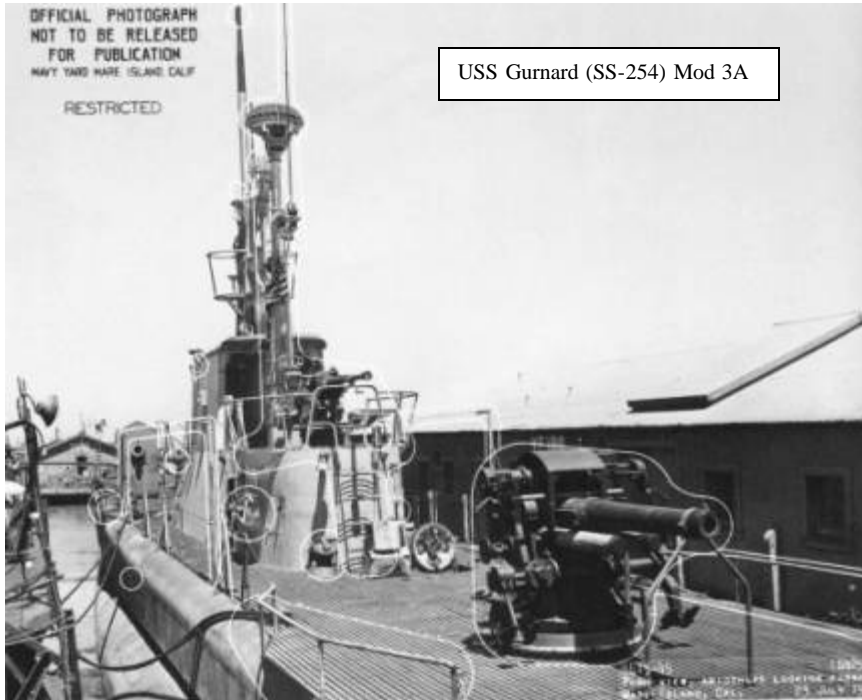
Towards the end of the war, the much more capable SV radar with its large wire mesh antenna replaced the SD radar antenna on the same mast. Many other detail changes were made as well. Additional ammo lockers, ladders down from the cigarette deck, rearranged lookout perches, and small spindle mounts for .50 cal machine guns appeared in a bewildering number of arrangements. Note also in the 23 July 1945 photos of *Gurnard* below that she has been up gunned with the addition of 40 mm single mounts on the forward and cigarette deck mounts and a 20 mm mount on the forward main deck position, with the 5-inch/25 sited aft. One other minor mod common at this time was the addition of a non-watertight door through the bridge fairwater, leading to the forward gun deck. This improved the access to the forward guns. Many of the *Gato* class boats finished the war with a Mod 3A fairwater.

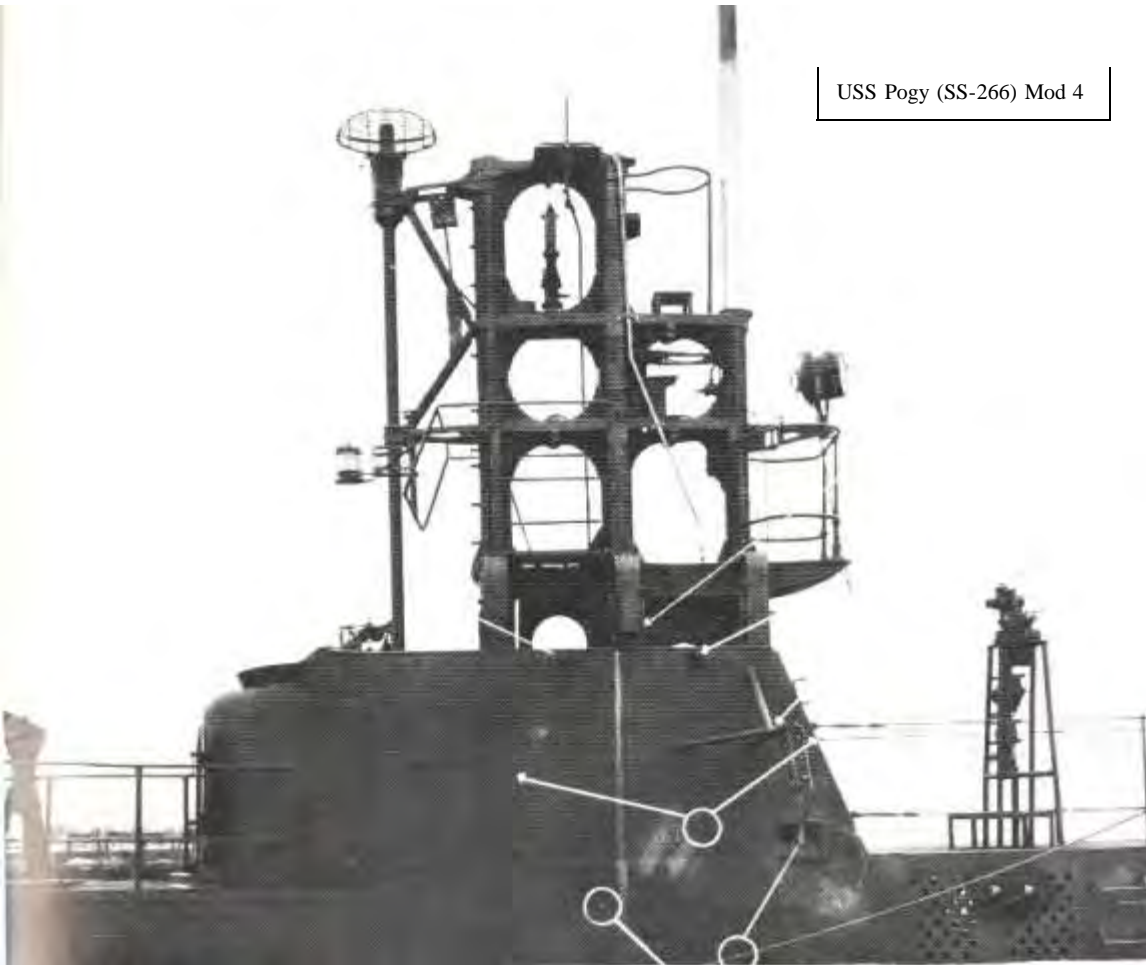
USS Pogy (SS-266) Mod 4

This shot is of the oft-modified *Pogy*, taken in August 1944 shows the typical Mod 4. Note the skeletal look of the thin scopes and the prominent mount for a TBT (Target Bearing Transmitter) on the cigarette deck. The SJ radar mast is still mounted forward (the late war improved SJ-1 with the bigger antenna), and the SD mast immediately aft on the shears, identical to the Mod 3 arrangement. Removing the fairwater plating and exposing the ribs gave this mod a distinctive look and is what gave rise to the *Gato* class being called the “covered wagon” boats.

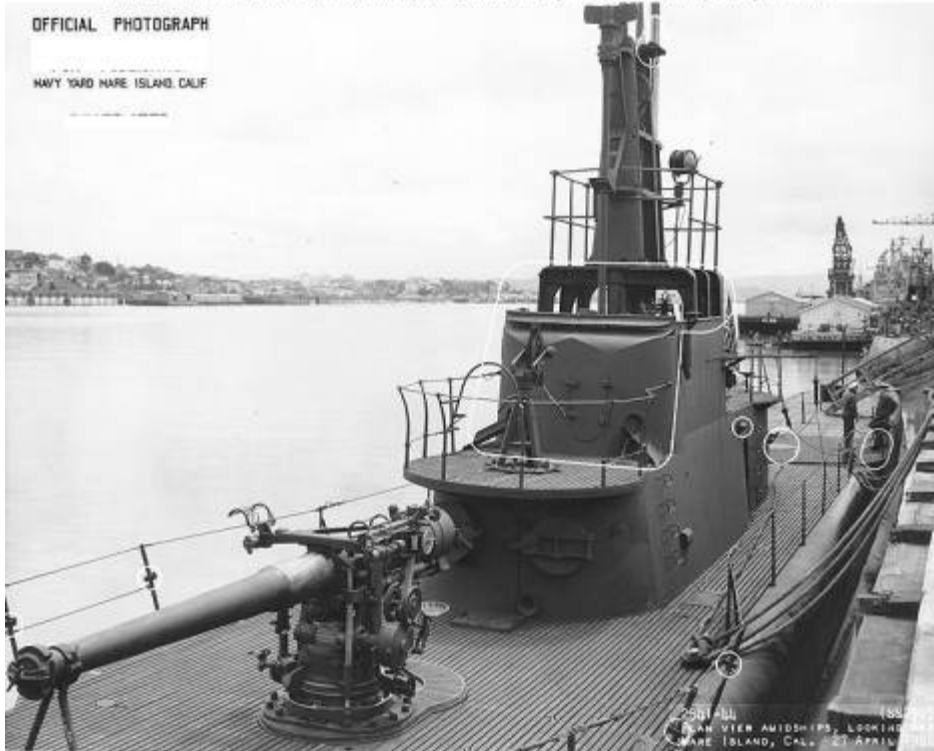
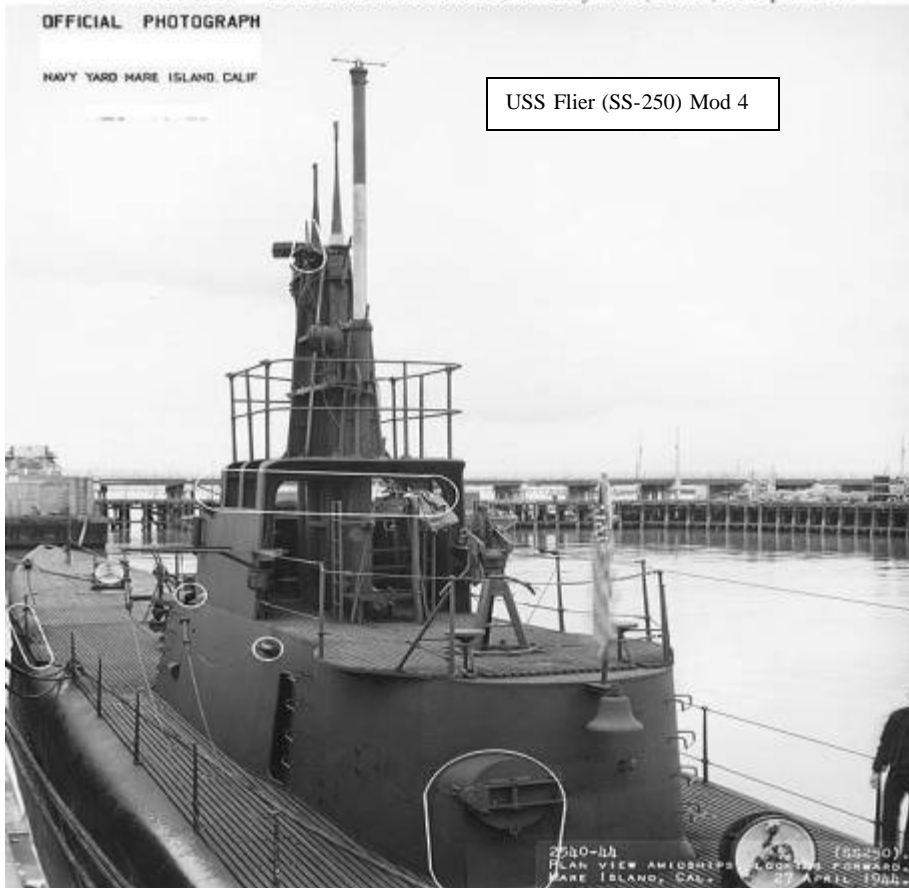
USS Flier (SS-250) Mod 4

These two 27 April 1944 photos of *Flier* are a good representation of a Mod 4. The covered wagon ribs are very prominent. Her armament at this time was a 20 mm on an open mount on the forward gun deck and cigarette deck, and a 4-inch/50 in the forward main deck position. Two ammunition-passing scuttles have been cut into the bridge fairwater, allowing the quick passing of 4" ammo from the conning tower to the forward gun crew. These photos also show *Flier* with the original SJ small dish radar.

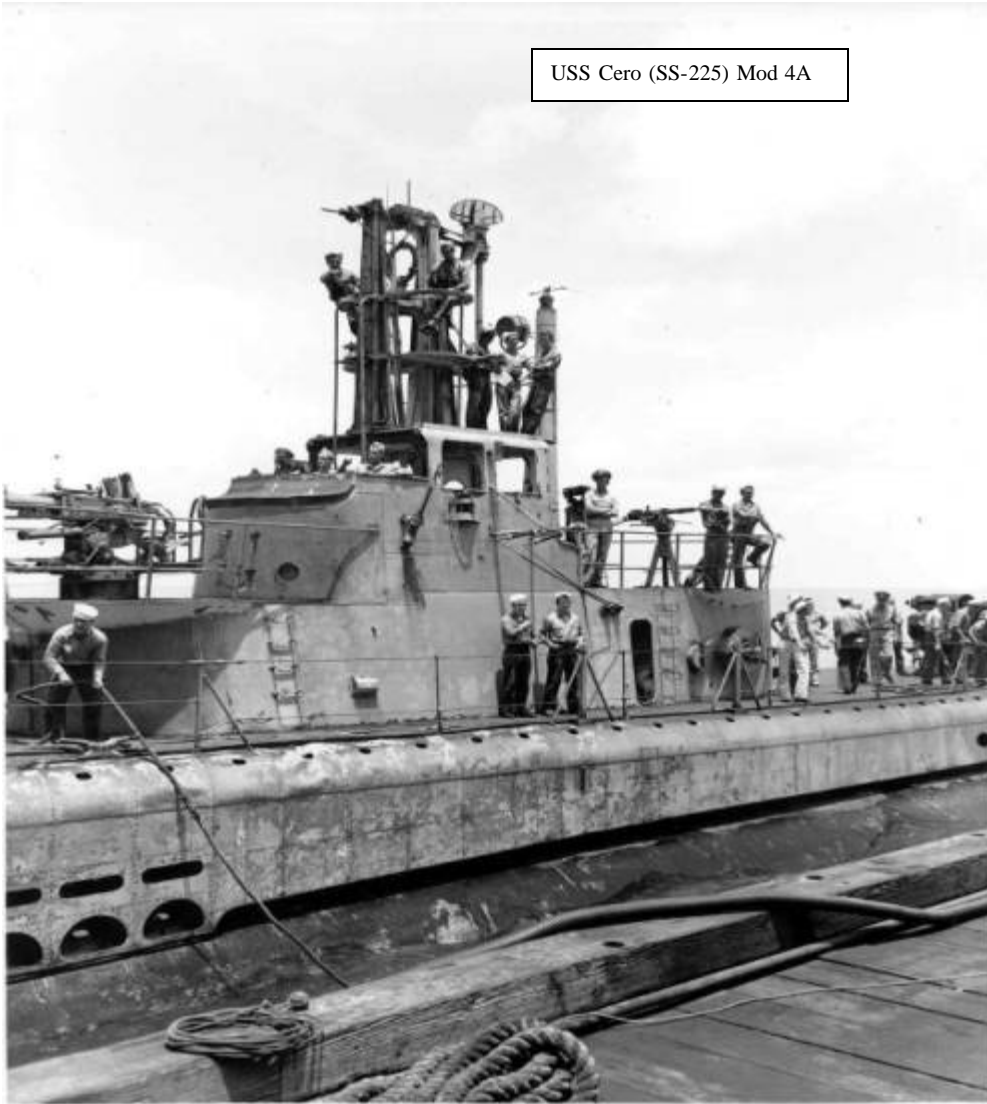
USS Cero (SS-225) Mod 4A

Running virtually parallel with the Mod 3A, the 4A was very similar, but with the low bridge and the covered wagon ribs of the Mod 4. This was the last major modification of the *Gato* fairwaters during the war. The photos of *Cero*, *Dace*, and the museum boat *Cod* all show the classic Mod 4A. All three show the late war SJ-1 radar, but none had received the new SV radar to replace the SD when these photos were taken. The SV was just coming into service when the war ended and availability was limited. Between the thick scopes, the circular radio direction finder (DF) loop can be seen. There are numerous minor detail differences between the three boats. The smaller changes were easily done by tenders between patrols and whether they were accomplished was usually left to the preferences of the boat's commanding officer.

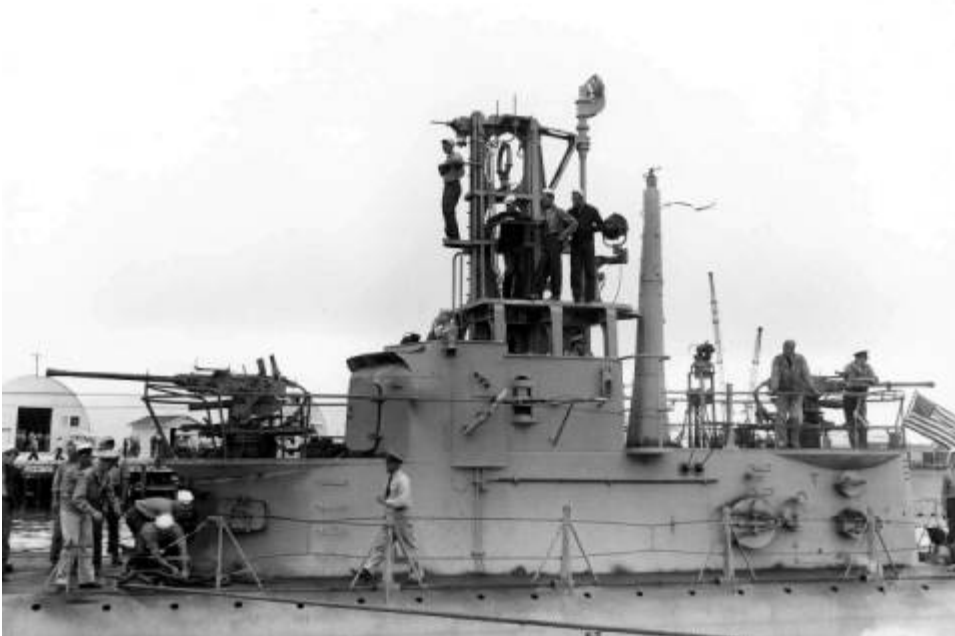
USS Dace (SS-247) Mod 4A

In the photo of the *Dace* below, note the difference in the wind venturi along the front edge of the bridge. The purpose of this device was to channel wind up and over the heads of the bridge crew. Having looked at *a lot* of photos during the course of research for this article, I found an amazing variety of modifications for this venturi. There was seemingly no rhyme or reason to the design, and apparently they reflected a lot of different ideas on how to mitigate the wind problem. This experimentation with the venturi took place throughout the war and was not specific to any particular *Gato* fairwater Mod, or even to the *Gato* class itself.

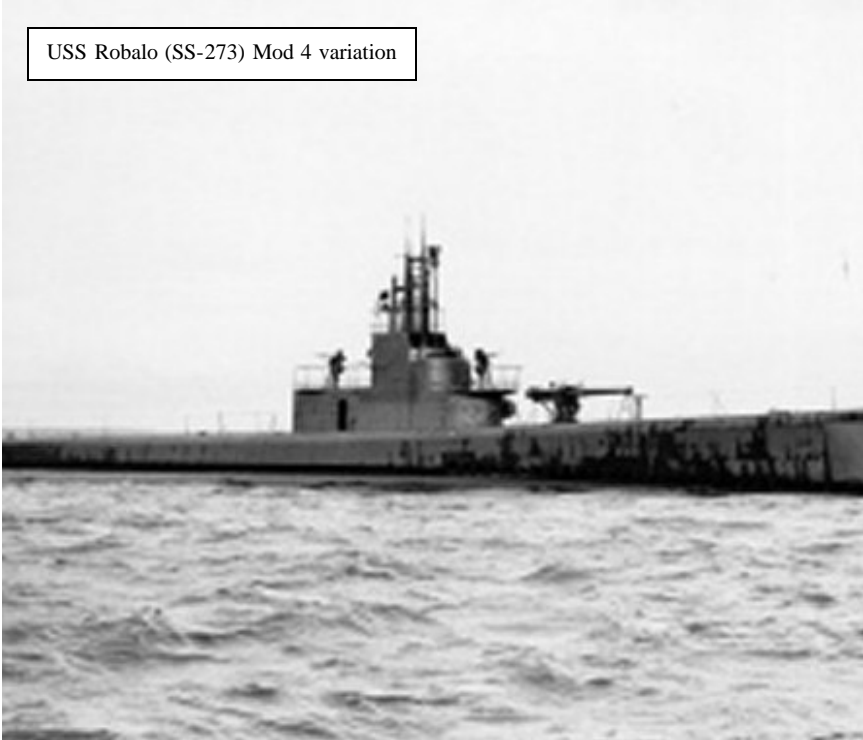
USS Robalo (SS-273) Mod 4 variation

Robalo and *Gabilan* both sported at one time a Mod 4, but with the covered wagon ribs still plated. *Robalo* was launched with a Mod 3 and was converted to this version before her sea trials began.

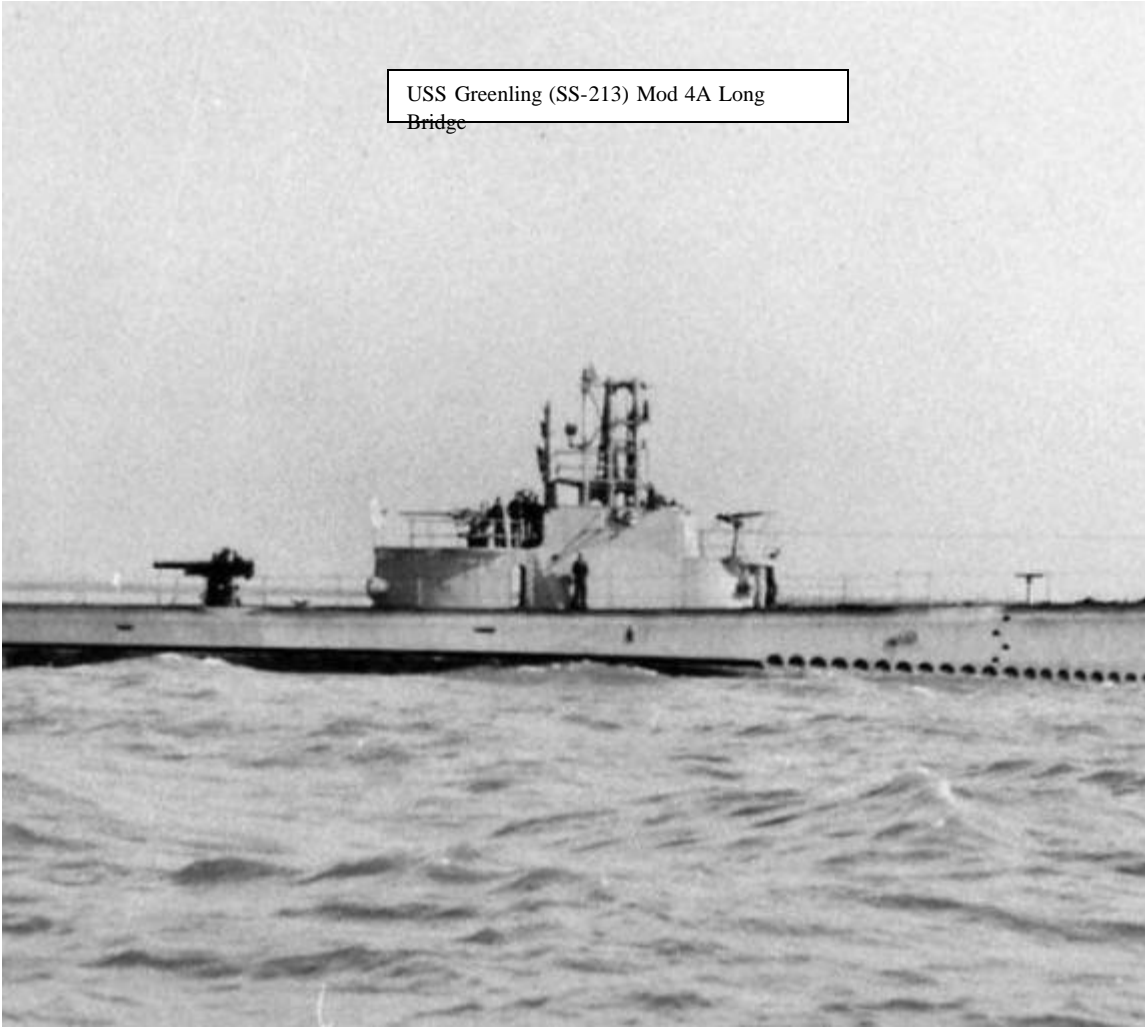
USS Greenling (SS-213) Mod 4A Long
Bridge

Greenling is shown in the photo below on 3 May 1945 with a Mod 4A, but with a long bridge fairwater. This is the only boat with a Mod 4 or 4A to have the long bridge variation.
