A VISUAL GUIDE TO THE U.S. FLEET SUBMARINES
PART ONE: GATO CLASS
(WITH A TAMBOR/GAR CLASS POSTSCRIPT)
1941-1945

DAVID L. JOHNSTON

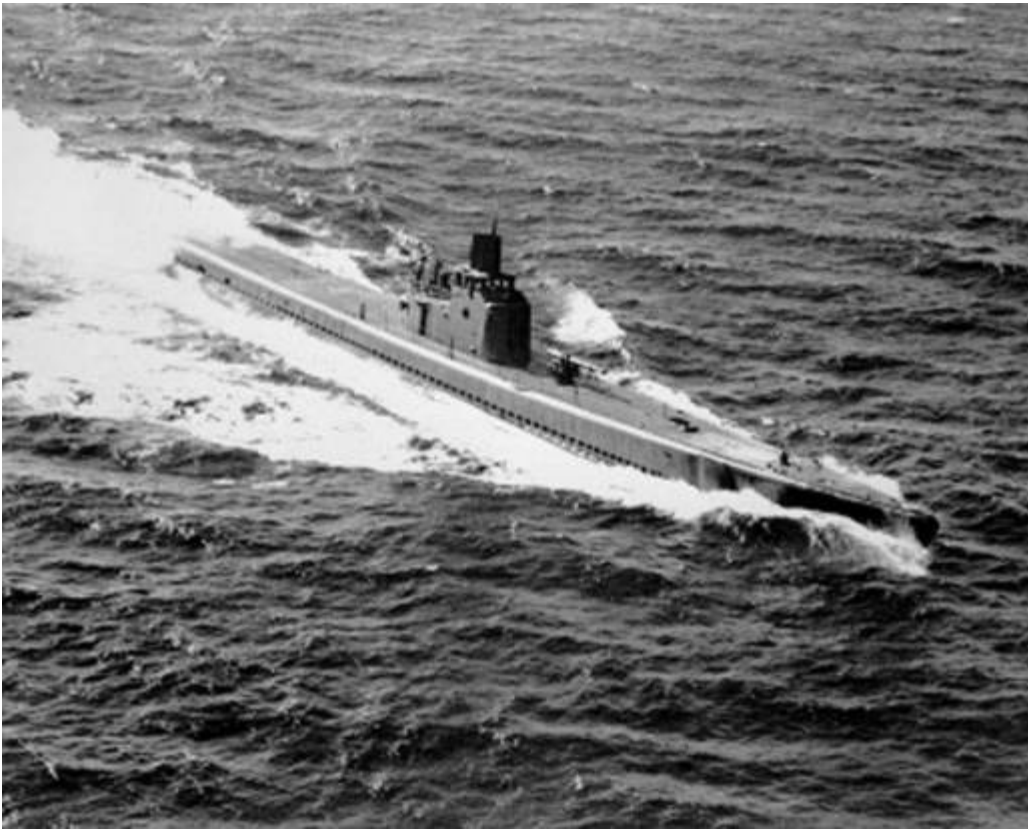
USS Halibut (SS-232) altered post damage photo.
Originally identified as Shad (SS-235)

The next photo reportedly shows *Shad* on 21 Mar 1944 with a very unusual Mod 2 low bridge. This would have required the sheltered navigation bridge to be cut down and then rebuilt to match the level of the lowered bridge. There also would have been no point. Why lower the bridge, unplate the wagon ribs, then leave the huge bulk of the navigation bridge in place? A close look at the photo shows unmistakable evidence of censoring and alteration. The area forward of the bridge and the periscope shears have been heavily censored, the deck gun altered, and details on the main deck obscured. She is also missing her radars. Other views of *Shad* taken at the same time show her with a Mod 4 configuration, so there seems to be very little reason for the Navy to want to heavily censor this photo of *Shad*.

Notice the close similarities between the purported *Shad* photo and that of the confirmed post war photo of *Halibut*

above. I now believe that the first photo was an attempt to hide the fact that *Halibut* was so badly damaged that she had to be decommissioned, for all intents and purposes a war loss. The photo was probably taken during her transit between San Francisco and New London. Sometime in the intervening years the photo was mis-identified as *Shad*.

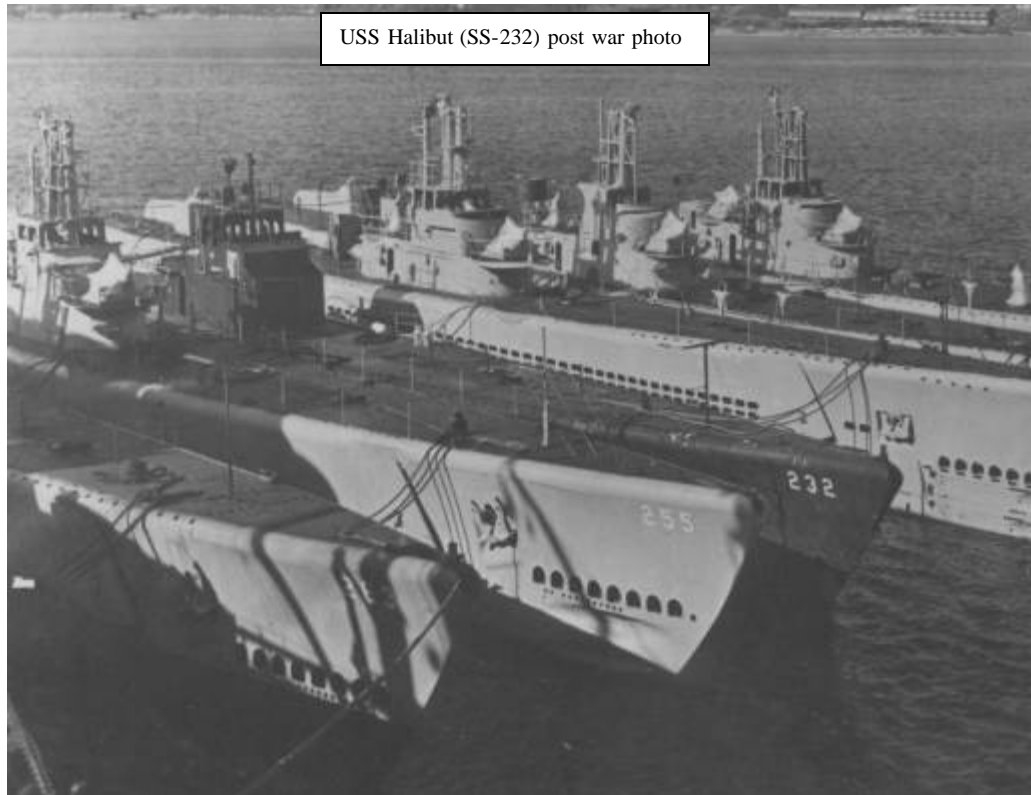
Recently, however another photo has come to my attention that I think clears up this mystery. The *Halibut* was severely damaged in an aircraft born depth charge attack on 13 November 1944. Only through heroic efforts by her crew was the terribly damaged *Halibut* able to return safely to port. Examined by engineers at Saipan, Pearl Harbor, and San Francisco she was deemed to be beyond economical repair. Temporarily patched up she sailed from San Francisco on 16 February 1945 for New London where she was decommissioned there on 18 July 1945.

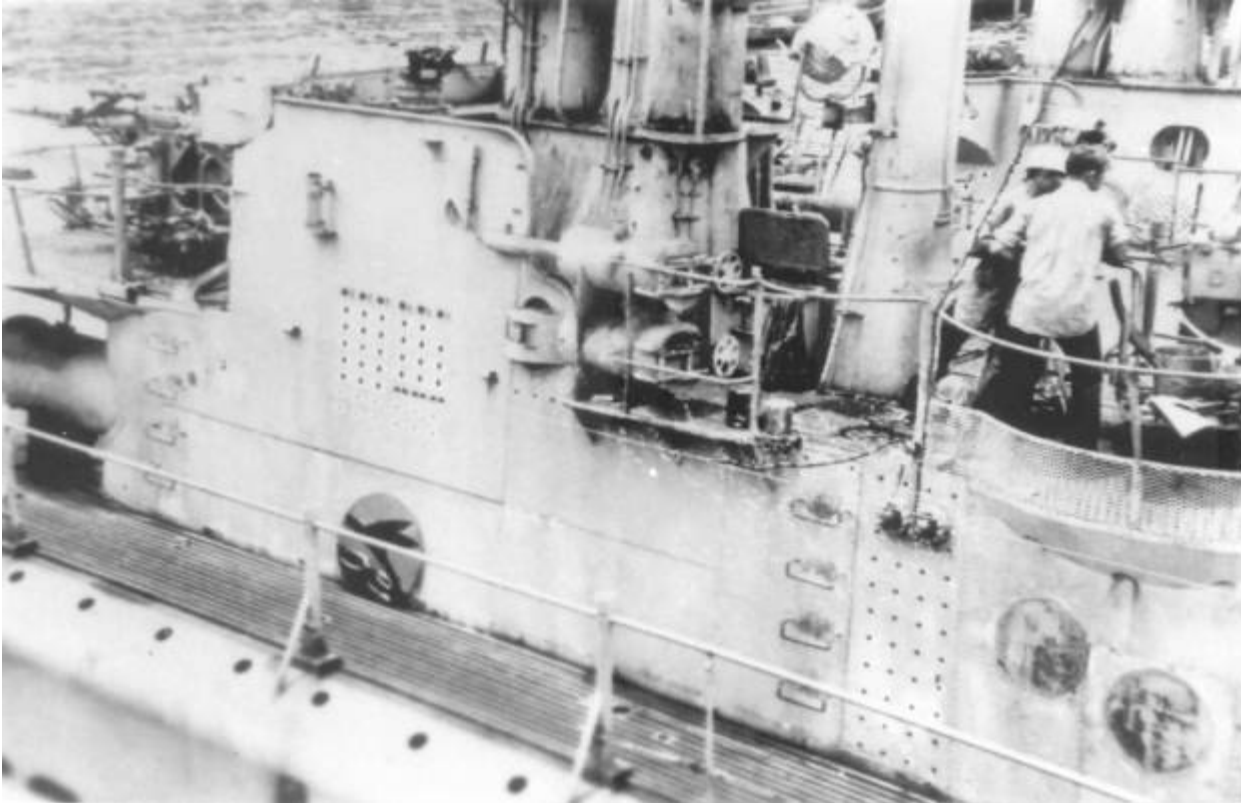
USS Flying Fish (SS-229 with Balao style modification to periscope shears and bridge

Flying Fish and *Steelhead* were unique among the *Gatos*. Both of these boats had complete rebuilds done on the fairwaters during the war. This involved the complete removal of the fairwater and periscope shears (including the distinctive covered wagon ribs) down to the main deck and the replacement of this structure with one that closely matched that of the later *Balao* class. In the case of *Flying Fish*, the reason for this radical, expensive, and time-consuming change is not yet clear. For *Steelhead*, it is known that she had a major fire in the conning tower on 01 October 1944, with the damage being extensive enough to warrant the installation of a new conning tower. Apparently the fairwater was rebuilt at this time as well.

Despite the visual similarity of these two boats to the *Balaos*, one major difference sets them apart. The elimination of the watertight door in the aft end of the conning tower in the *Balao* design allowed the repositioning of the main induction valve closer to the conning tower. This had the desirable effect narrowing the fairwater to a fine point at the aft end in the early *Balaos*, or of shortening the fairwater altogether in the later boats. The size of the cigarette deck gun platform had to stay the same, so the platform overhung the aft end of the fairwater, giving the *Balao* and *Tench* boats a look very distinctive from the other classes. (See the photo of the *Balao* and *Hardhead* below)

The *Flying Fish* and *Steelhead* did not have their main induction valves moved forward so they did not have the overhang at the aft end of the fairwater, this area remaining rounded on the end with the cigarette deck much longer when compared to the *Balaos*.

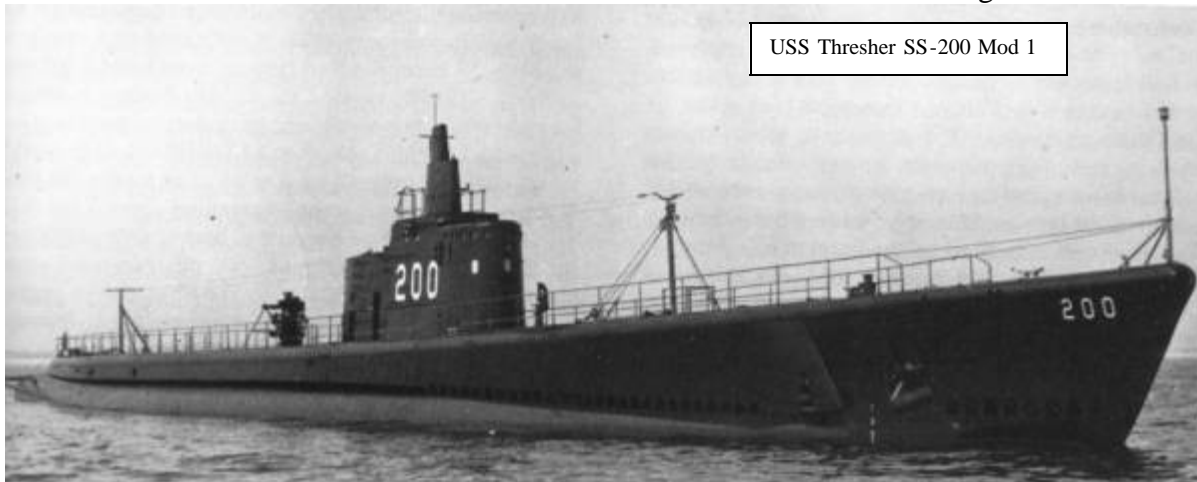
USS Thresher SS-200 Mod 1

These two photos show *Thresher* and *Grampus* in a classic as-built EB Mod 1 configuration. As you can see, they are nearly indistinguishable from the *Gatos*. The only readily apparent difference is in the periscope shears. All of the *Tambor/Gar* class boats had two 40-foot long periscopes, but they were the last class to retain a periscope station in the control room. This resulted in #1 scope position in the shears being shorter than the #2 position, giving the shears a stepped appearance. Later modifications eliminated the control room station and both scopes eventually let into the conning tower. The only other external difference between these boats and the later *Gatos* is that the *Tambor/Gar* class

was five feet shorter. This was due to the fact that all four main engines and generators were contained in one large engine room. Concerns over flooding of this one large space led to the *Gato* class engine room being divided in two, with a watertight bulkhead between them. The *Gatos* were lengthened slightly to accommodate this bulkhead. However, this difference in length is not readily apparent in photos. Notice how EB continued the practice of fairing the bull nose into the superstructure as they did with their *Sargo* class boats. In the *Grampus* photo you can see that for the first time the superstructure aft ended short of the hull, much different from the preceding *Porpoise/Shark/Perch* and *Salmon/Sargo* classes which had the aft end faired into the rest of the hull.

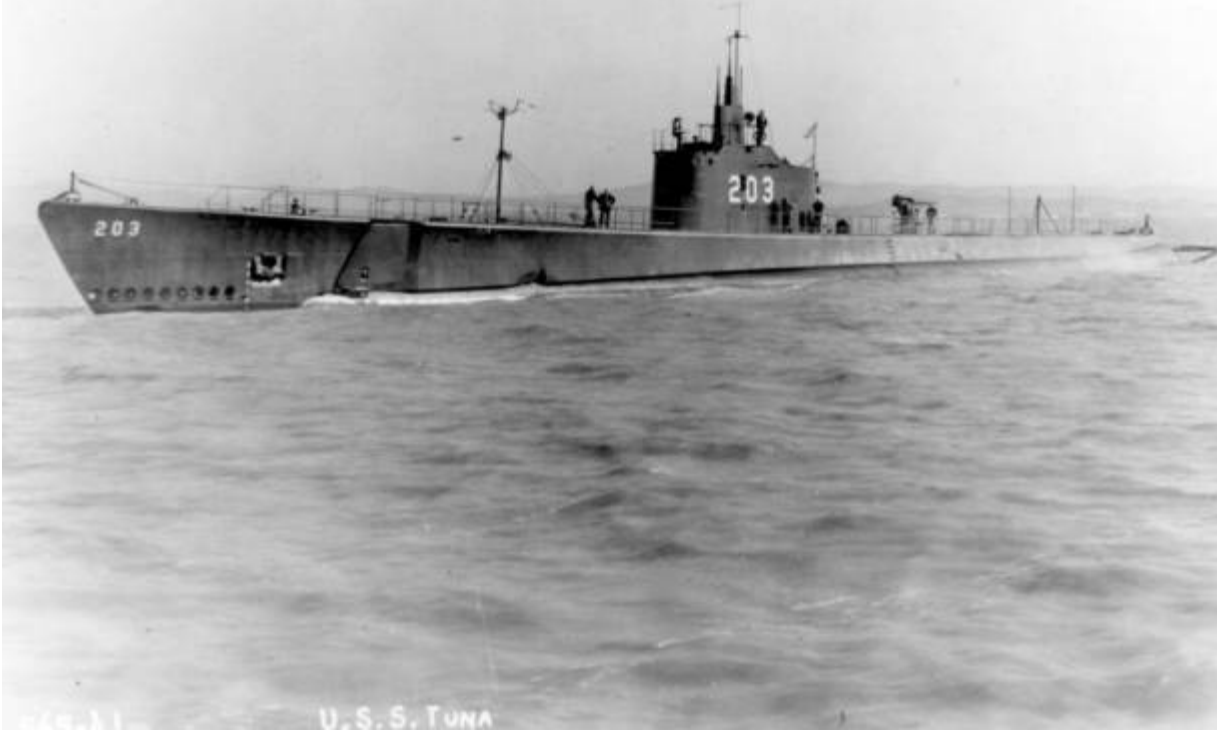
USS Tuna SS-203 Mod 1

The Mare Island built *Tuna* is typical of the Government design for these boats. There are few differences from the EB boats, but a two features stand out. Continuing the practice from the earlier *Salmon/Sargo* class, the six Government built *Tambor/Gars* were the last to have the above deck, ring-type bull nose. All fleet boats built after this point, whether EB or Government design had the faired-in style bull nose. Also, the EB style large semi-circular limber holes aft of the bow planes for flooding the superstructure are absent on the Government boats. There is a slight gap between the bottom edge of the superstructure and the pressure hull on the Government boats and it is here that the water floods in. This tended to slow dive times and shortly after commissioning most of the Government *Tambor/Gars* were retrofitted with a small set of limber holes. This photo of *Tuna* is interesting in that she seems to have some damage to the superstructure along the bottom edge, just aft of the forward radio aerial mast.

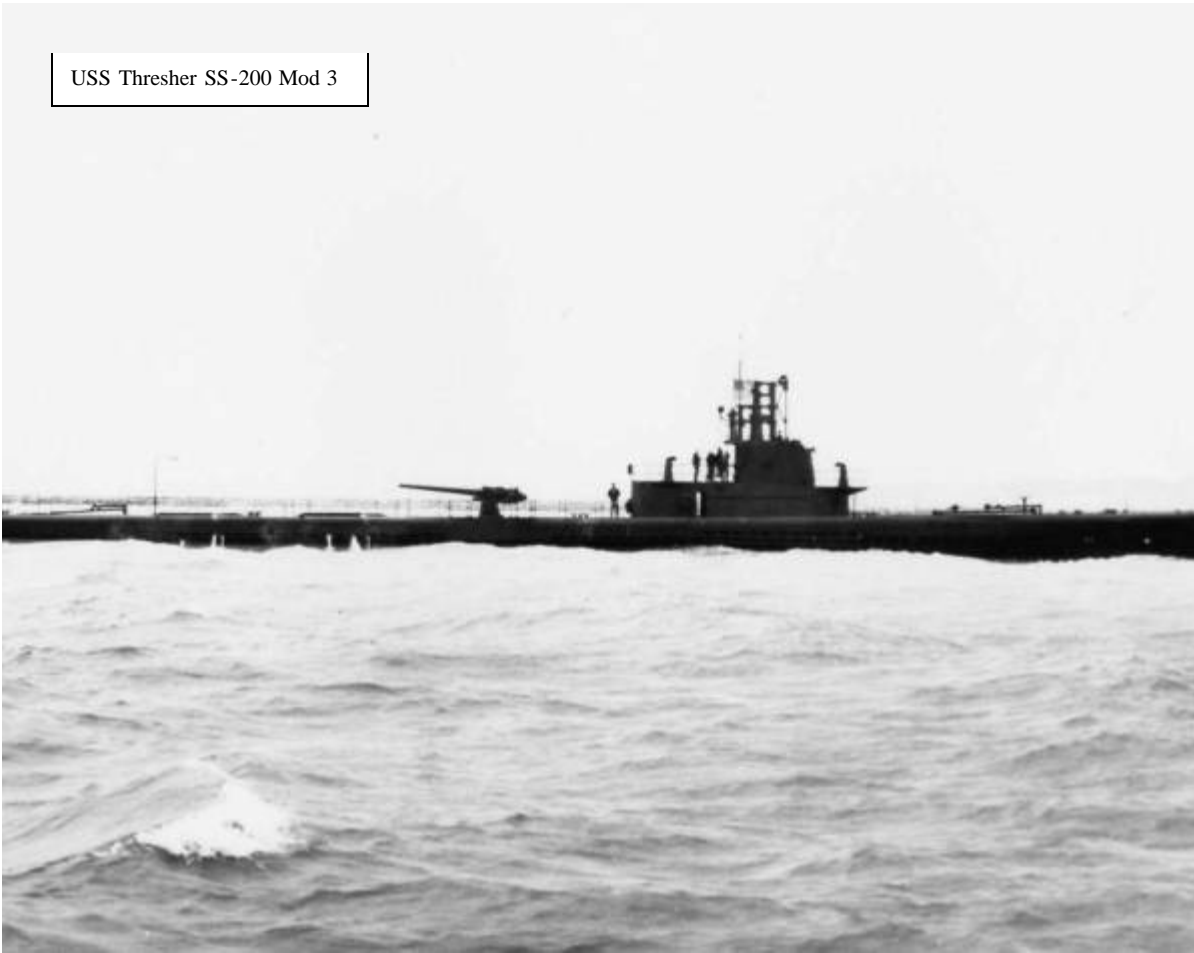
USS Thresher SS-200 Mod 3

This shows the cut away of the forward navigation bridge and the aft “cigarette” deck on the fairwater. The SJ radar mast is mounted forward of the shears and the SD mast aft of the shears. The bridge fairwater is cut away under the aft lookout platform and ready-use ammo tubs have been added on the aft edge of the fairwater near the deck. The 20 mm mounts are still the older solid base type; the lighter weight open mounts will come later. On the main deck aft of the gun mount you can see raised platforms over the engine mufflers. On older fleet boats that were re-engined, this was sometimes necessary to accommodate the larger mufflers of the new engine types. However, re-engining of the *Tambor/Gars* does not seem to have taken place as the Navy was quite satisfied with the GM/Winton 16-248 and Fairbanks-Morse 38D8 1/8 diesels that were installed in these boats. I have yet to determine the true purpose of these raised platforms in this class. The original 3”/50 caliber deck gun has been replaced with a large 5”/51 caliber Mk. 9 gun at the insistence of Admiral Charles Lockwood. Not apparent in this photo is the flared out sponson on the port and starboard sides of the superstructure needed for the gun crew to maneuver this large gun through its full firing arc. Intended to provide more hitting power than the dinky 3”/50, this gun proved to be unwieldy in practice and its use was not repeated on the *Gatos*.

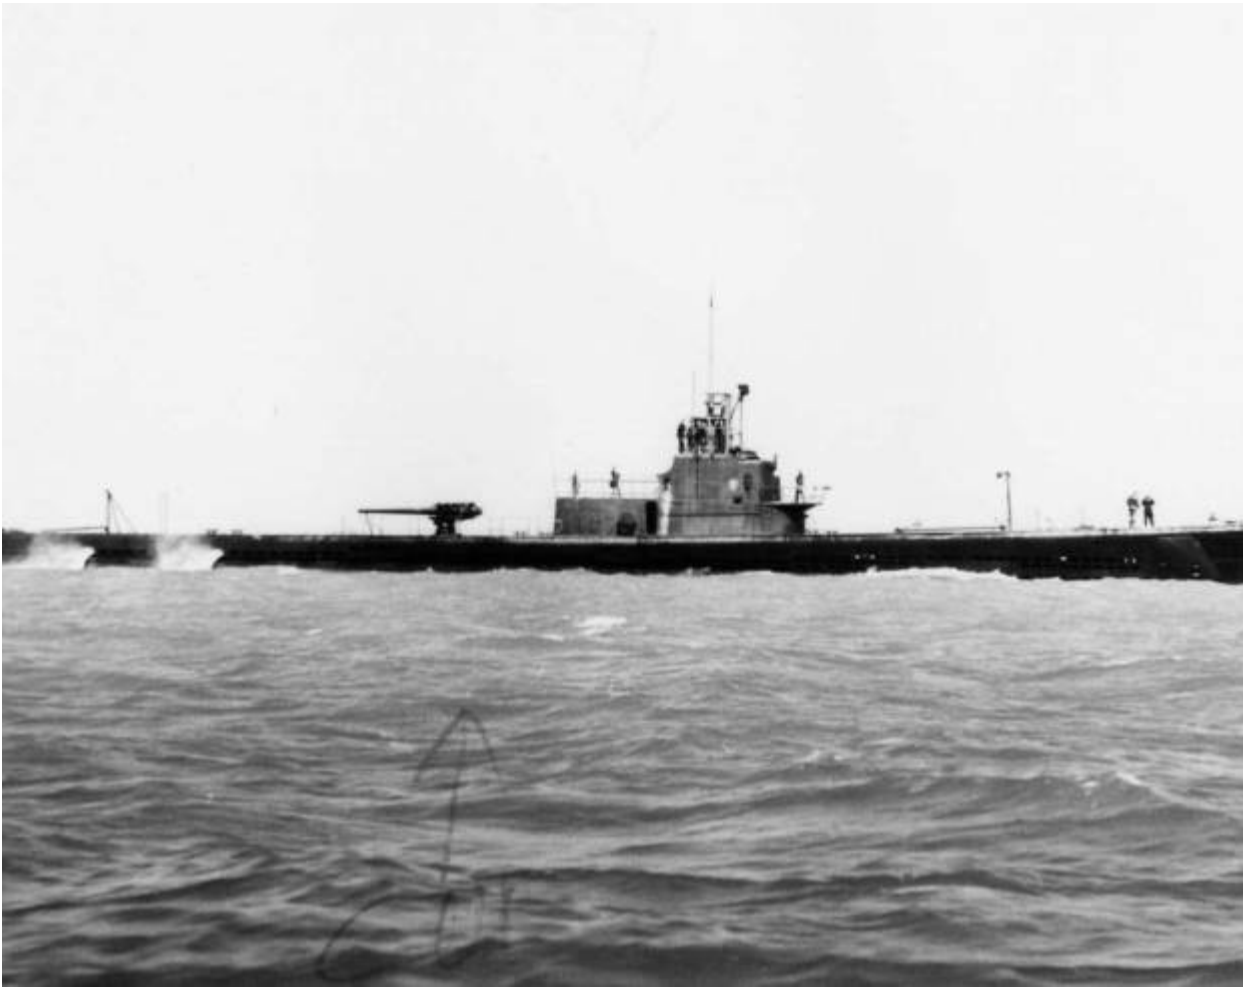
USS Grayback SS-208 Mod 3 Long Bridge

The ill-fated *Grayback* is shown here with a Mod 3 Long Bridge, a 5"/51 caliber gun, and the later open mount 20 mm anti-aircraft guns on the forward and aft gun decks. *Gudgeon* also received a similar mod prior to her loss.

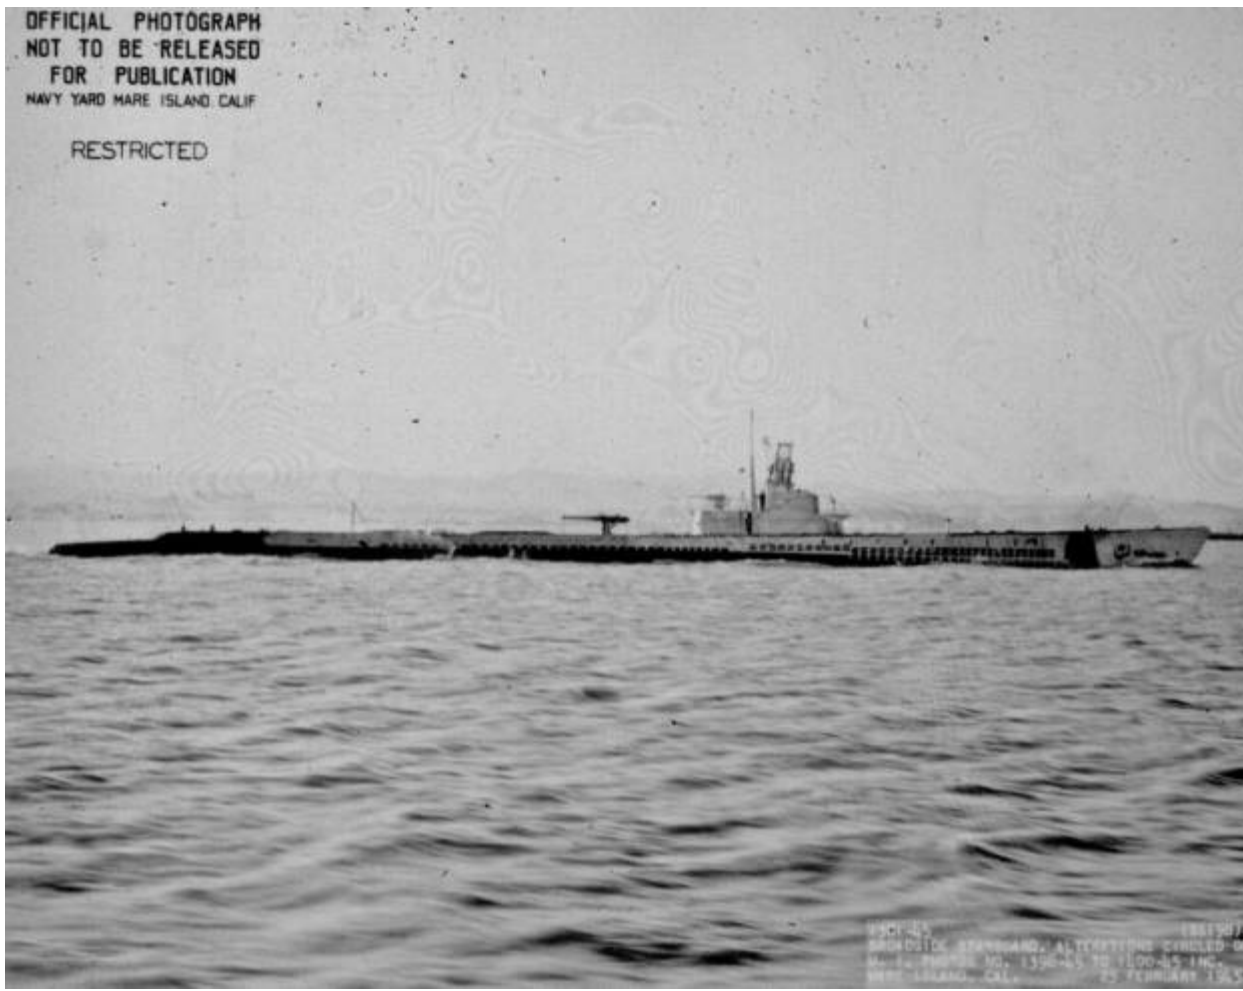
USS Tambor SS-198 Mod 4A

Tambor alone seemed to receive the full suite of mods, with the photo above showing her with a Mod 4A, a 40 mm on the cigarette deck, open mount 20mm on the forward gun deck, and the SD radar on the separate mast. She also lost her big 5"/51 gun in favor of the smaller but easier to use 4"/50.
