USS Vulcan

USS *VULCAN*
(AR-5)
James River Reserve Fleet
Newport News vicinity
Virginia

USS *VULCAN* (AR-5)

HAER No. VA-129

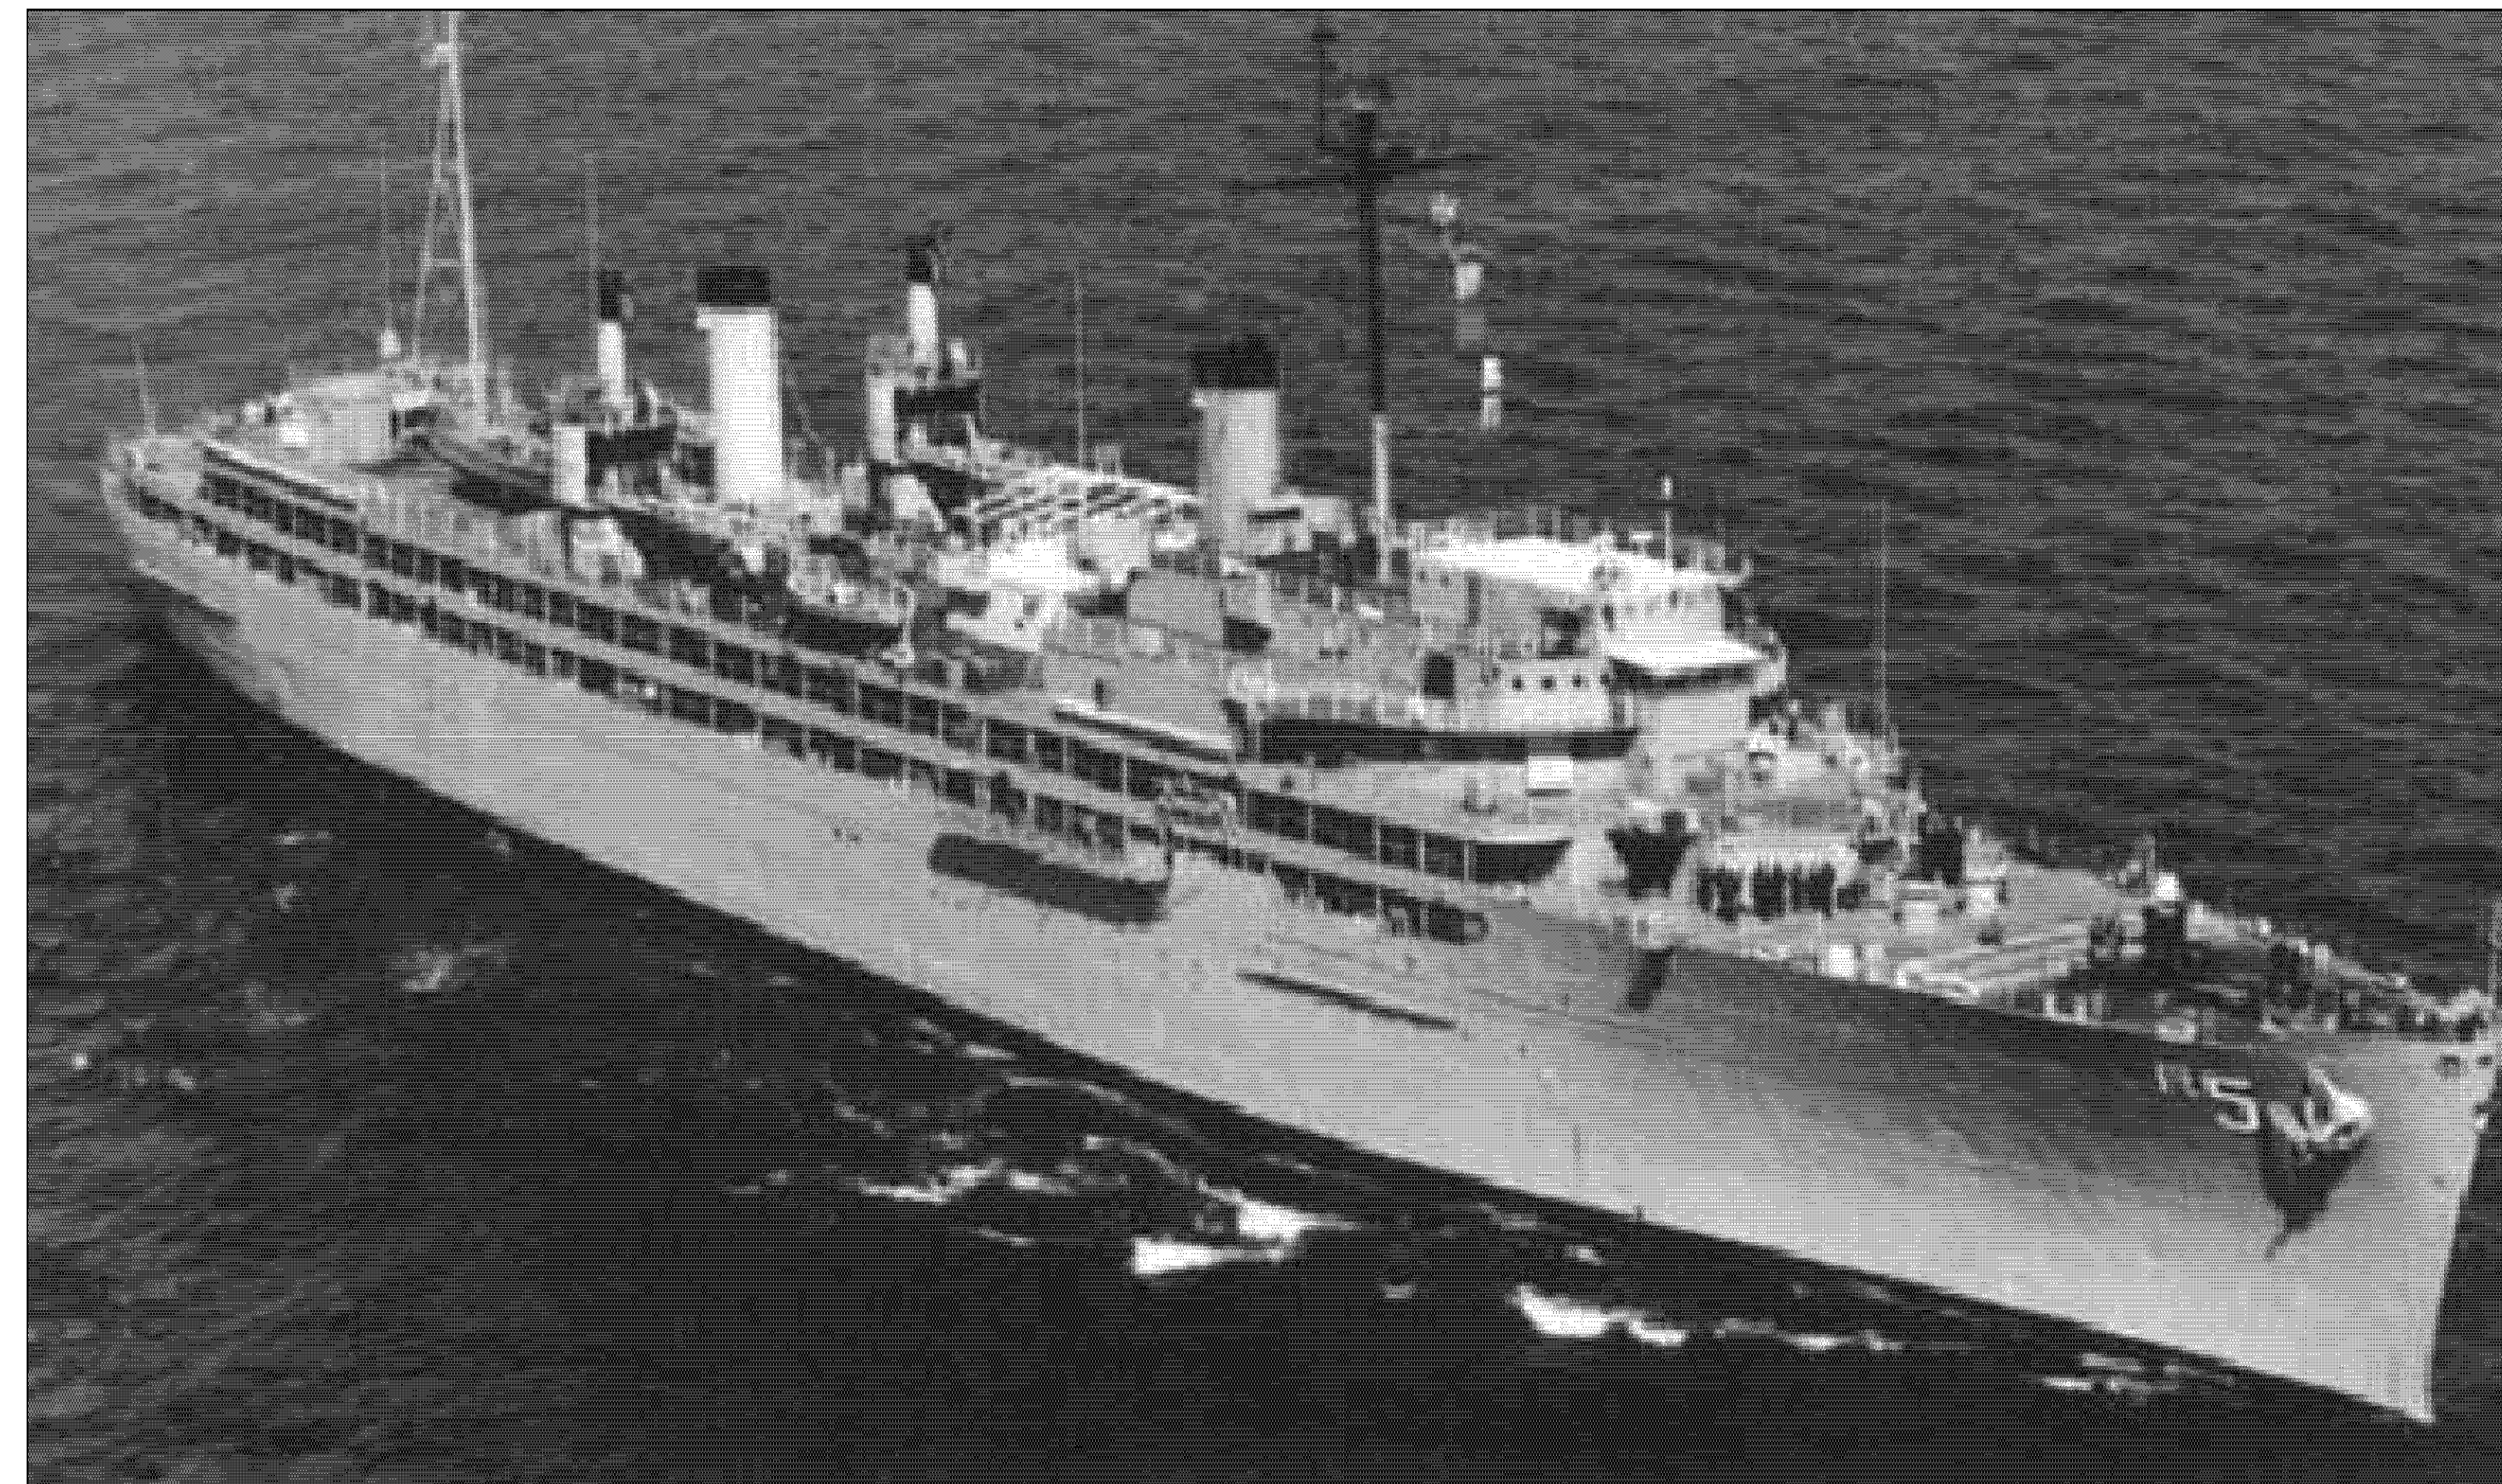
NAVY REPAIR SHIP *USS VULCAN*, CIRCA 1941.

THE VULCAN WAS AN AUXILIARY REPAIR SHIP DEPLOYED TO FORWARD AREAS SUPPORTING THE U.S. NAVY. WHEN NOT ENGAGED IN WAR, THE SHIP PROVIDED ASSISTANCE FROM PORTS CLOSE TO THE OPERATIONAL AREAS OF THE ATLANTIC FLEET. VULCAN PARTICIPATED IN WORLD WAR II, THE OCCUPATION OF JAPAN, THE CUBAN MISSILE CRISIS, AND VARIOUS NATO EXERCISES. THE SHIP IS NOTABLE FOR ITS ROLE AS A TEST PLATFORM FOR THE WOMEN IN NAVY SHIPS (WINS) PROGRAM AND FOR HELPING THE NAVY MAKE THE TRANSITION TOWARDS INTEGRATING WOMEN INTO THE FLEET. VULCAN'S FIFTY YEARS OF SERVICE IS A PROVEN TESTAMENT TO THE NECESSITY OF AUXILIARIES IN THE U.S. NAVY.

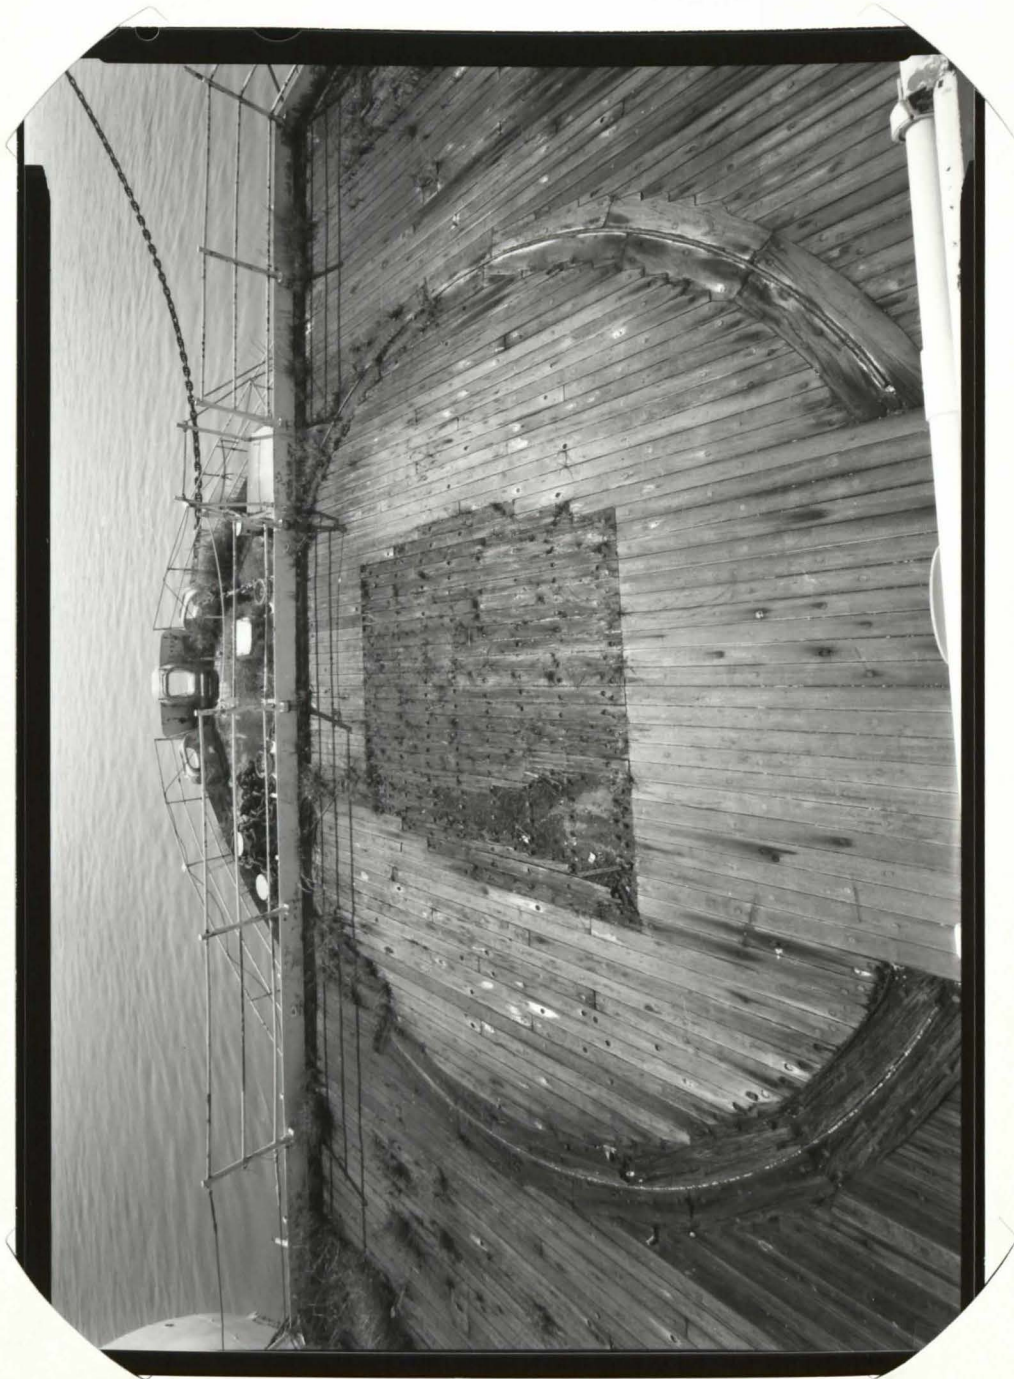
HAER No. VA-129-9

| VA-129-9 | Detail of ghosting of turret mount on aft deck. |

For the duration of its career, the *Vulcan* remained home ported at Norfolk, Virginia, operating off the East Coast repairing ships for the Atlantic Fleet. Deployments ranged from the Caribbean to Canadian ports. During the Cuban Missile Crisis, the *Vulcan* supported the ships involved in the blockade while based out of San Juan, Puerto Rico. The ship participated in two NATO exercises in fall 1964 and made ports of call in Belgium, France, and Spain before returning to Norfolk where it underwent a major overhaul in 1976. The work included removal of the 5" guns and replacement with four 20-mm guns.
